MILL POND DAM
PHASE I
INSPECTION / EVALUATION REPORT

Dam Name: MILL POND DAM
State Dam ID #: 7-4-327-1
NID #: MA02480
Owner: Town of West Tisbury
Owner Type: Municipal
Town: West Tisbury, Mass.
Consultant: Kent A. Healy PE
Date of Inspection: August 30, 2006 - October 30, 2006

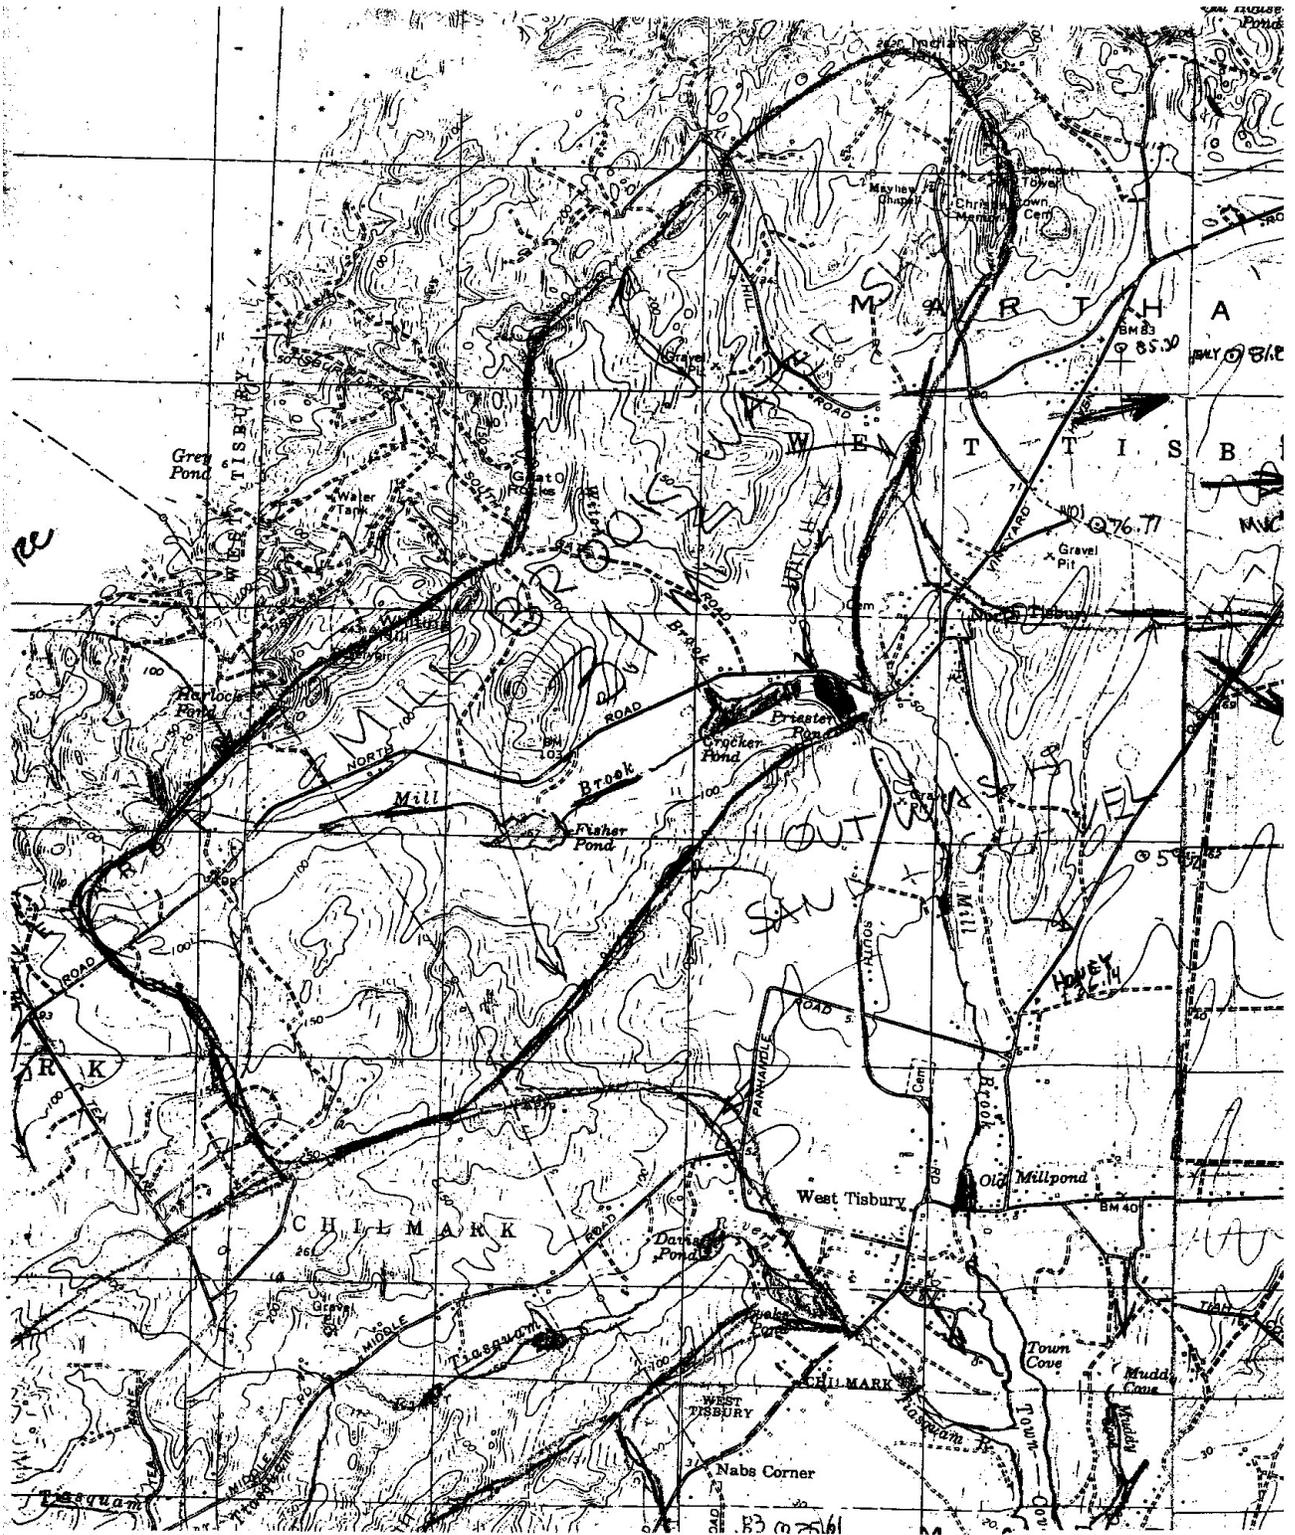
FIGURE 5
MILL BROOK WATERSHED, WEST TISBURY, MASS

The 100 year flood flow was calculated in the 1987 and 1995 inspection reports by multiplying a drainage area taken from a USGS Quadrangle map and multiplying that area (6.7 square miles) times a preliminary guidance quantity of 1350 CFS/ square mile giving a probable maximum flood (PMF) flow of 9000 CFS. The 100 year flood flow was taken as 1/5 of the PMF. This calculation gave too large a 100 year flow for two reasons. The actual water shed area is only 3.1 square miles because of the out wash deposits, and the actual runoff is much less than 1350 CFS/square mile because of the large area of wetland and woodland in the water shed, see figure 5.

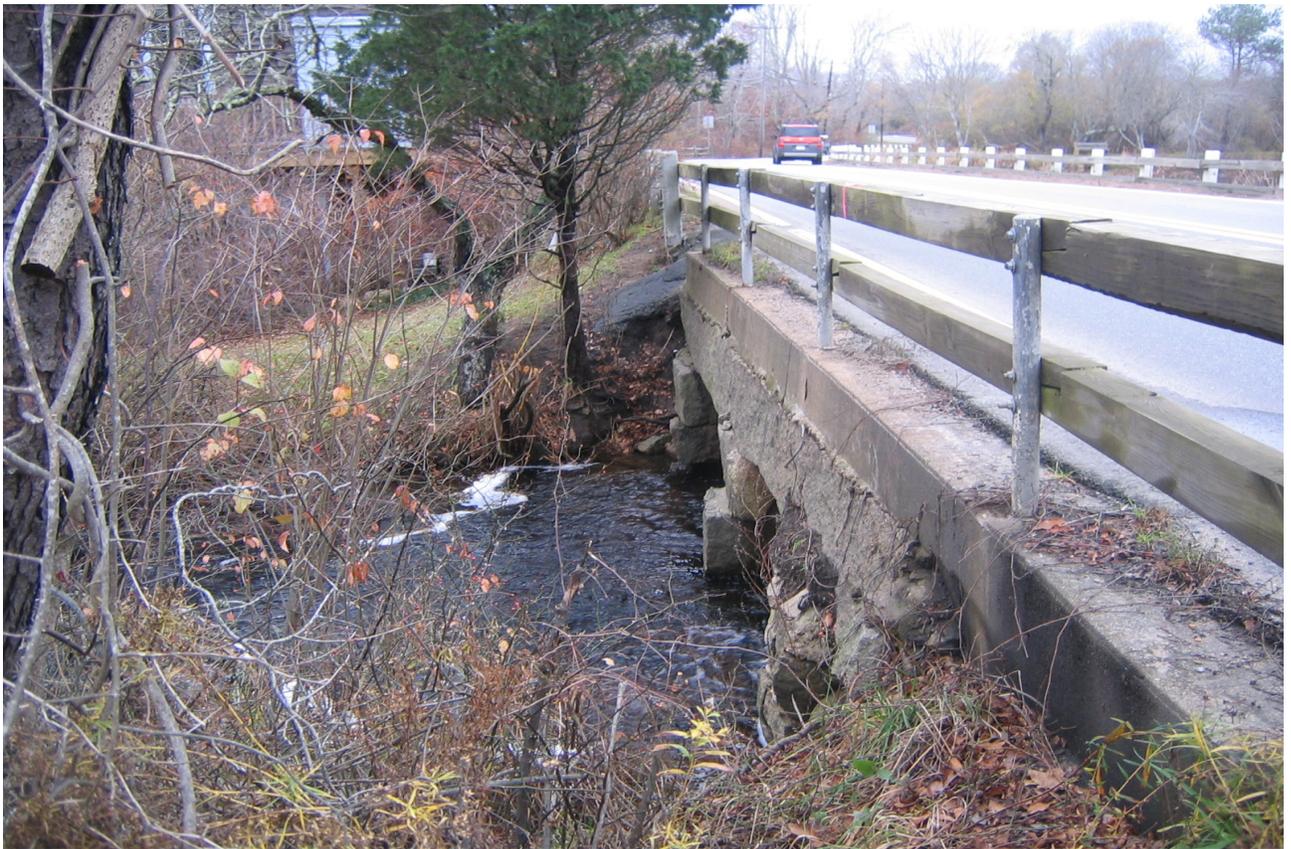
PHOTO 7 Overview of downstream Face from Right Abutment

The major recommendation of this report is that the high brush all along the downstream face of the dam be cut to allow inspection and that the areas of potential erosion from road runoff be protected with asphalt aprons. A perennial maintenance permit should be obtained from the West Tisbury Conservation Commission for this work.

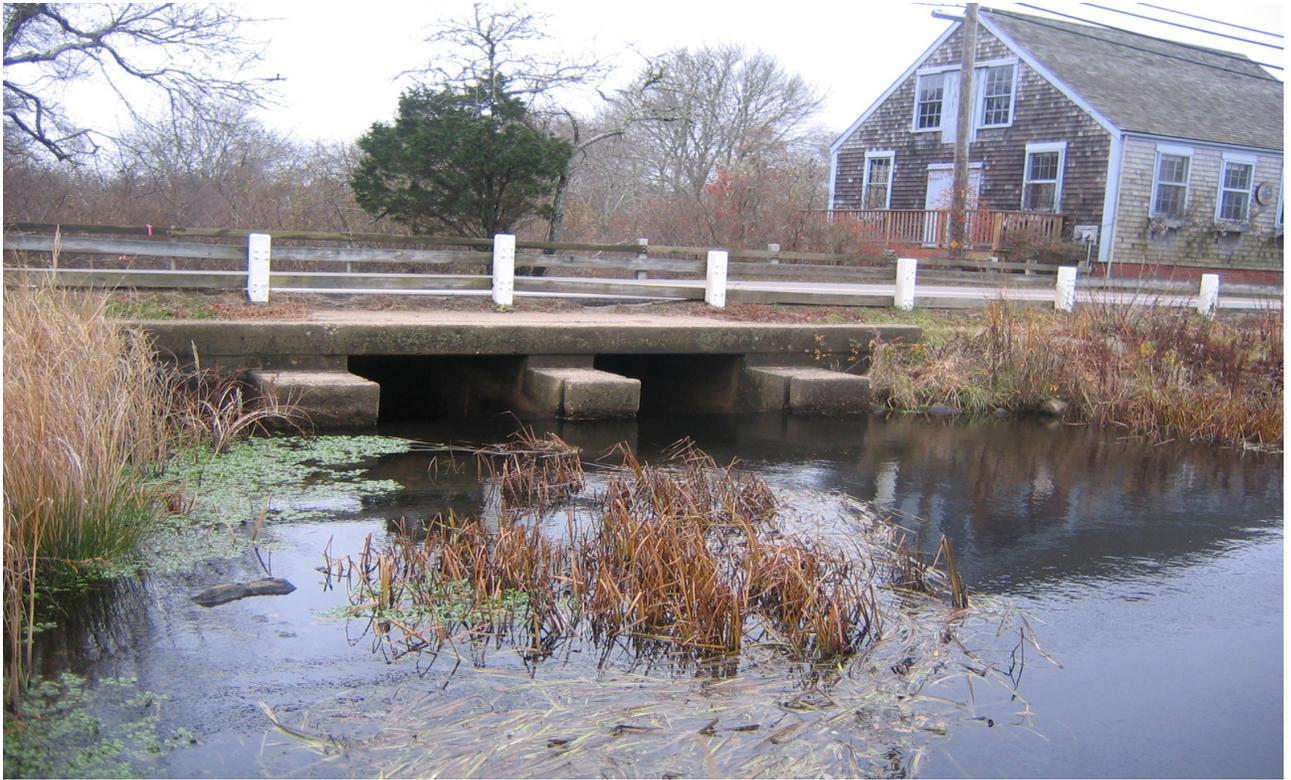
PHOTO 8 Overview of downstream face from Left Abutment

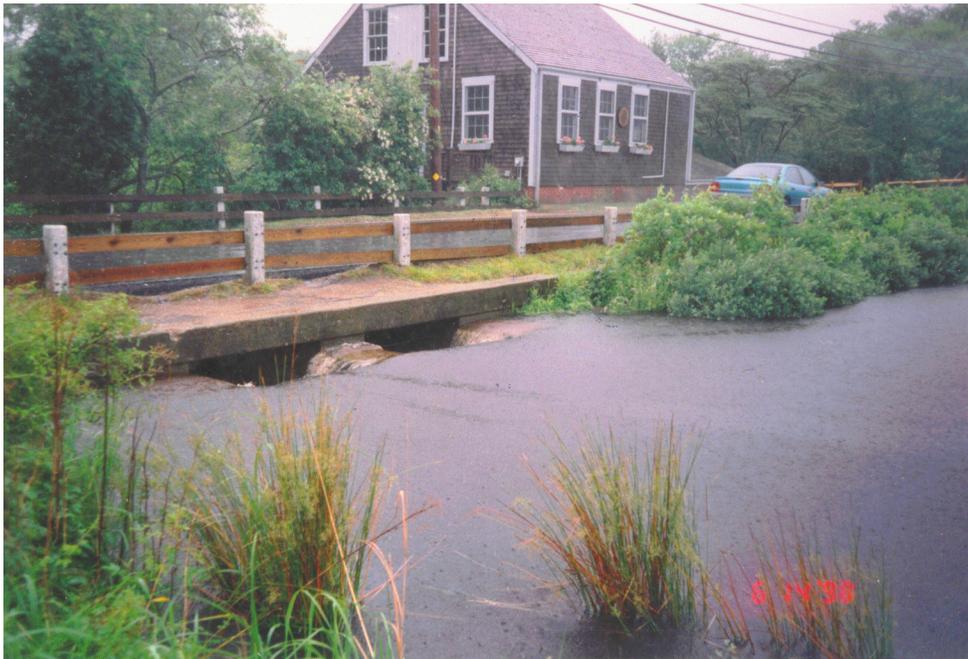
The largest stream flow during the last 20 years (1986 to 2006) occurred at about 7 AM June 14, 1998 after about 7 inches of rain fell on the Mill Brook water shed from 4 to 9 PM June 13, 1998. The peak flood flow of (main spillway 110 cfs and the Factory Brook spillway 20 cfs) about 130 cfs occurred at a pond surface elevation of +13.9 USGS Datum.

PHOTO 16 June 14, 1998 Flow at 110 cfs.
