COASTAL PROCESSES AND HAZARDS SPECIALIST REPORT  
CAPE COD COOPERATIVE EXTENSION  
WOODS HOLE OCEANOGRAPHIC INSTITUTION SEA GRANT  
bryan.mccormack@capecod.gov | 508-375-6849  
193 Oyster Pond Road, MS #2, Woods Hole, MA 02543-1525

4 August 2026

RE: Thumb Point Cove

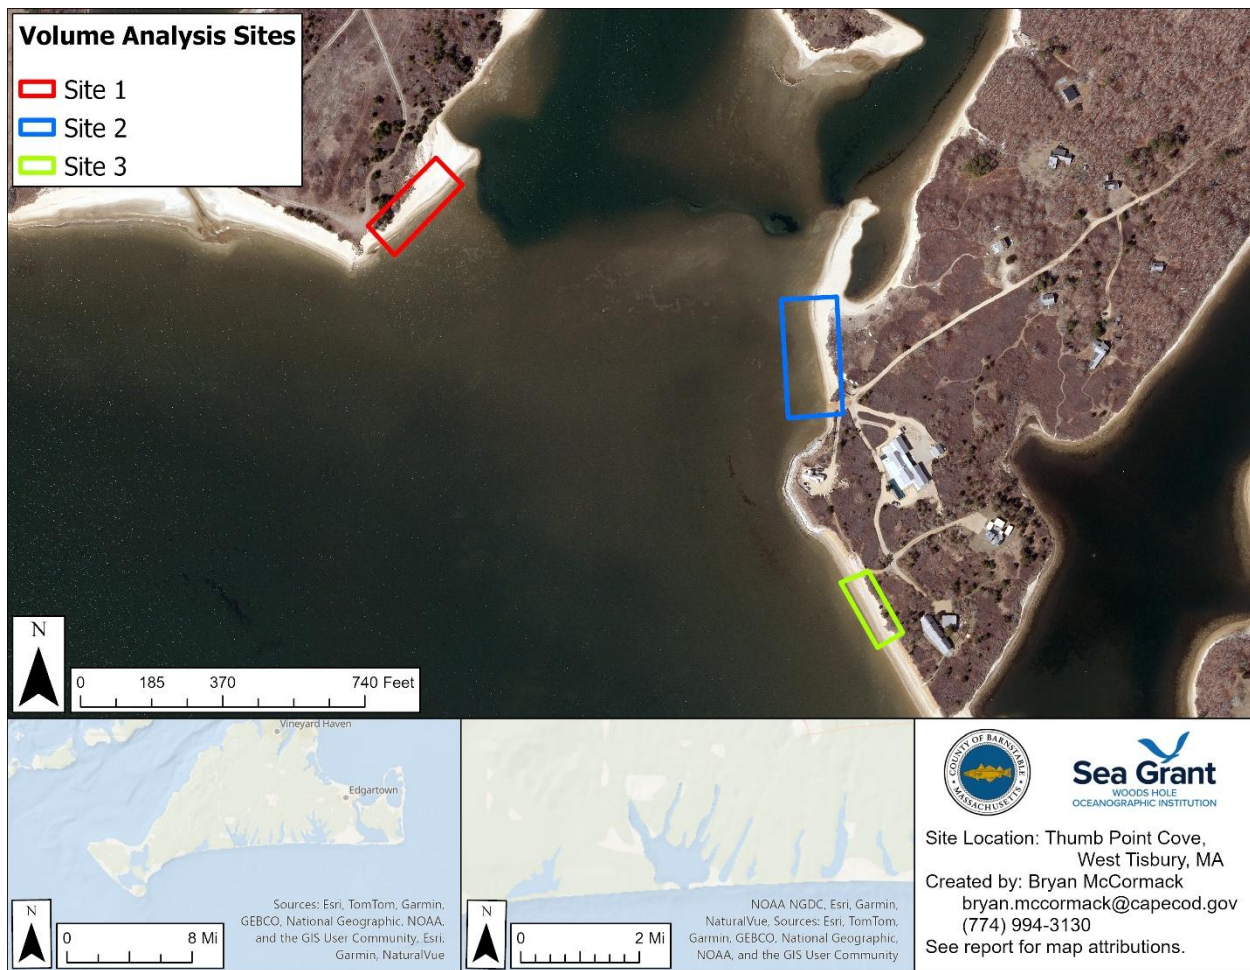
Figure 2: Sites for volume change analysis around Thumb Point Cove.

Three areas around Thumb Point Cove that do not have erosion control were used to calculate volume changes using lidar datasets (Figure 2). The analysis was conducted for 2010 to 2021, 2013 to 2021, and 2016 to 2021. These volume changes were used to calculate the erosion per linear foot of shoreline per year for a direct comparison to the nourishment figures calculated above. The figures for sites 1, 2, and 3 are shown in Tables 1, 2, and 3 below, respectively. It is important to note that these figures would be reflective of any nourishment that was transported into these areas within the timeframe.

All the sites in the analysis showed erosion throughout each time period. Despite the adjacent nourishment, sites 2 and 3 showed higher annual erosion per linear foot of shoreline. This suggests that the erosional volume being brought in for these sites is likely appropriate for the scale of erosion control.

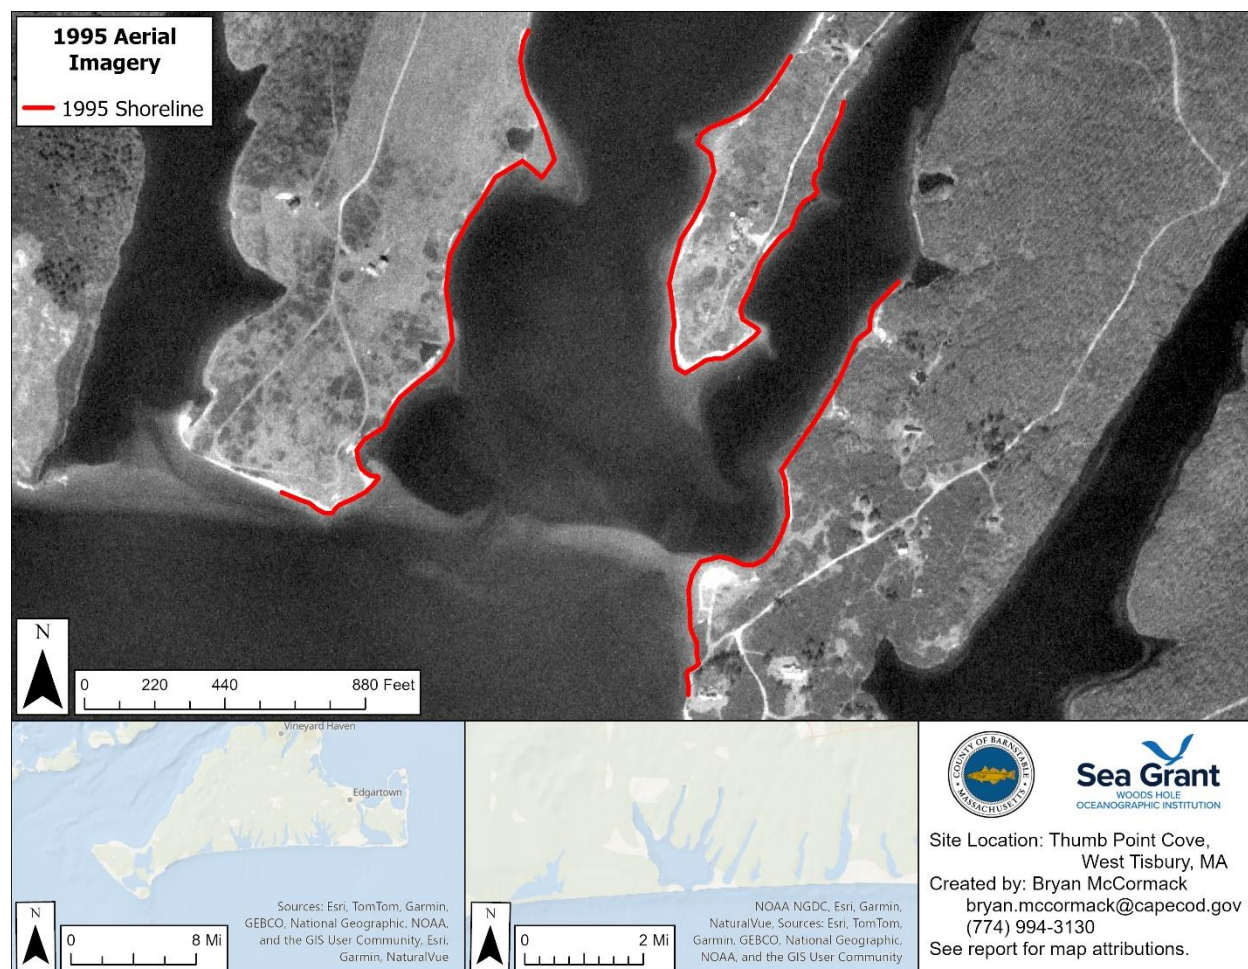
Figure 3: 1995 aerial imagery.

This area shows a flood dominant sediment transport regime, meaning that sediment is more likely to travel into the cove. This is likely due to wind coming from the south and potentially from a stronger flood current when Tisbury Great Pond is opened to the ocean. This is evident by the spit formation and elongation that can be seen in aerial imagery. Aerial imagery from 1995, 2014, and 2025 shows that this flood-dominant regime existed prior to the nourishment that began in 2014. These datasets are displayed below with traced shorelines to show the change through time.
