Aquatic Habitat Connectivity Survey

Mill Brook

West Tisbury and Chilmark, Massachusetts

August 2012

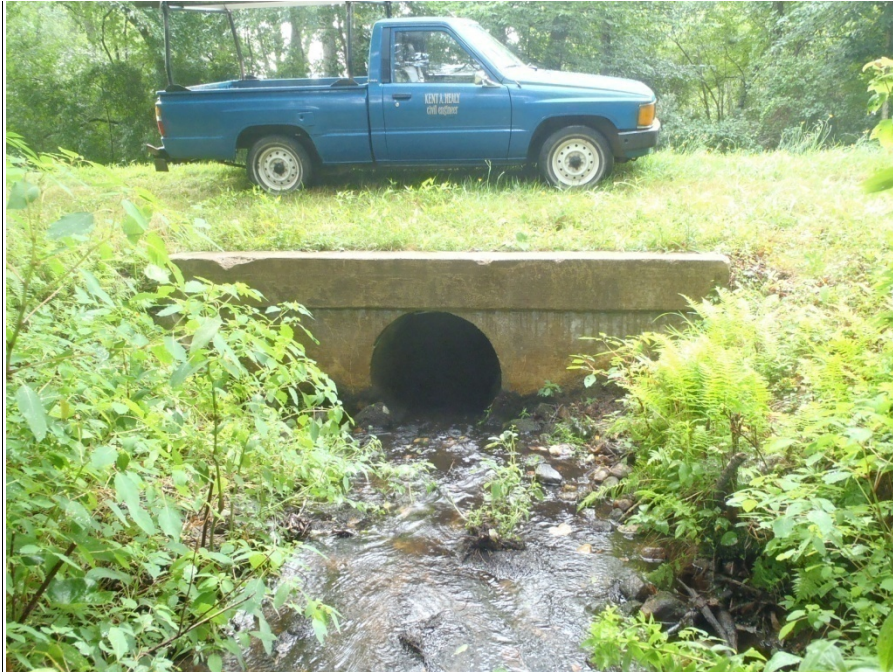
Upstream Face of culvert on Witch Brook at North Road

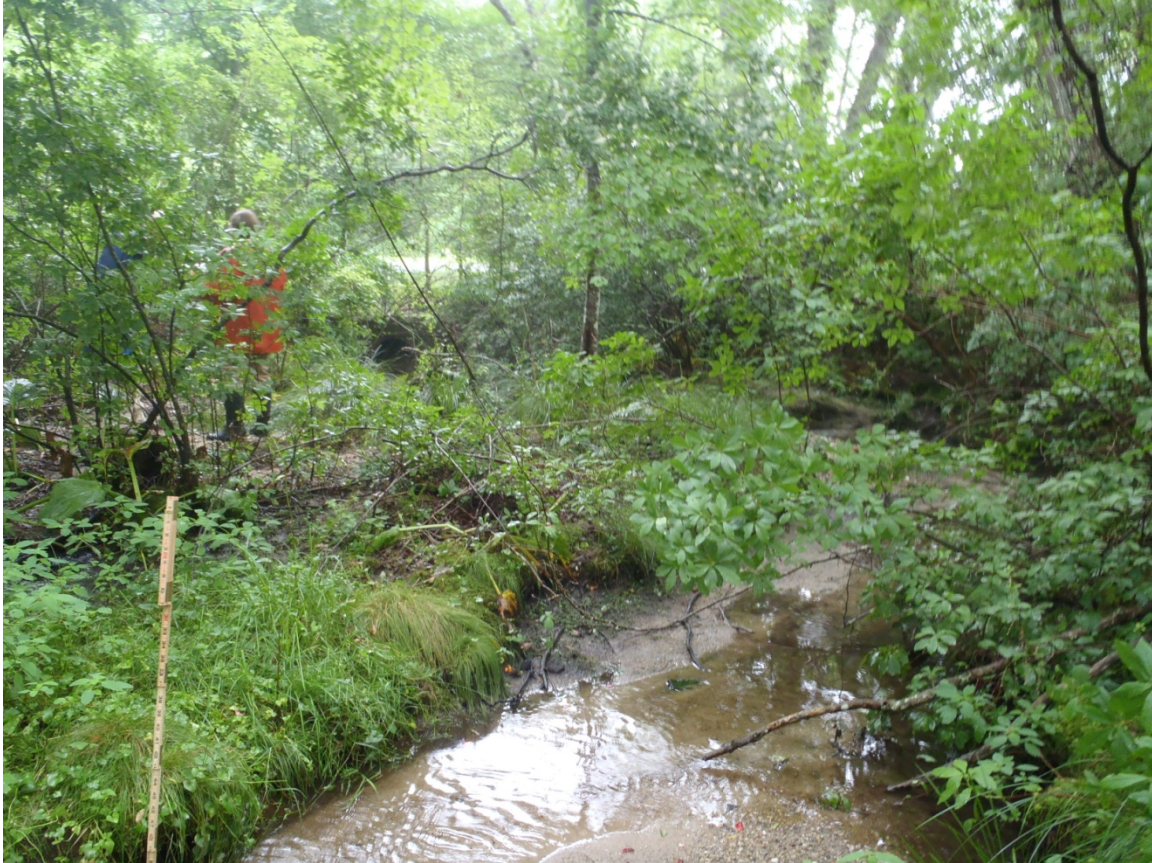
This culvert does form a constriction on the UNT as evidenced by its smaller width relative to the approximately 6-foot-wide bankfull width observed in this reach. Further evidence of a hydraulic constriction is found in the large scour pool at the outlet. This pool exceeds 3.5 feet of depth in spots and scour has displaced a quantity of sand and gravel into a large bar, likely restricting flow at certain times (see Photo 1 in Appendix A). This bar appears to backwater the outlet of the culvert under certain conditions, which may be a positive effect on upstream fish passage. However, the relatively small opening of the culvert, likely excessive velocities during high flows, and lack of dry passage through the culvert make it a moderate⁴ barrier to fish and wildlife passage. This culvert does not meet the Massachusetts Stream Crossing Standards for fish and wildlife passage

**Photo 1: Looking upstream at the sediment bar created at the outlet of the UNT to
Priester's Pond Culvert.**

The culvert appears to adequately handle a range of flows and certainly allows passage of most fish species under moderate to lower flows. However, because of its blockage of some fish and wildlife passage and apparent hydraulic inadequacy, this culvert would need to be replaced in order to fully meet the Massachusetts Stream Crossing Standards for fish and wildlife passage. In order for this crossing to achieve unimpeded passage of fish and wildlife, the crossing would need to be replaced, or at least modified, per the Standards. The size, alignment, geometry, and invert elevation of a replacement culvert would need to be determined based on engineering studies, consideration of beneficial and adverse environmental impacts, and fluvial processes in the downstream reach, including potential changes in downstream conditions that could occur following replacement of the North Road culvert. The selection and design of any replacement crossing should accommodate at least the “General” standards established by the Massachusetts River and Stream Crossing Partnership described under Section 2.0 above. The design of a new crossing would likely need to be performed in accordance with MassDOT standards. To the extent that the Town is interested in pursuing culvert replacement and has funds available, replacement of this culvert might be undertaken during upcoming road resurfacing work.

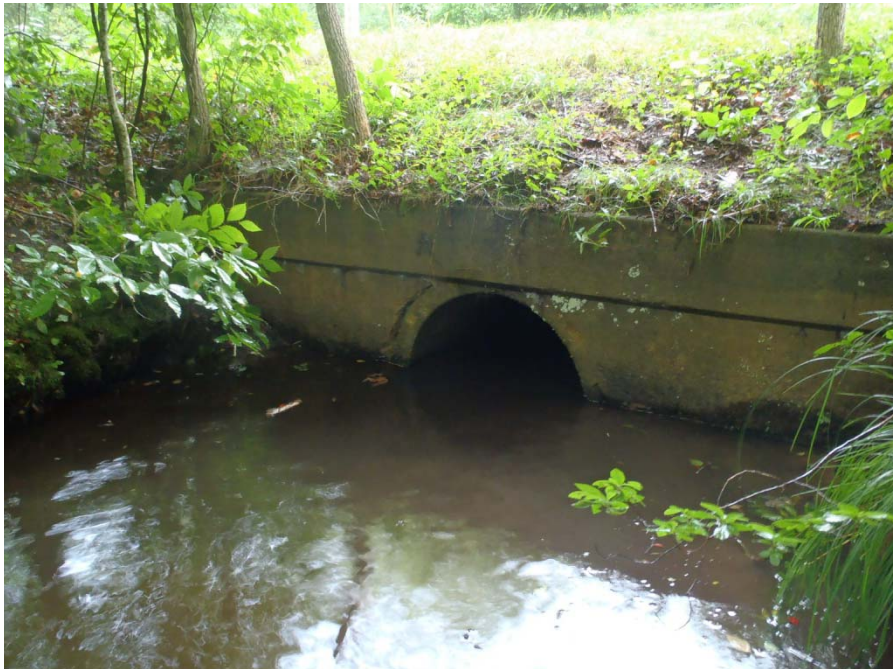
Photo 2: The downstream outlet of the culvert passing the UNT to Priester's Pond showing expansion scour and scour pool.

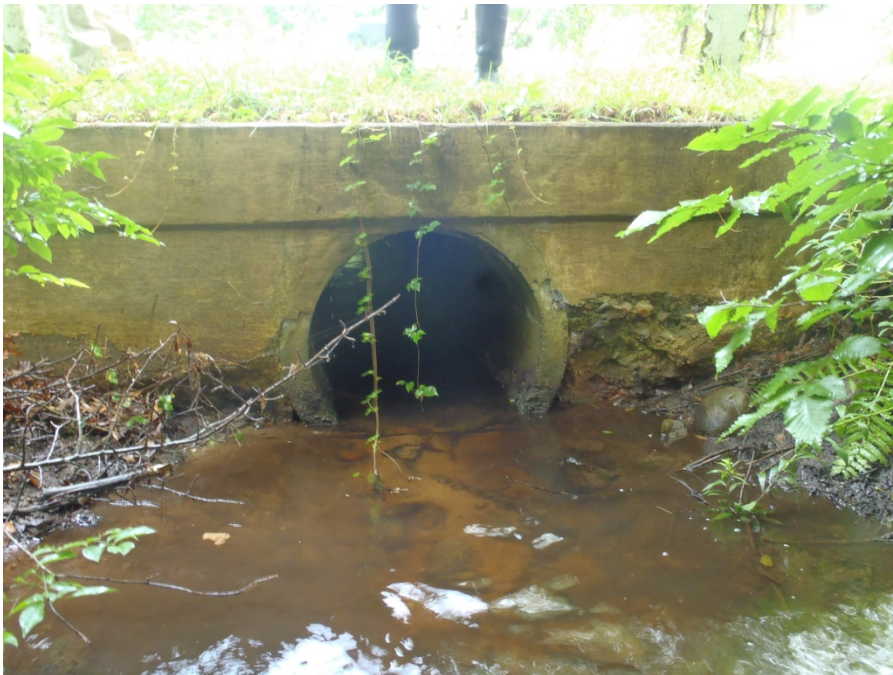
This culvert does not meet the MA Stream Crossing Standards for fish and wildlife passage. This culvert does form a constriction on Witch Brook as evidenced by its smaller width relative to the approximately 4-to-6-foot-wide bankfull width observed in this reach (see Photo 3). Further evidence of a hydraulic constriction is found in the small scour pool at the outlet. This pool is somewhat larger and deeper than representative areas of this reach of Witch Brook. However, the relatively small opening of the culvert,

Photo 3: Outlet of the Witch Brook culvert showing expansion scour.

The culvert on Witch Brook at North Road appears to adequately handle a range of flows and certainly allows passage of most fish species under moderate to lower flows. However, because of its blockage of some fish and wildlife passage and apparent hydraulic inadequacy, it does not meet the Massachusetts Stream Crossing Standards for fish and wildlife passage. In order for this crossing to achieve unimpeded passage of fish and wildlife, the crossing would need to be replaced, or at least modified, per the Standards. The size, alignment, geometry, and invert elevation of a replacement culvert would need to be determined based on engineering studies, consideration of beneficial and adverse environmental impacts, and fluvial processes in the downstream reach, including potential changes in downstream conditions that could occur following replacement of the North Road culvert. The selection and design of any replacement crossing should accommodate the “General” standards established by the Massachusetts River and Stream Crossing Partnership described under Section 2.0 above. The design of a new crossing would likely need to be performed in accordance with MassDOT standards.

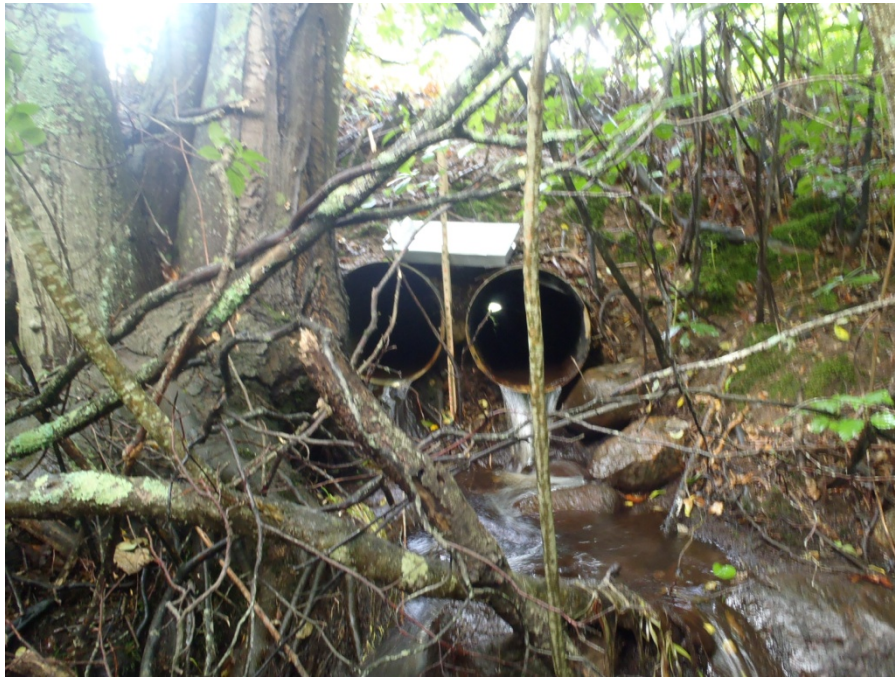
The two twelve-inch-diameter corrugated metal culverts appear in adequate condition. Despite being nearly inundated at the upper end, flow at the outer end encompassed a depth of only one inch. This may indicate partial blockage with debris, a problem with the culverts' horizontal alignment, or some compromise of the culverts' internal integrity, though this could not be verified based on visual assessment. Given the densely vegetated nature of the impoundment, it is likely that debris may become stuck in the relatively small diameter pipes from time to time.

Photo 4: The downstream side of the outlet of the Old Farm Road Dam

A certified dam inspector should be consulted to obtain recommendations regarding the advisable outlet dimensions and configuration for a dam of this size as well as any maintenance or repair recommendations that might serve to improve its safety. Reconfiguration of the dam's outlet should also take into consideration potential improvements to fish and wildlife passage, however, due to its separation from potential diadromous fish passage, traditional fish ladders and the like are probably not necessary or appropriate at this time. Removal of the outlet structure and replacement with a properly-sized span would alleviate dam safety concerns and provide excellent fish and wildlife passage. This option would likely mean the loss of some of the impoundment and should be balanced against other goals. Depending on the extent of the dam chosen to remain, local hydrology, and the crossing type chosen, stabilization of the channel through the area of the crossing would be required.

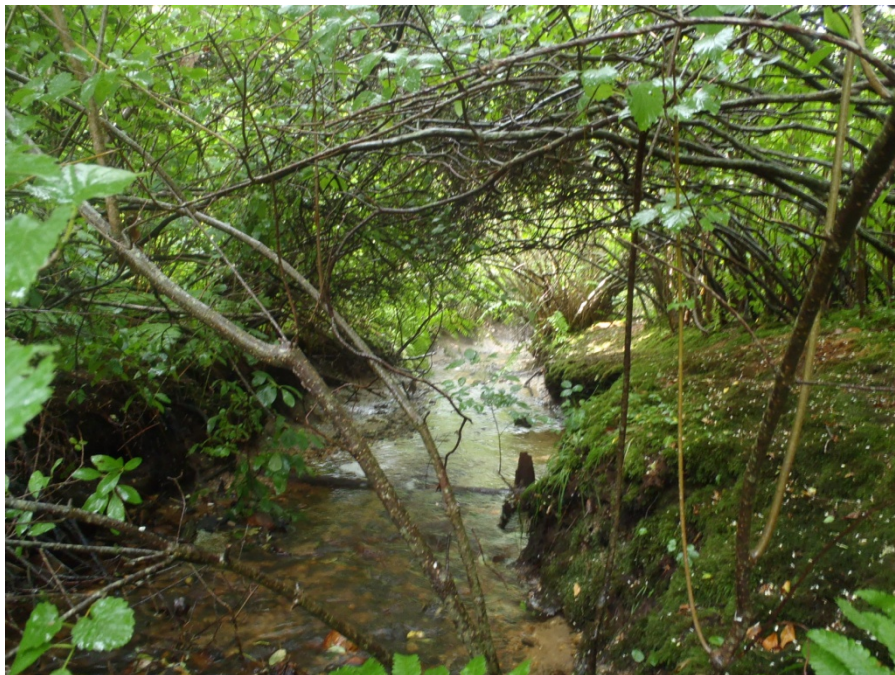
Photo 5: View looking upstream from the culvert on Tiah's Cove Road

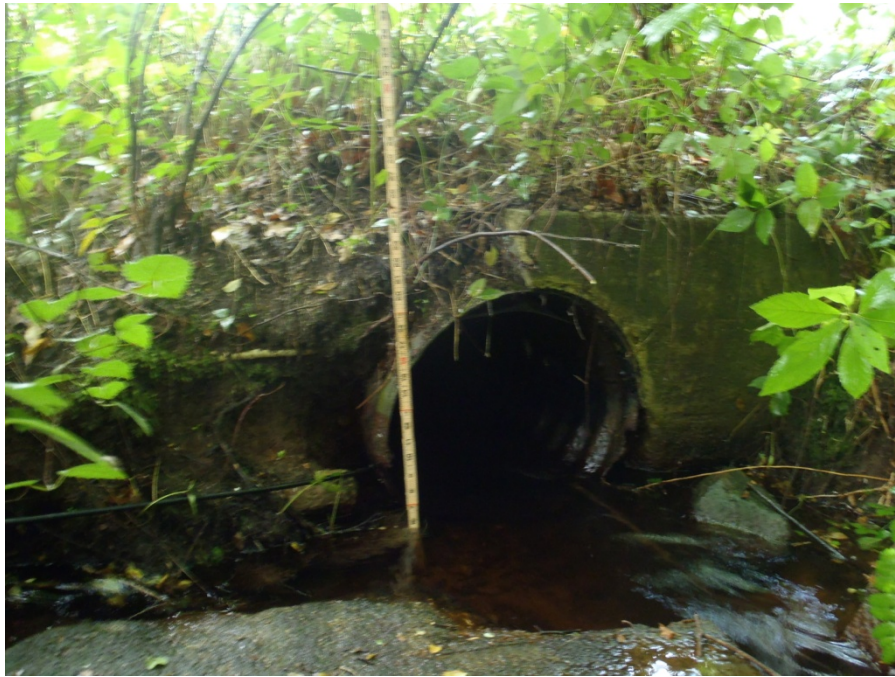
The UNT passes under Tiah's Cove Road via a corrugated metal pipe. This crossing does not meet the Massachusetts Stream Crossing Guidelines for fish and wildlife. The culvert measured 18 inches in diameter at its upstream end and 28 inches in diameter at its downstream end. Both ends of the culvert are supported by concrete headwalls. Part of the upstream⁹ headwall has dislodged and fallen into the stream forming a partial barrier to fish and wildlife movement through the culvert (see Photo 6). In addition, what appeared to be a coaxial cable was observed passing through the culvert on its eastern side. It is not clear what service, if any, this cable provides and to what adjoining properties.

Photo 6: Inlet of culvert at Tiah's Cove Road showing the broken piece of the headwall in the foreground and coaxial cable exiting on the left.

It is not immediately clear why this culvert has a smaller upstream opening as compared to its outlet. A professional engineer should be consulted relative to hydrologic and hydraulic changes that might result from replacing this culvert with a more wildlife-friendly crossing. In addition, before pursuing any replacement, the Town should make contact with the relevant utilities that might be responsible for the coaxial cable currently running through the culvert and develop a plan to terminate or relocate that service.
