CROCKER POND DAM

PHASE I

INSPECTION / EVALUATION REPORT

Dam Name:	CROCKER POND DAM
State Dam ID#:	7-4-327-4
NID ID#:	MA 01011
Owner:	Seven Gates Farm Corp.
Town:	West Tisbury
Consultant:	Kent A. Healy, P.E.
Date of Inspection:	May 22, 2009

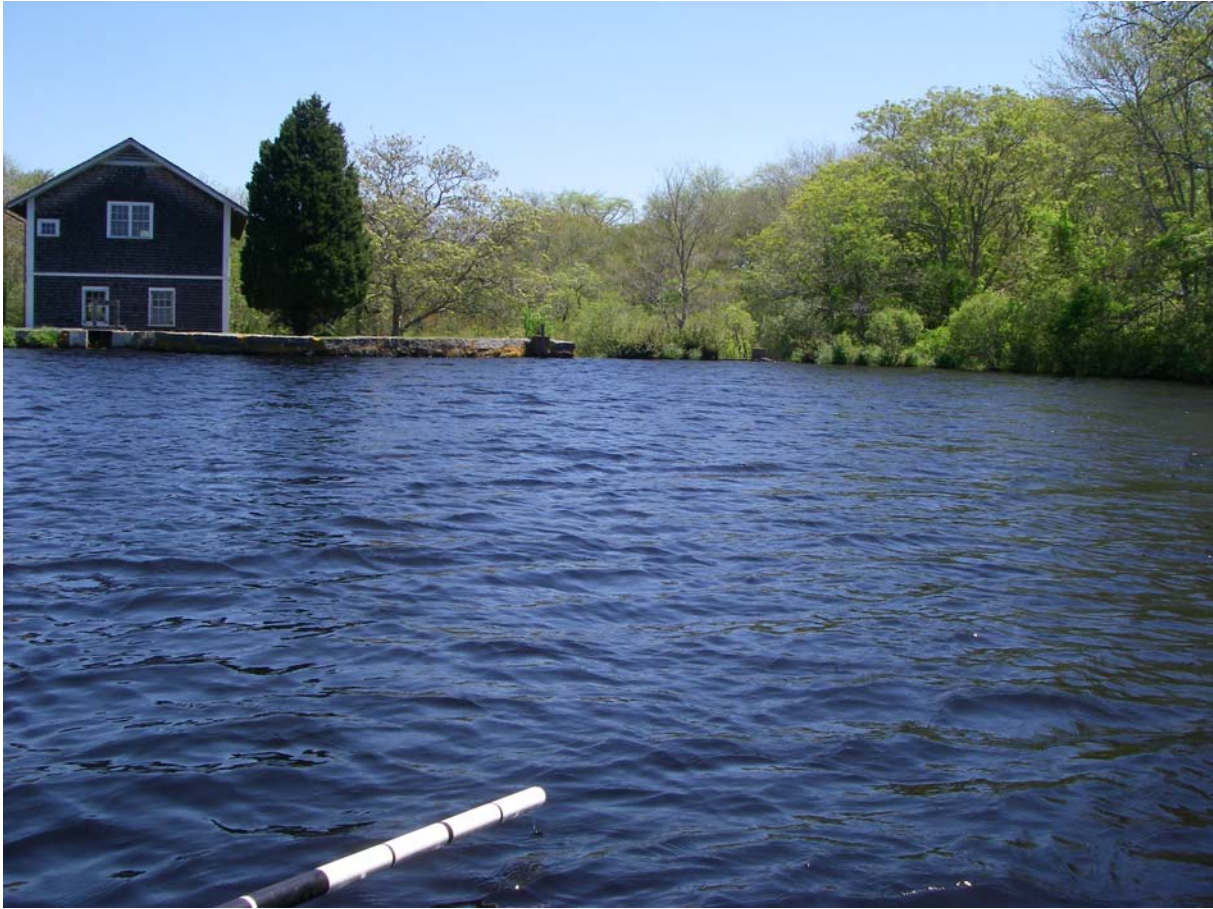
The upstream face is faced with a cut stone wall which provides protection from ice and wave damage.

Upstream face from the Right

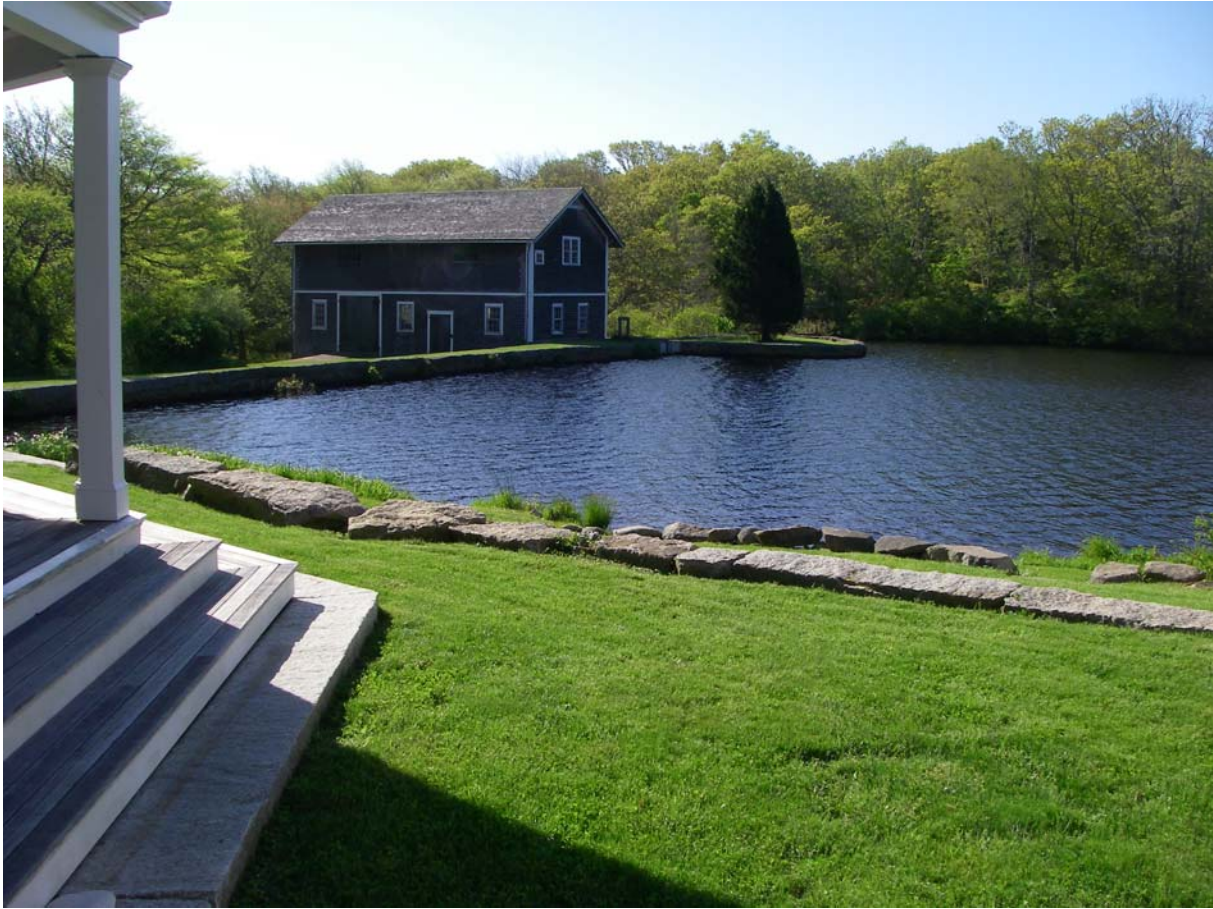
Upstream face from left abutment

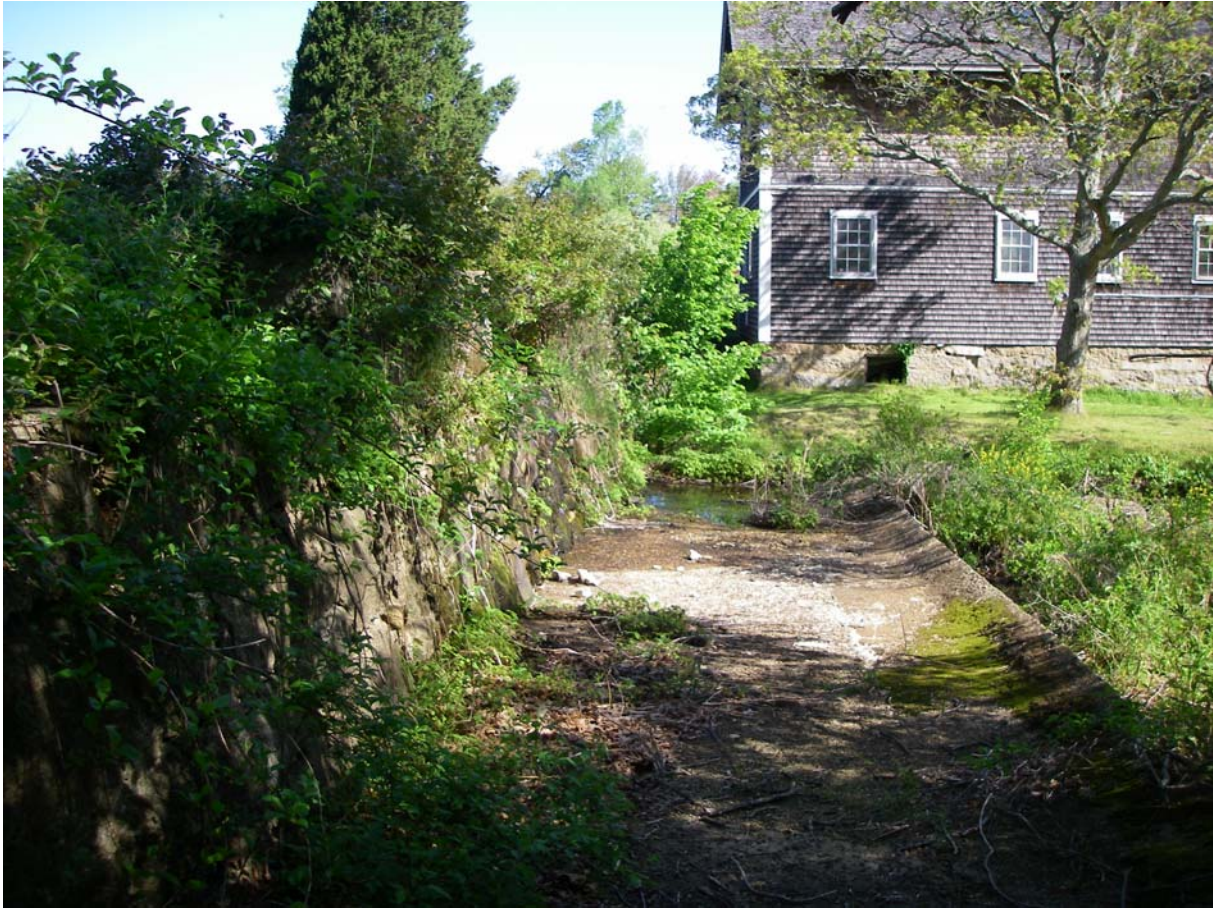
The dam north of the mill building is about 30 feet wide. The 10 feet abutting the pond is mowed grass with an elevation of +56.0' or higher. The next 20' has a grassy road for access to the mill building and is at elevation $\pm 53.0'$. The downstream face is vegetated with brush and small trees.

Overview of downstream face from right abutment

Maintenance of the dam has been good. The area on the downstream side of the dam should be maintained clear of brush and trees.

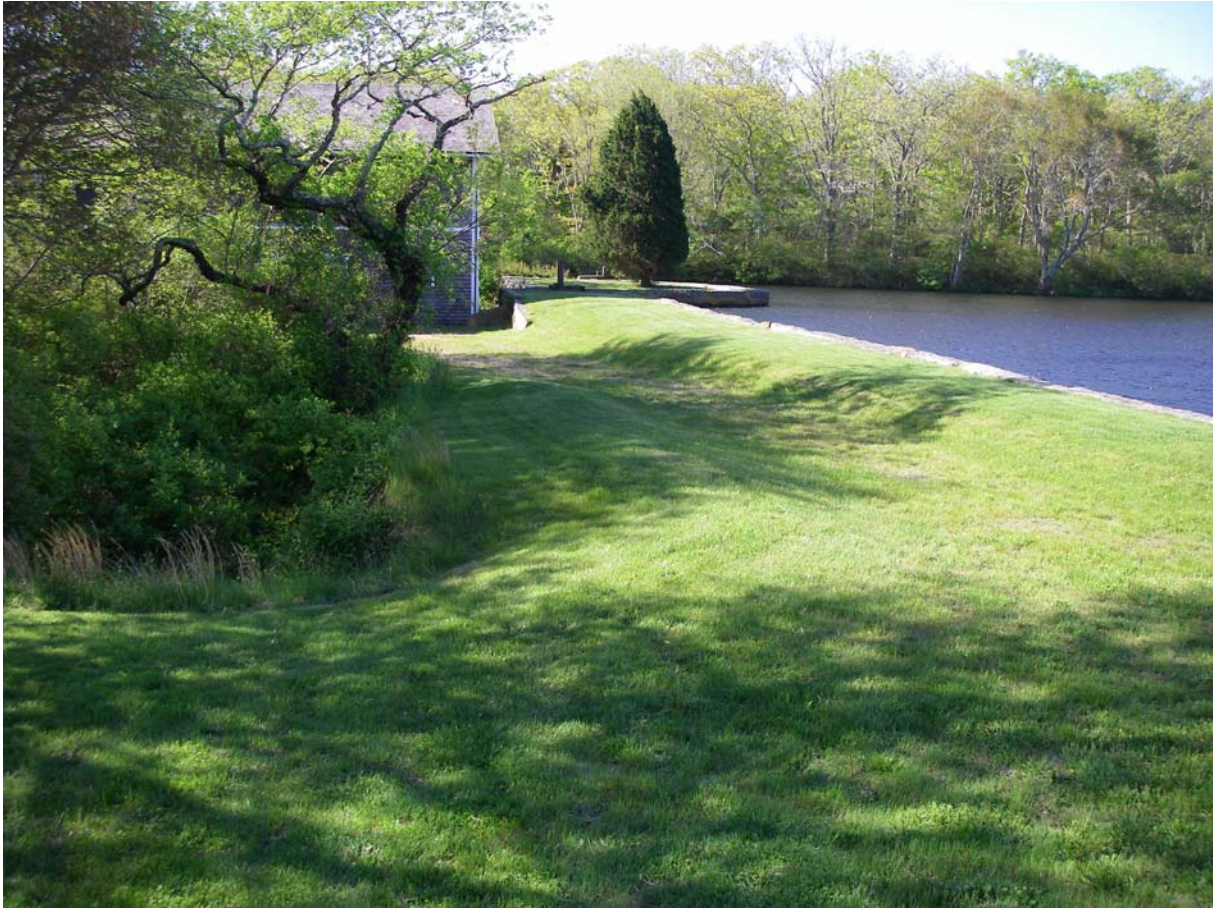
The downstream face of the dam to the south of the main spillway is a cut stone wall with overflow spillways on top. There is a concrete slab abutting the. This slab is designed to catch the water from the spillway above and prevent erosion and undermining of the wall.

Overview of downstream face from left abutment

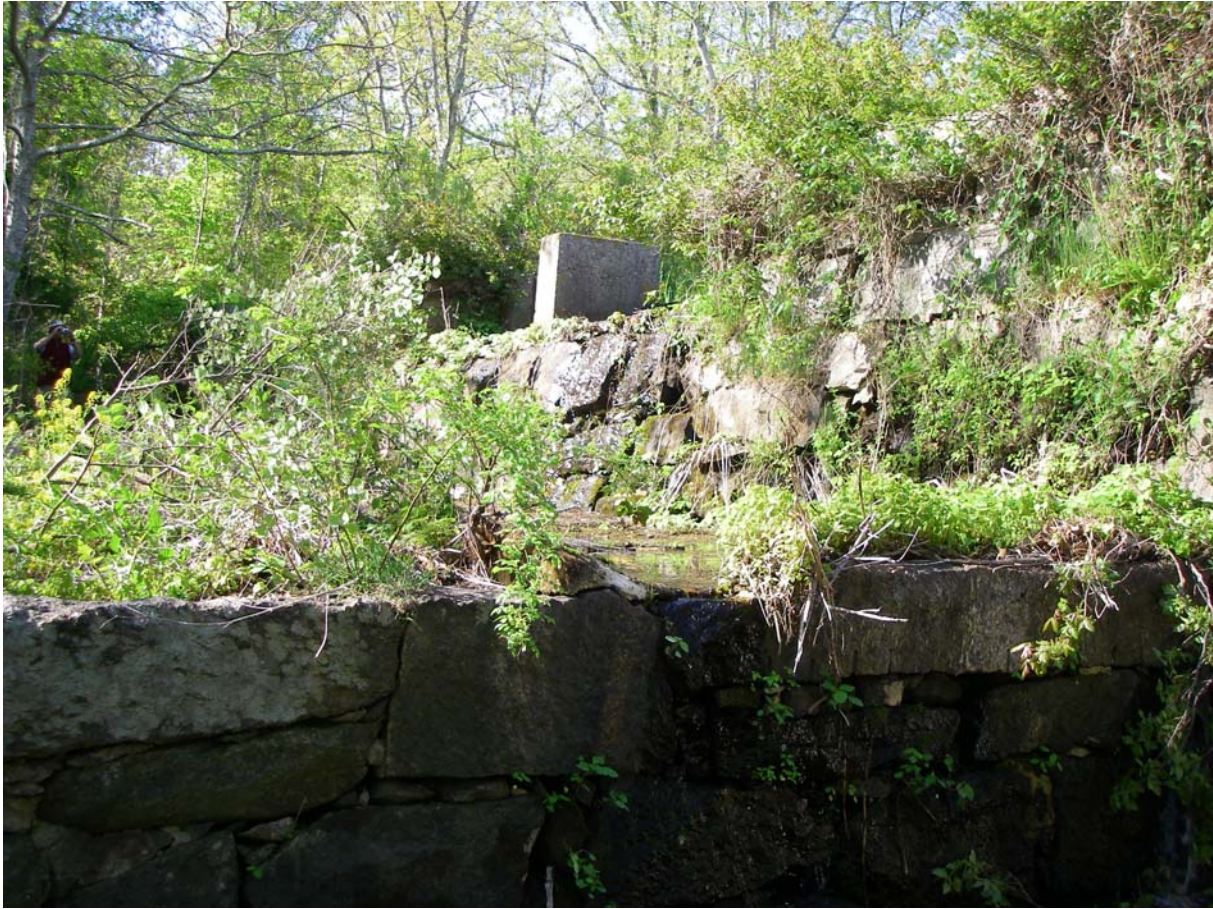
The main spillway is cut granite on each side and the bottom sill is granite and concrete. There are slots for stop logs to control the flow.

Overview of spillway

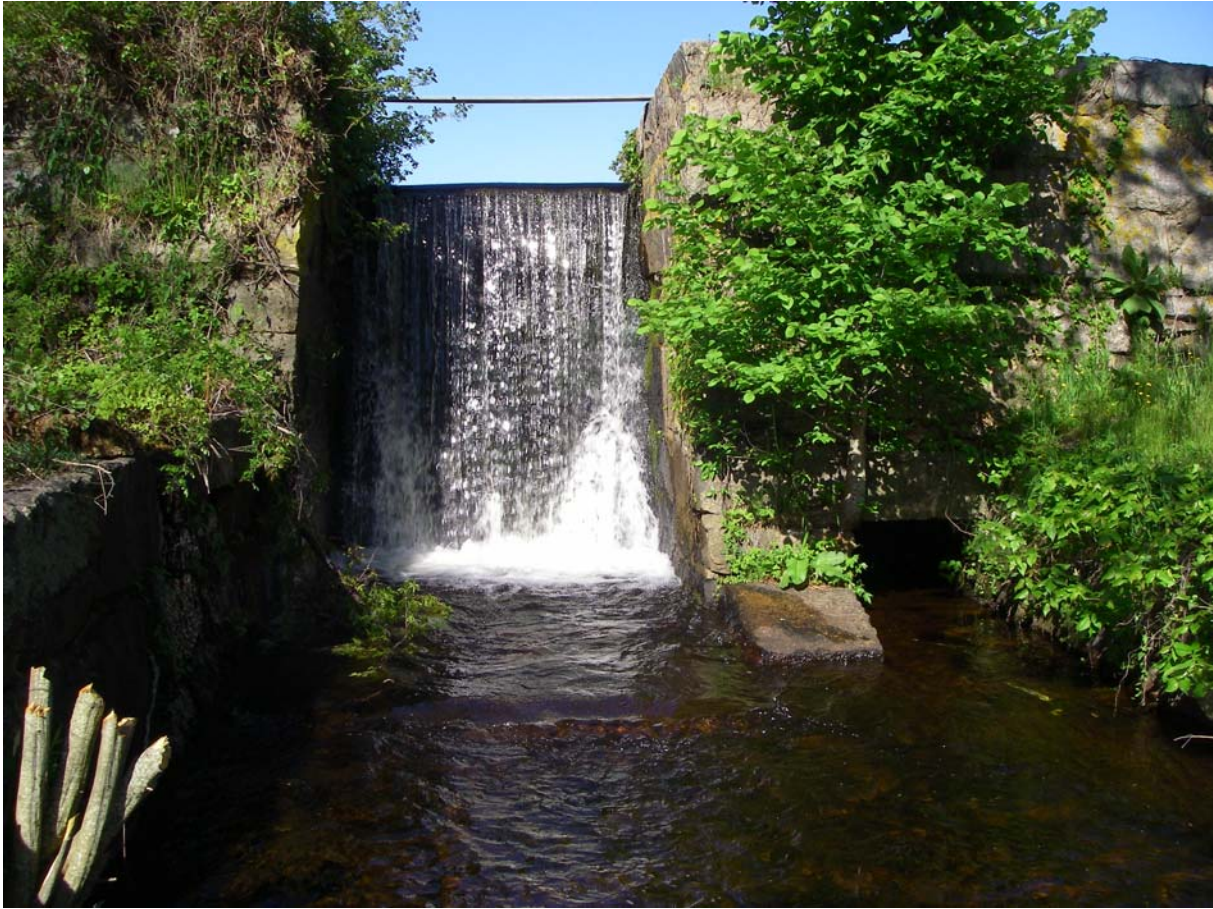
On the downstream side of the dam at the emergency spillways there is a concrete pad to catch the discharge and prevent undermining and erosion of the face of the dam. This slab is pitched to drain into the main discharge channel.

Overview of stilling basin

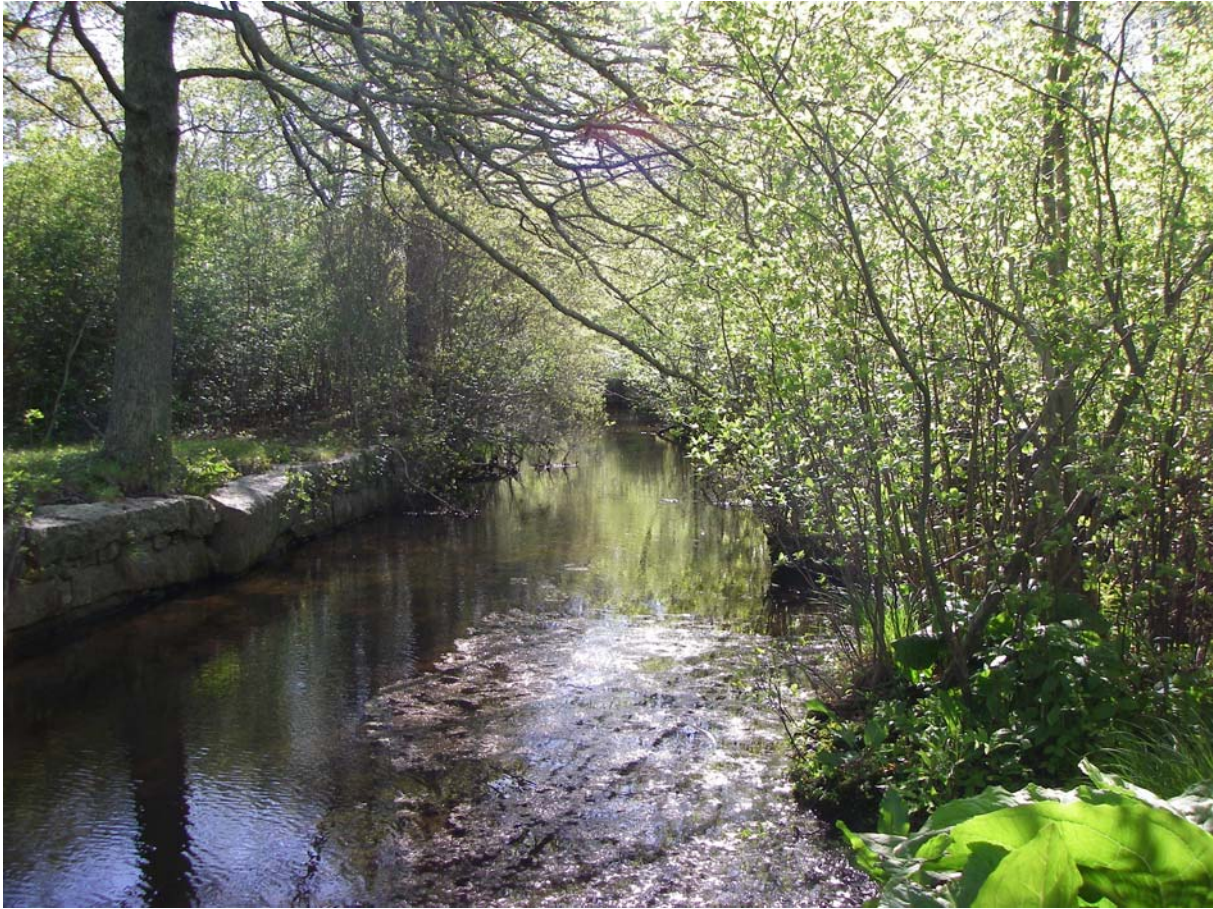
The discharge channel for the main spill way is approximately 15' wide and the sides are lined with stone to prevent erosion. The stream runs east into a swamp and then into Priester Pond.

Overview of downstream channel
