**FISHER POND DAM**  
**PHASE I**  
**INSPECTION / EVALUATION REPORT**

| Dam Name: | FISHER POND DAM |
| Consultant: | KENT A. HEALY |
| Date of Inspection: | JULY 31, 2009 |

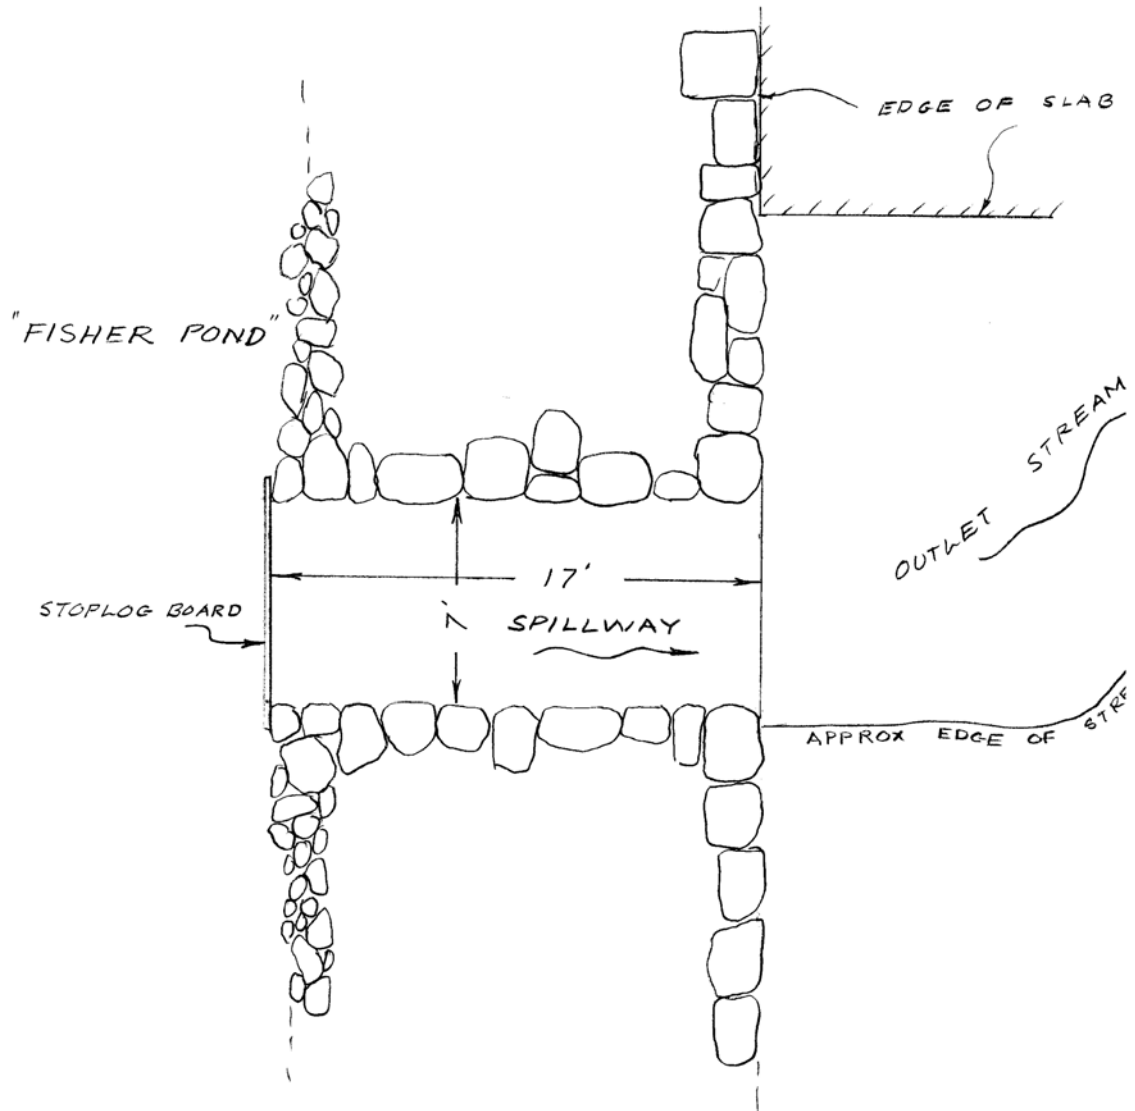
FIGURE 6 SPILLWAY

The primary spillway is a granite masonry structure at about the middle of the dam, with concrete floor and granite masonry training walls, and granite masonry downstream face. A 1 foot by seven feet long board at the inlet maintains the pond level one foot above the spill way floor. All of the structure is in good condition.

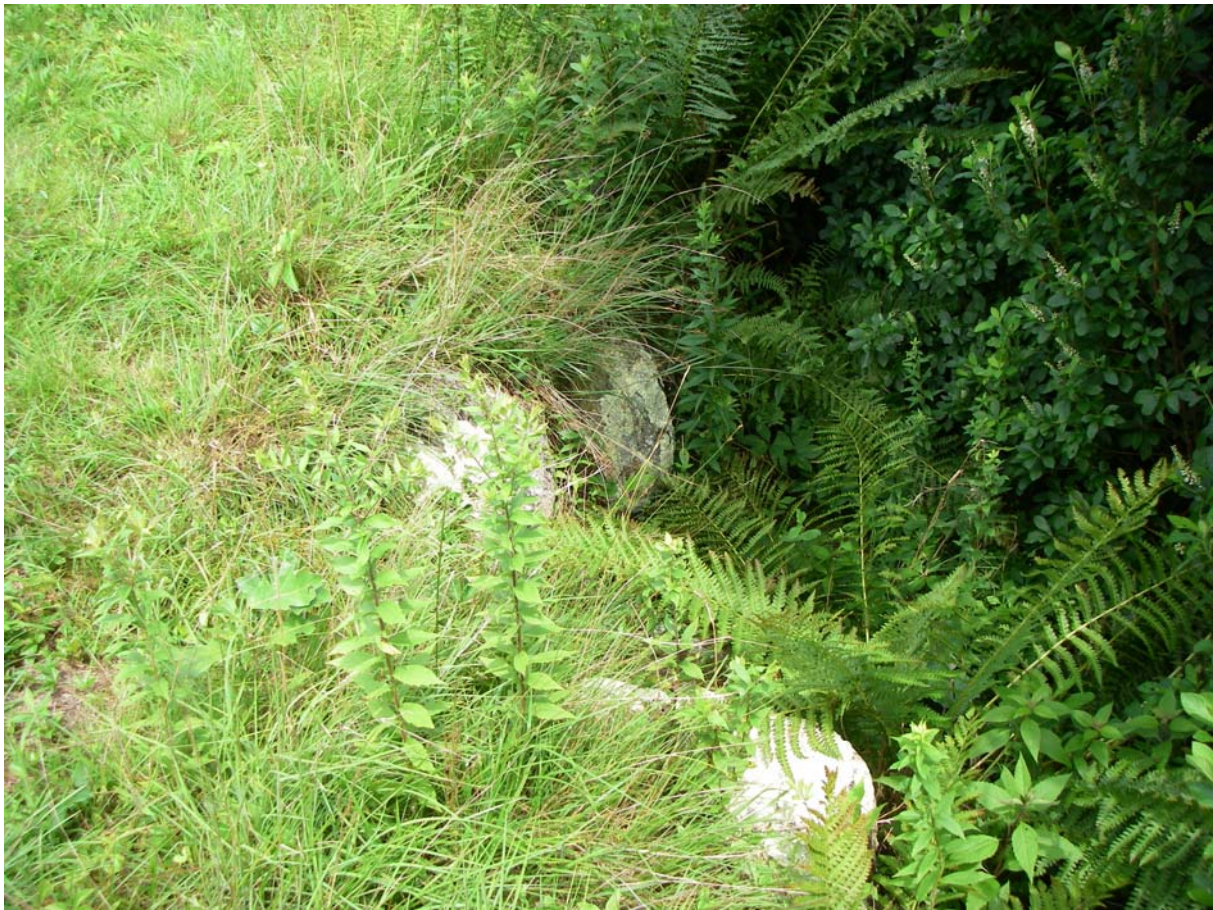
The upstream face is protected from ice and waves by a shallow stone wall. The down stream face is a vertical granite stone wall in good condition providing lateral stability to the embankment. The crest is a grassy path mowed annually and in good condition. There are no drains or instrumentation and access is by a path at the north end of the dam.

Overview of downstream face from right abutment

The trees and brush within 15, feet of the downstream face should be cut with the roots left in place.

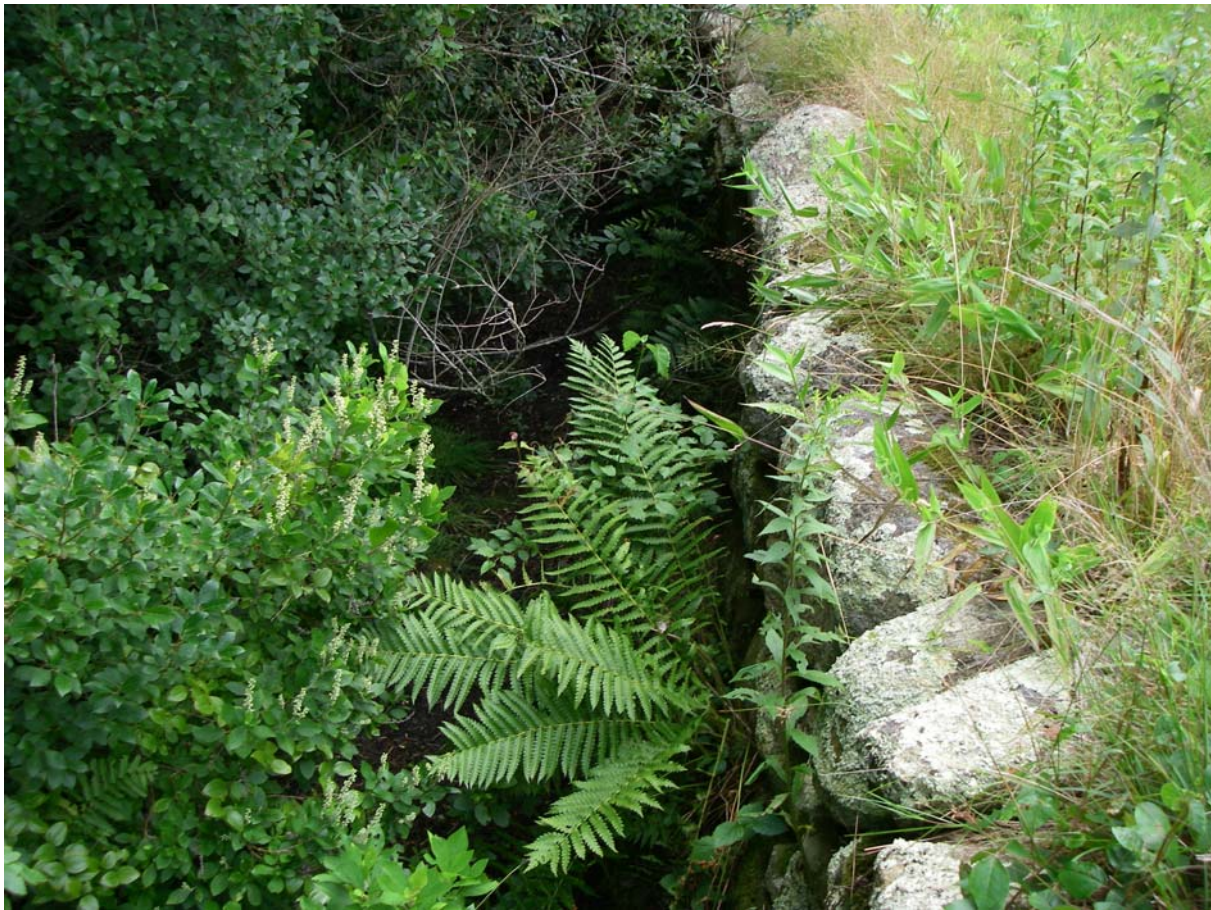
Overview of downstream face from left abutment

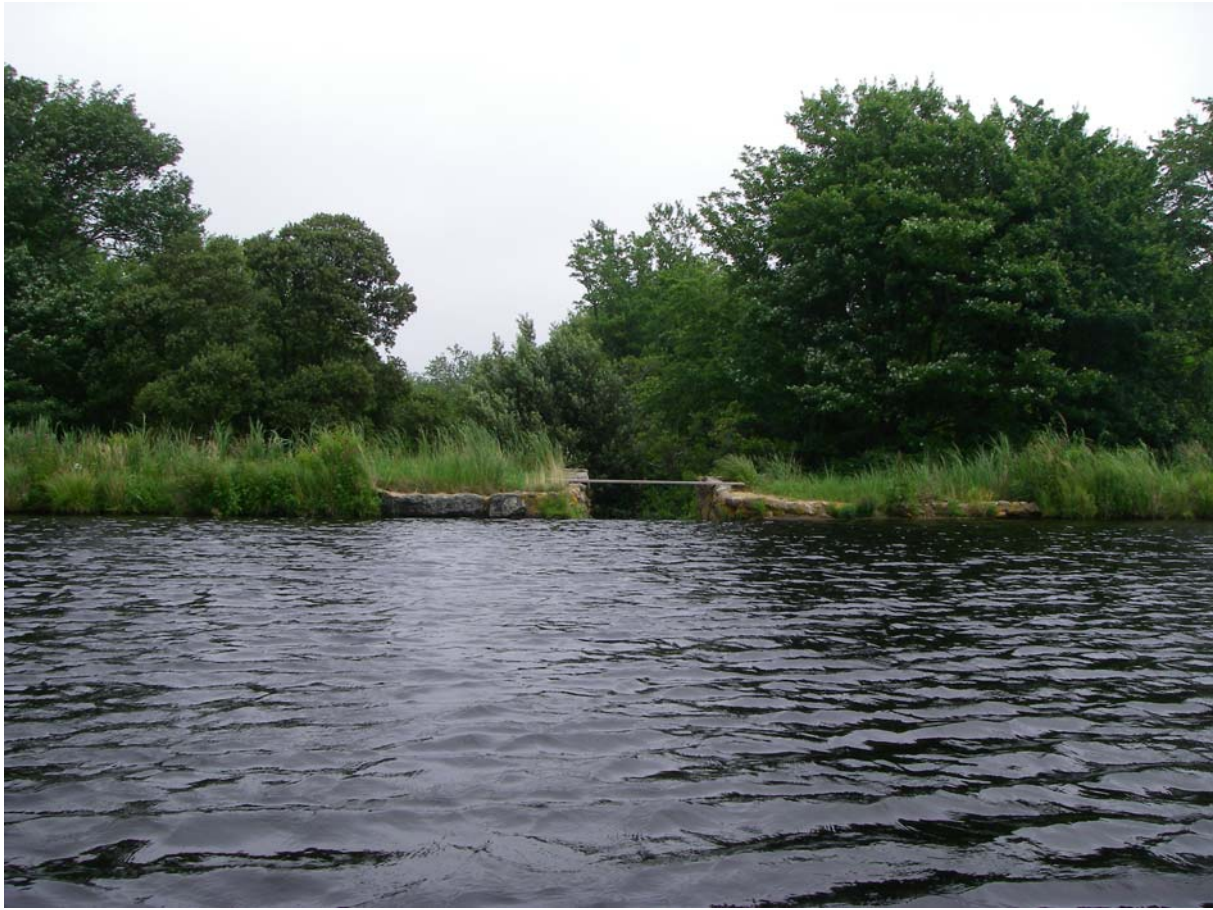
Overview of spillway from upstream

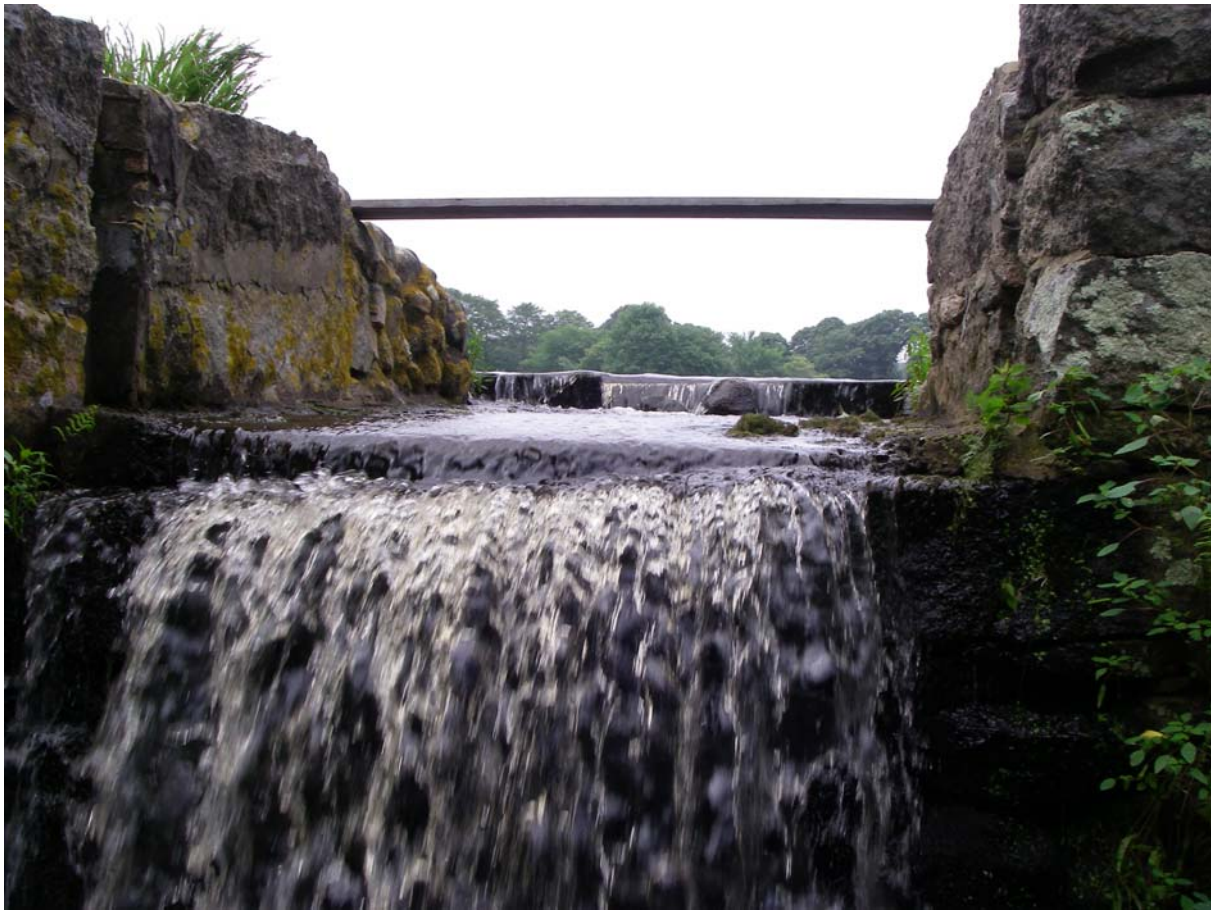
Overview of spillway from downstream
