# Site Reconnaissance, Preliminary Evaluation, and Opinion of Probable Cost for Dam Removal

## Old Mill Pond Dam West Tisbury, Massachusetts

June 2011

MILL POND DAM  
PHASE I  
INSPECTION / EVALUATION REPORT

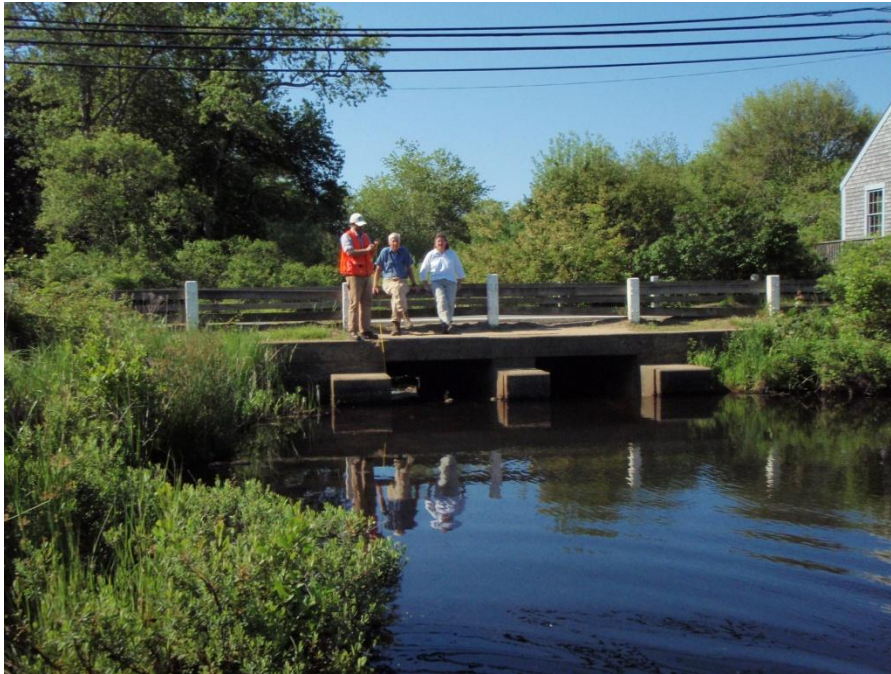
**Photo 1: Spillway Structure from Upstream**

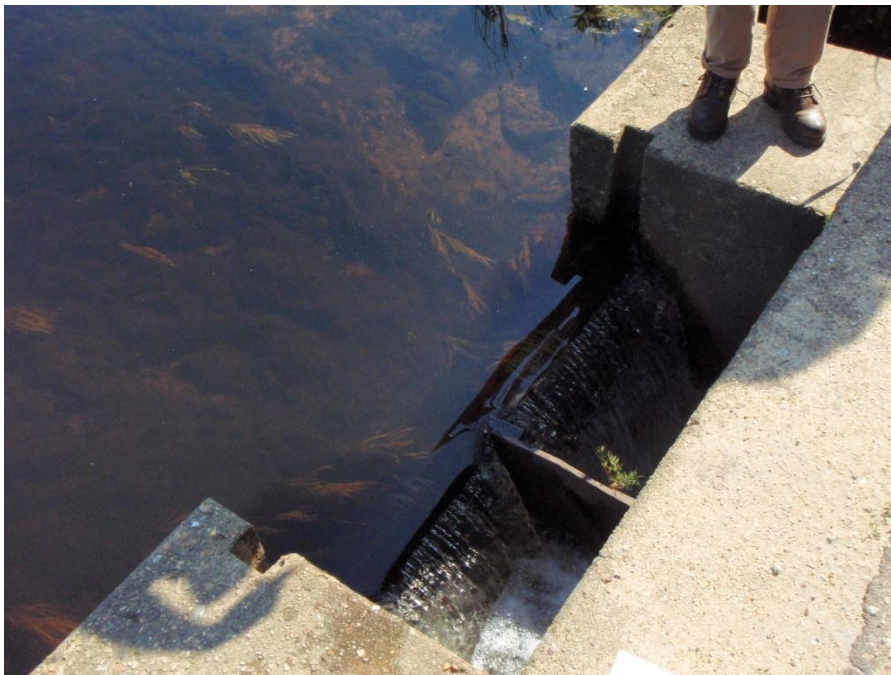
Despite the presence of a temporary upstream fishpass structure constructed of wood that was observed in the left masonry box culvert during the site visit, potential for upstream fish passage under the observed conditions was marginal due to shallow (depth of approximately 0.4 ft) and fast (speed of 5 to 6 feet per second) in the downstream portion of the culvert. It is therefore expected that upstream fish passage at this dam is limited to American eel (*Anguilla rostrata*) and perhaps river herring (*Alosa spp.*) under ideal flow conditions. Indigenous brook trout (*Salvelinus fontinalis*) occur in the headwater of Mill Brook and may similarly be able to pass upstream through the fishpass under ideal conditions. The Massachusetts Division of Fisheries and Wildlife stocks various trout species in the dam impoundment (Mill Pond).

**Photo 2: Left Stoplog Bay in Spillway (“fishpass” is visible on the near-side of the stoplog bay)**

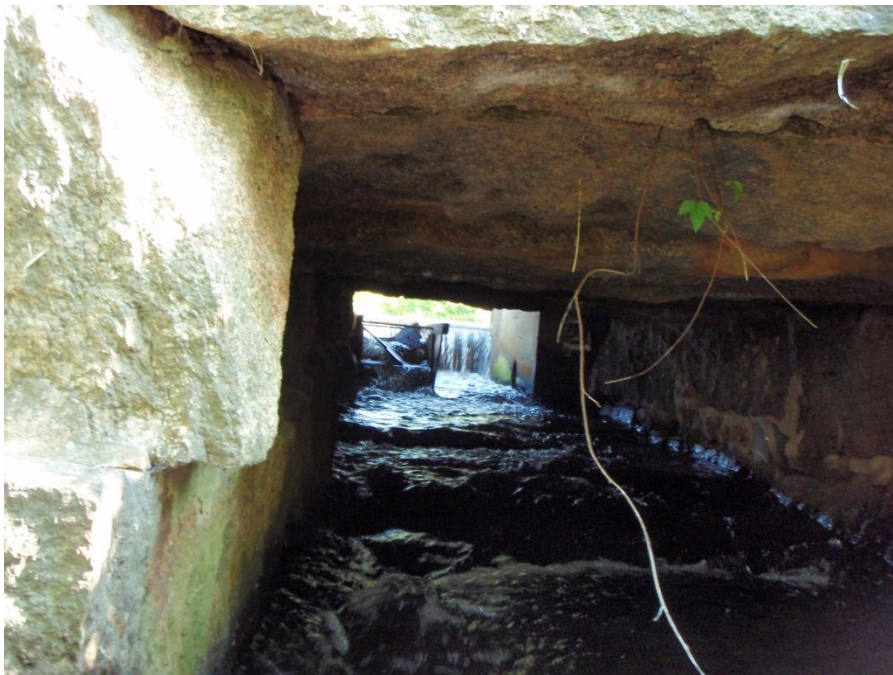
**Photo 4: View Upstream through Left Spillway Culvert under West Tisbury-Edgartown Road**  
(note “fishpass” on left side of image)

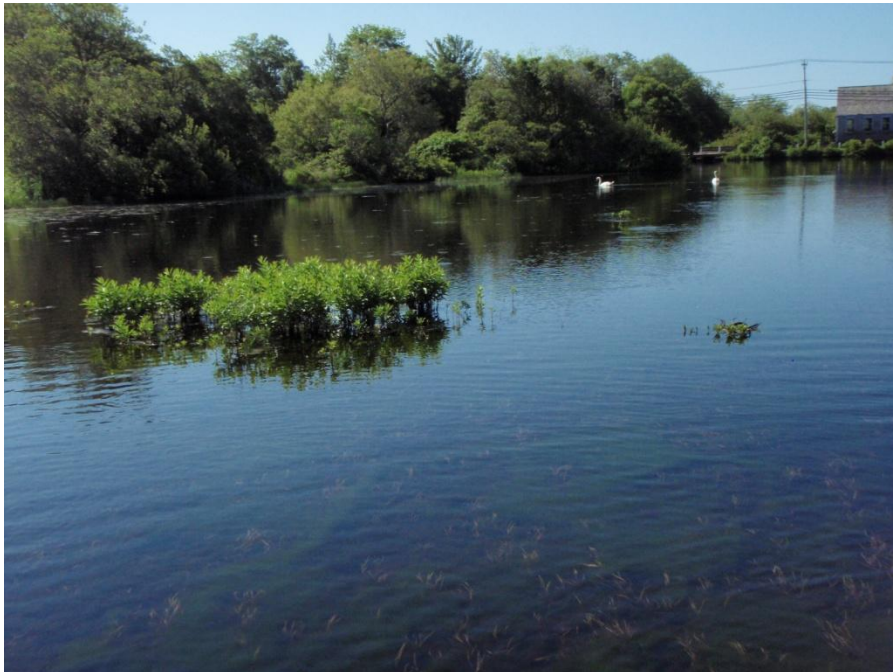
**Photo 8: Vegetation in Impoundment (note relatively shallow water in foreground)**

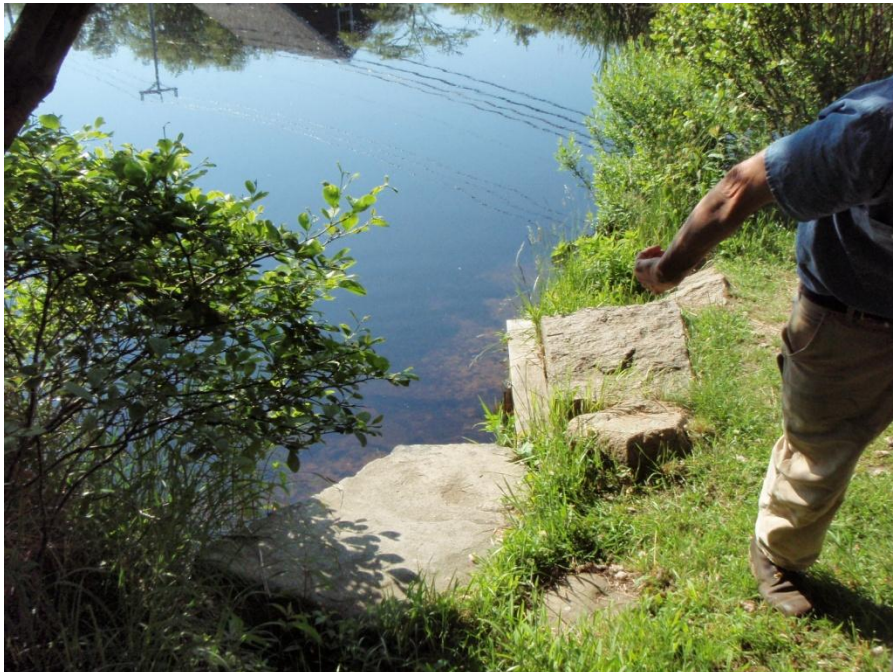
**Photo 10: Diversion Structure in Old Mill Pond Dam Impoundment to Maley's Pond**
