To: Music Street Architects
11 Music Street, PO Box 3000, PMB# 3109
West Tisbury, MA 02575

From: Energylogik
455 State Road, PMB# 385
Vineyard Haven, MA 02568

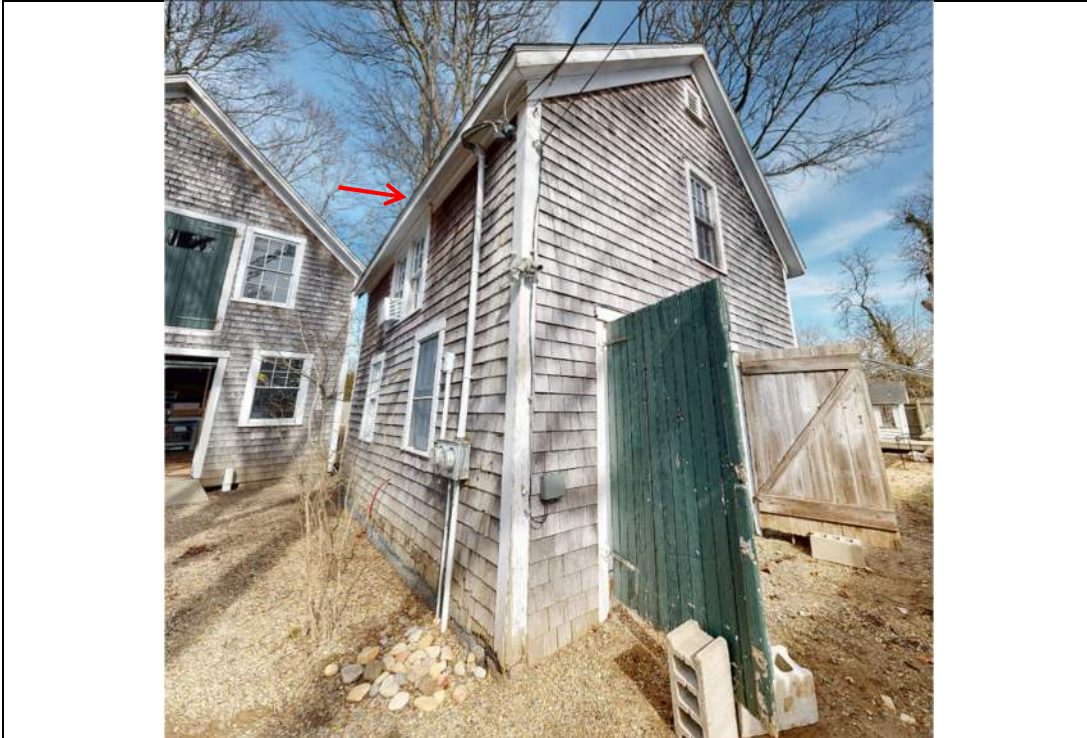
Photograph 1 – View of front (south elevation). Note staining and deteriorated siding at base of walls, and bow in center of roof at the eave

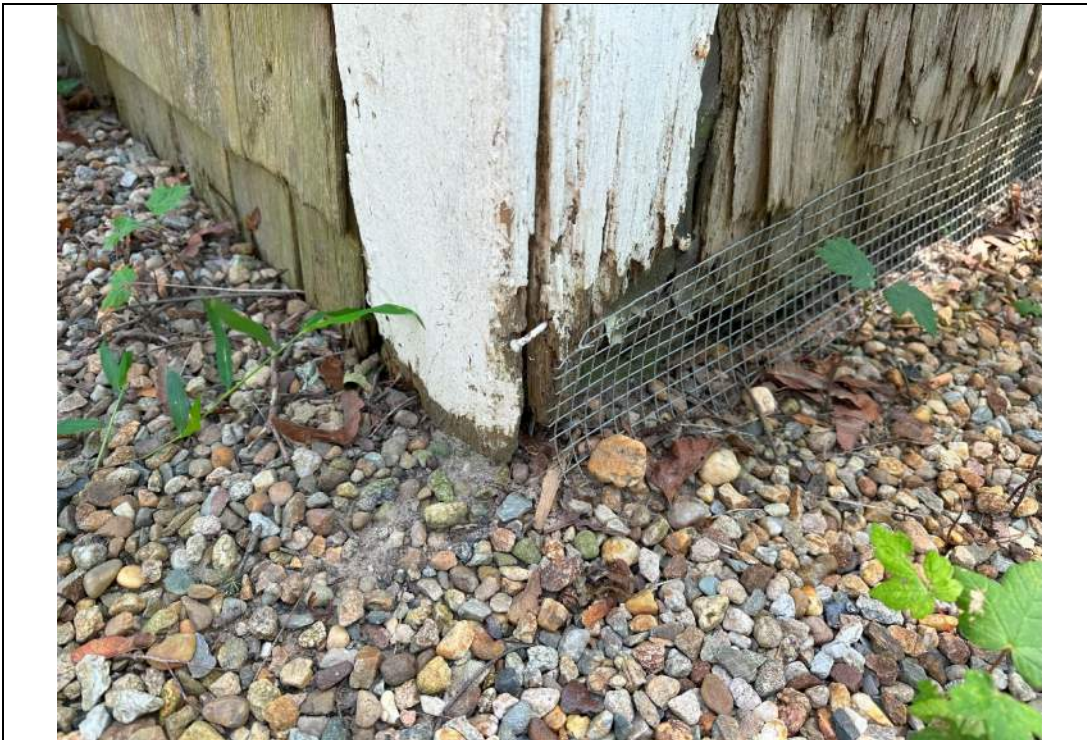
Photograph 2 – Close-up view of Northeast corner. Note deteriorated cladding and horizontal boards beneath

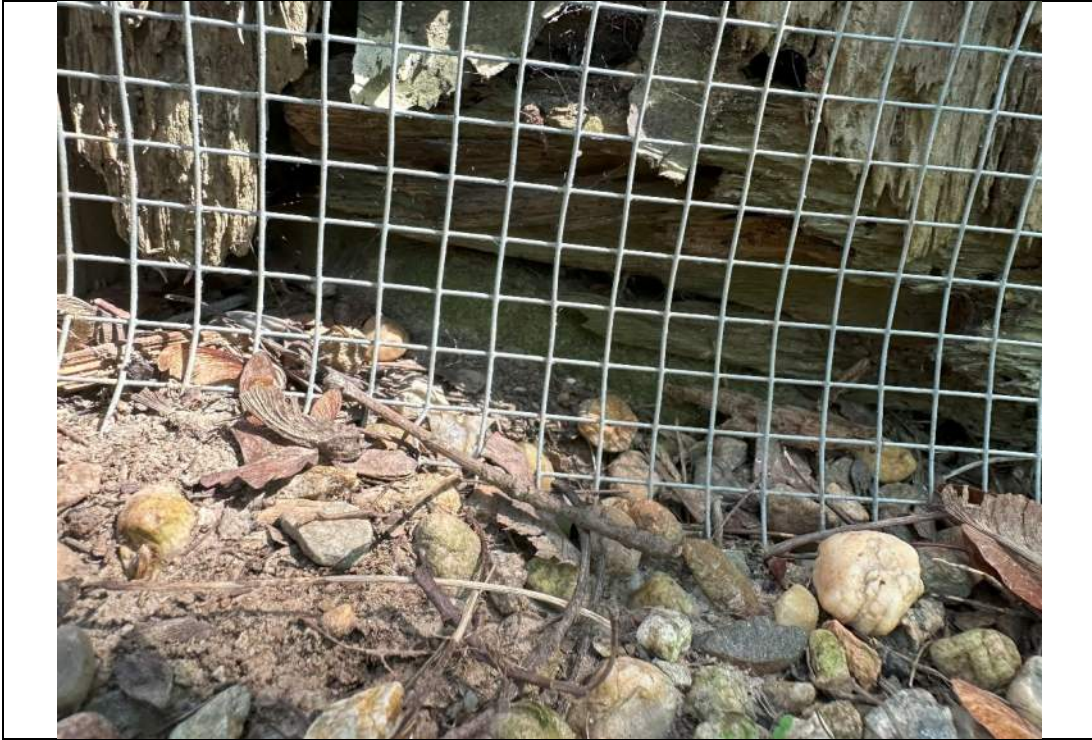
Photograph 3 – Close-up view of deteriorated cladding and bottom plate atop a stone pier.

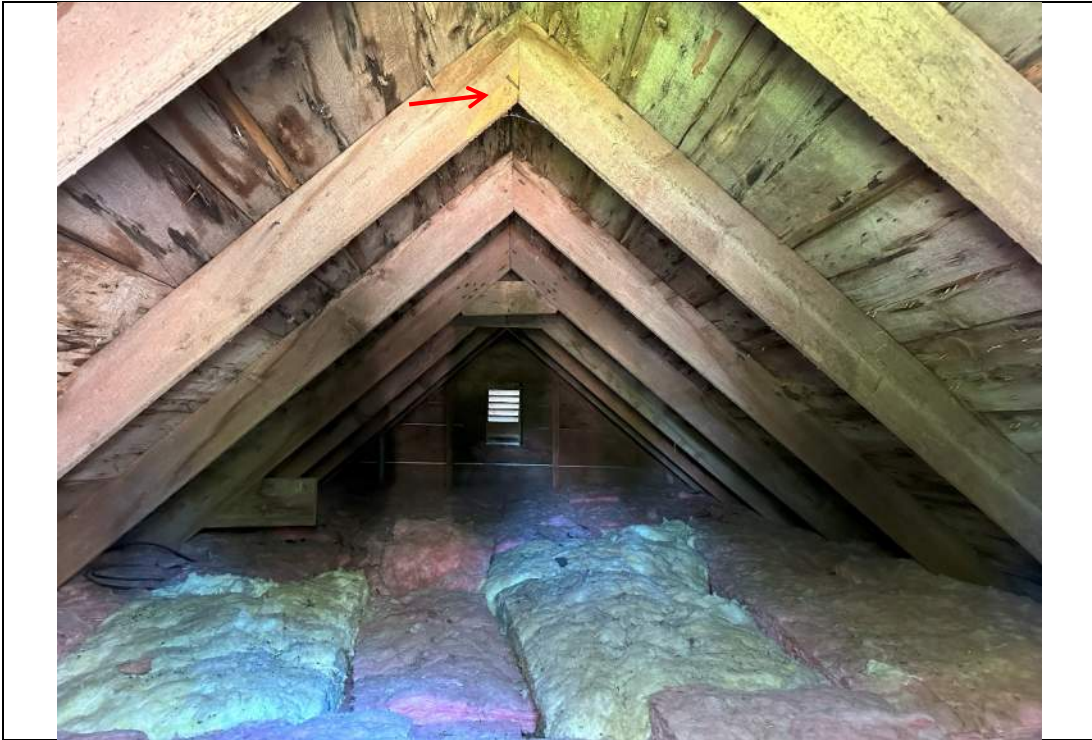
Photograph 4 – View of roof framing looking south. Note deteriorated boards, extensive staining, split at end with exposed corroded nail.

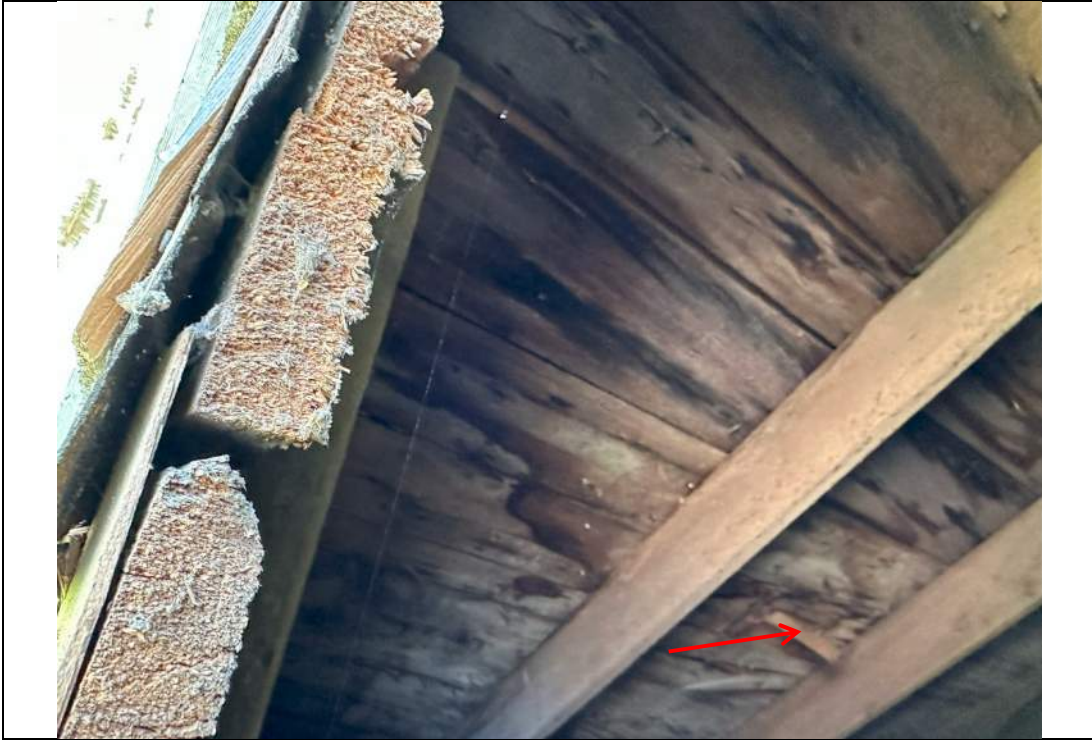
Photograph 5 – Close-up view of north wall boards and deteriorated roof boards (beyond).

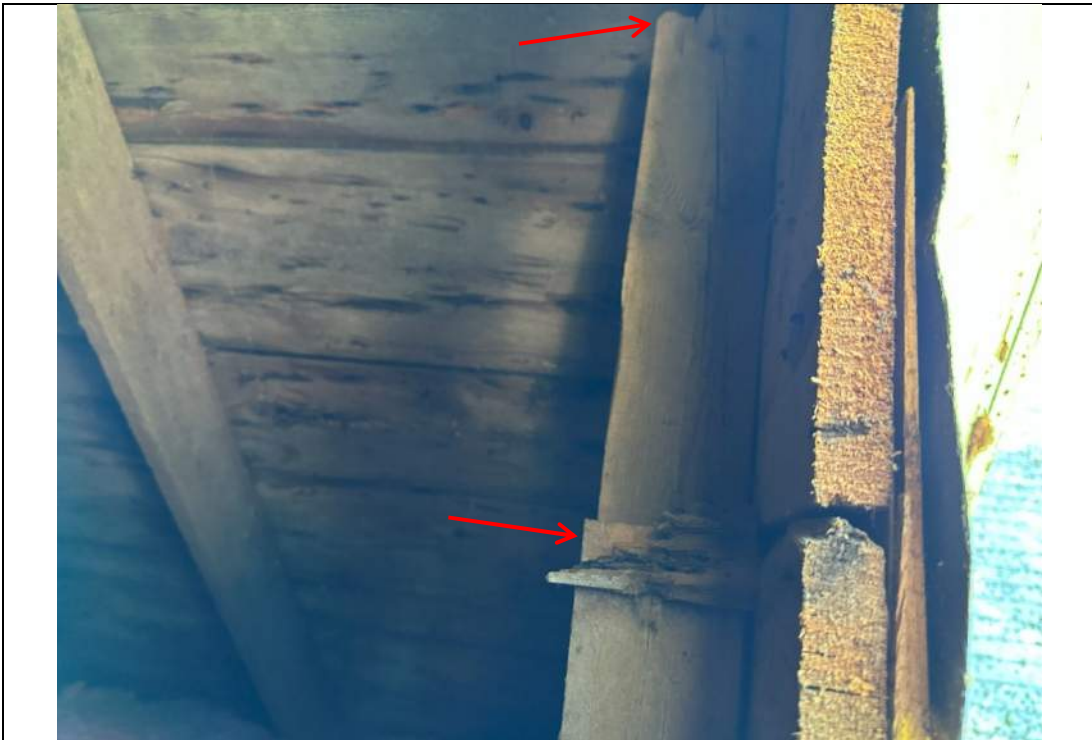
Photograph 6 – View of north gable end wall stud, note deterioration at connections.

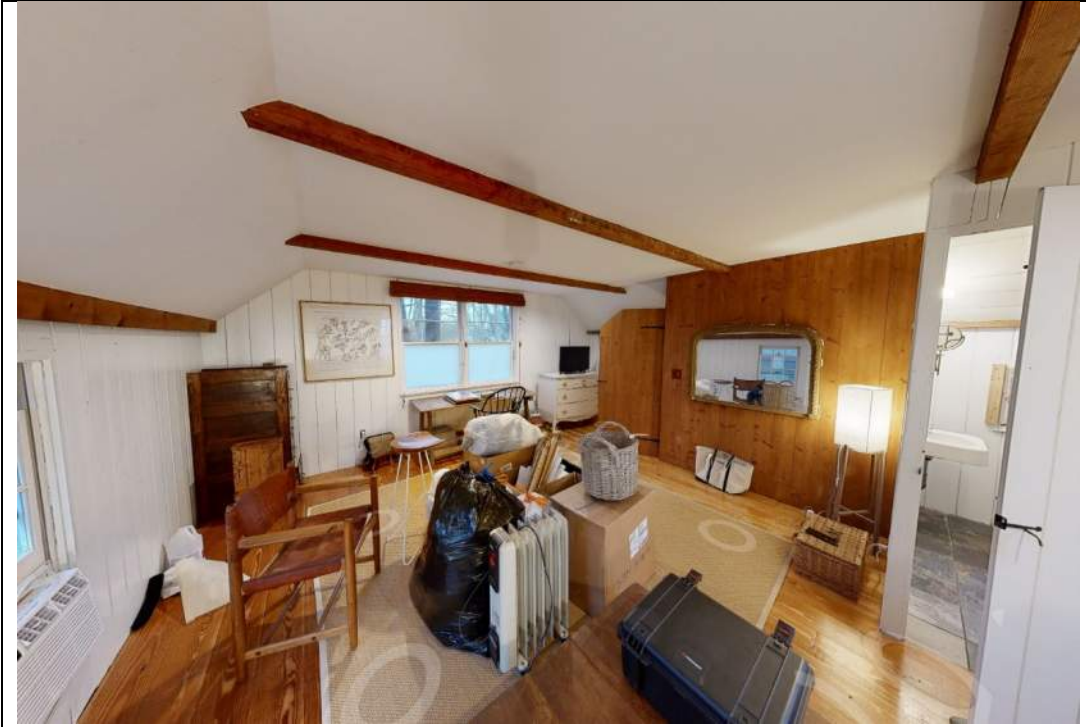
Photograph 7 – View of second floor.
