Map 1 Lot 38
Site Visit
May 9, 2022

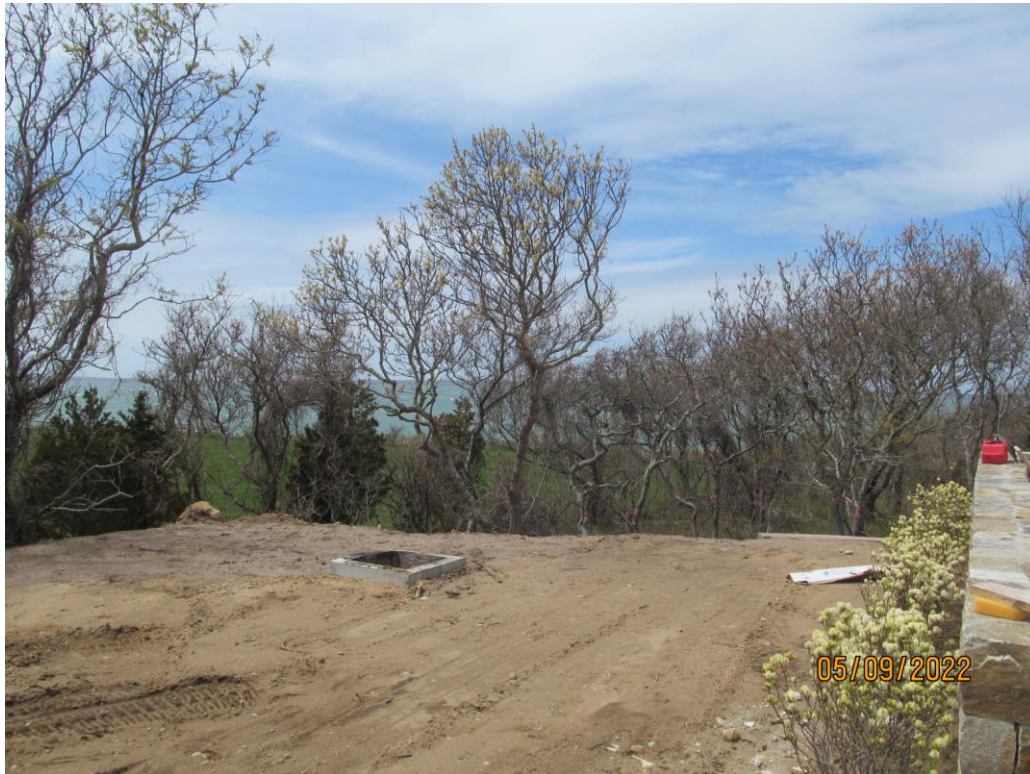
Existing view from corner to new terrace at the west corner

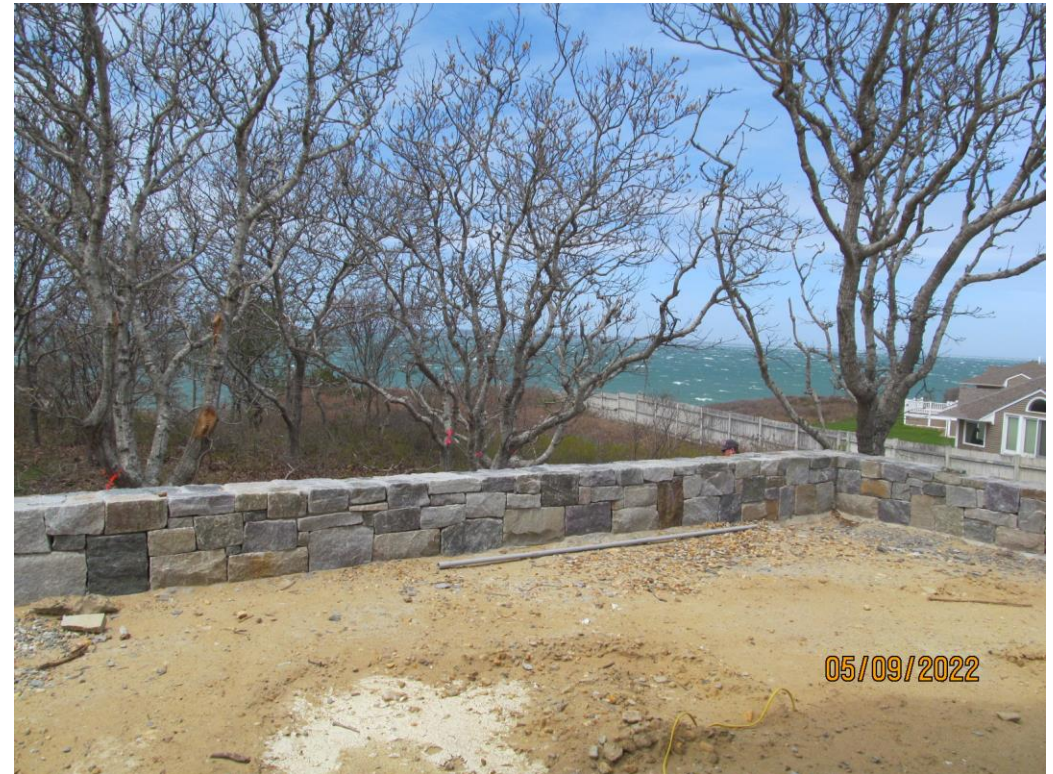
A new path would brush cut to meander through these trees to the stairs.

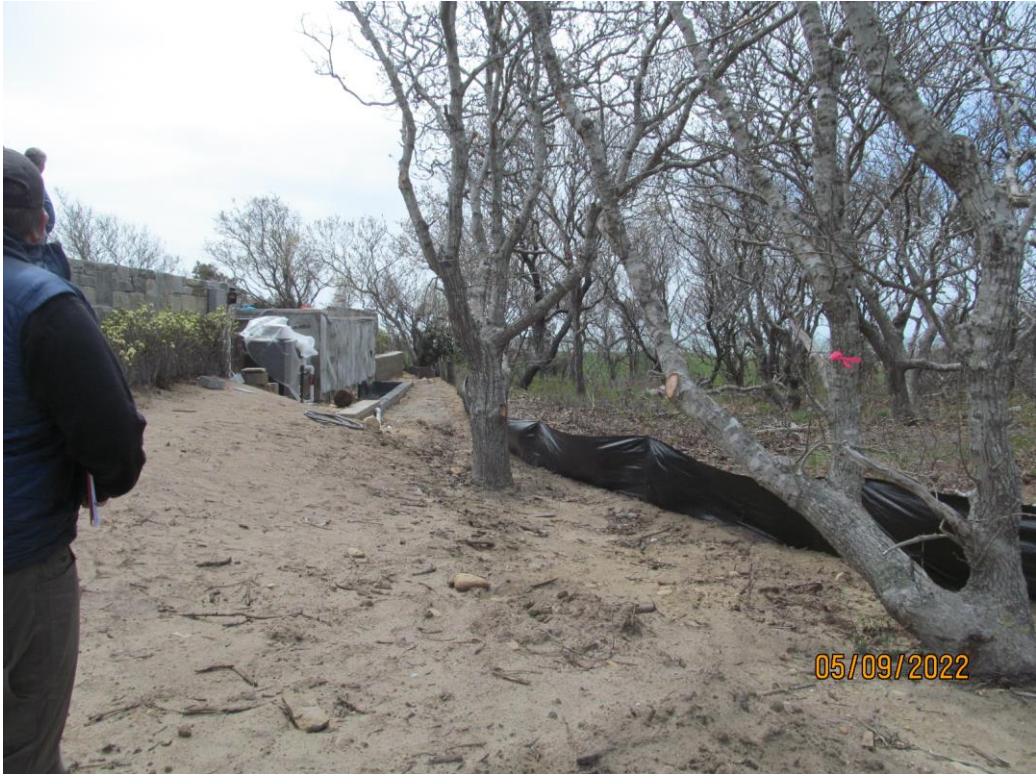
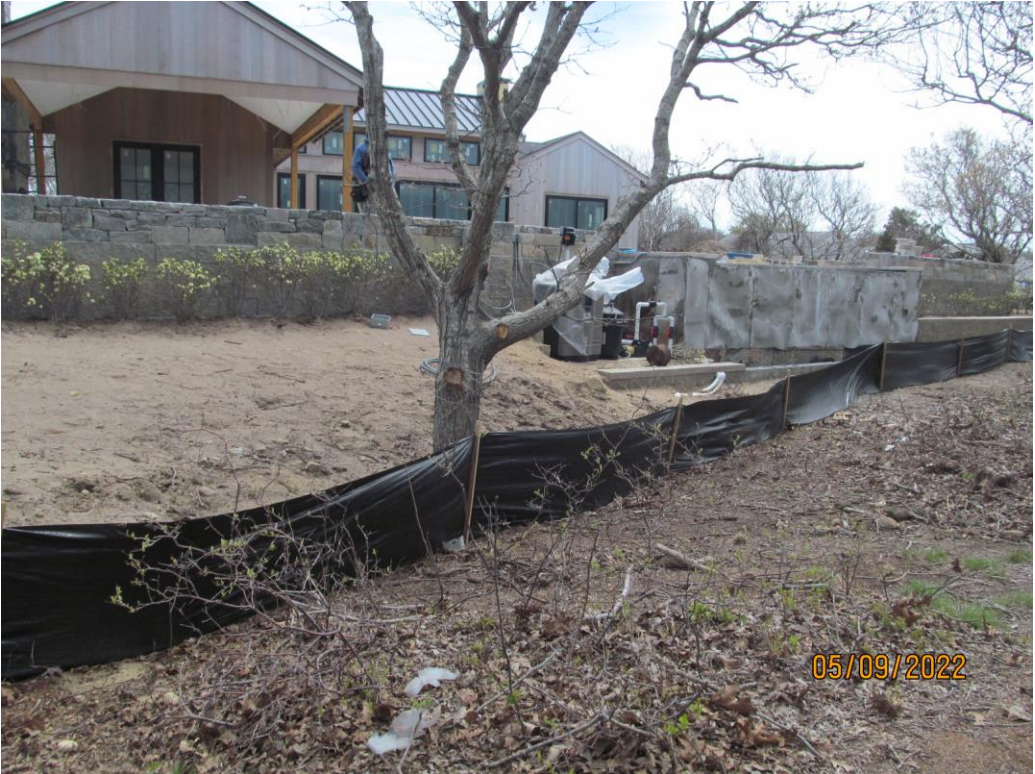
Silt fence represents edge of Buffer Zone to top of bank

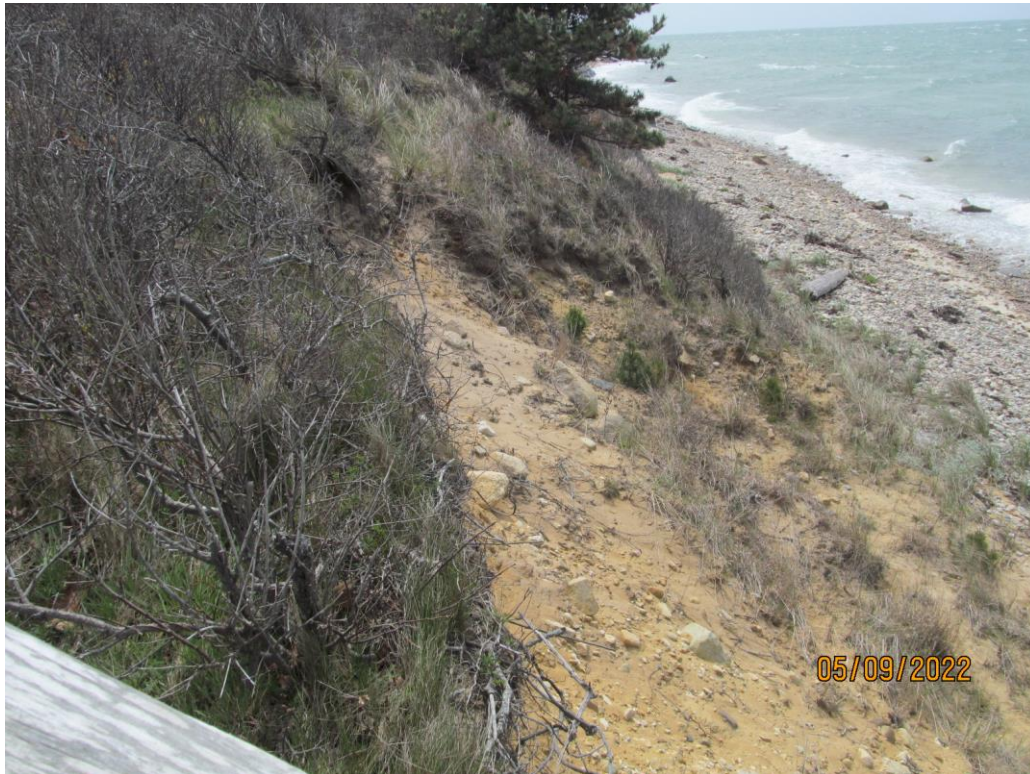
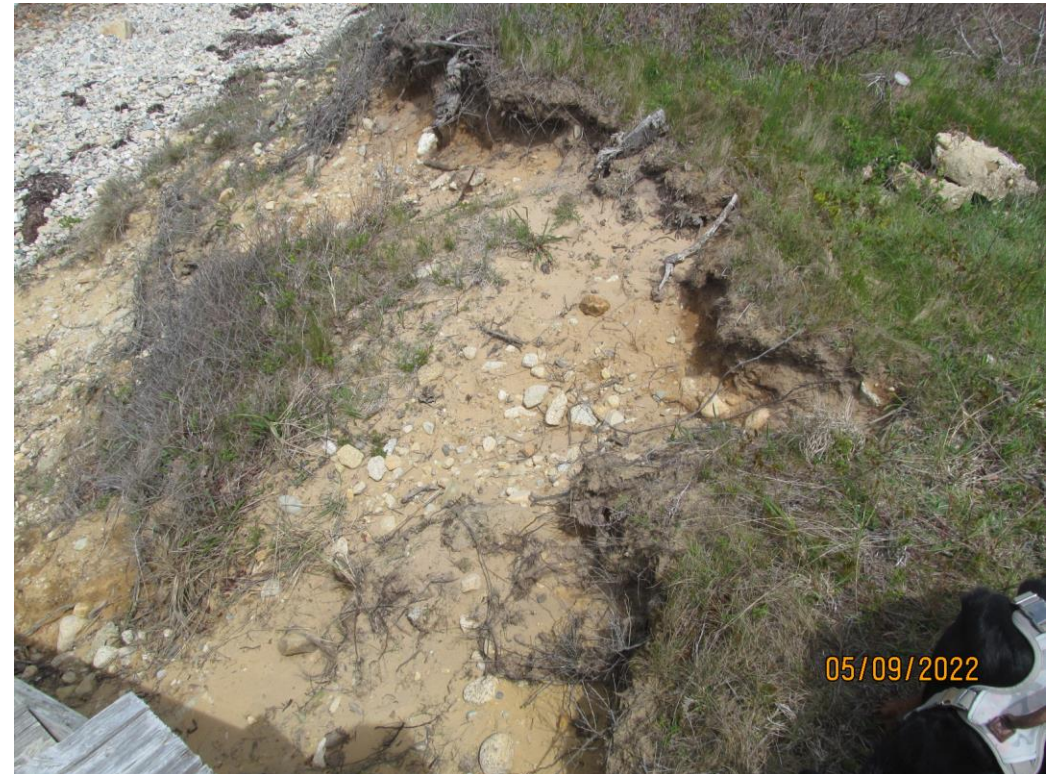
Erosion on either side of stairs

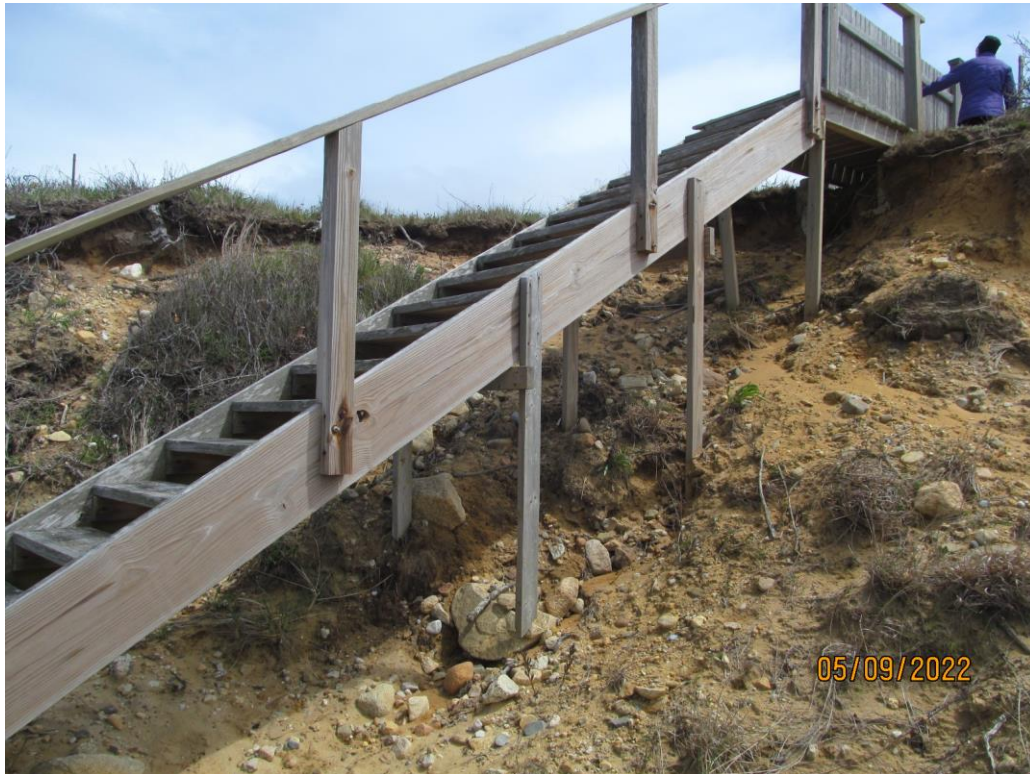
Erosion under stairs. A couple of posts are no longer anchored.

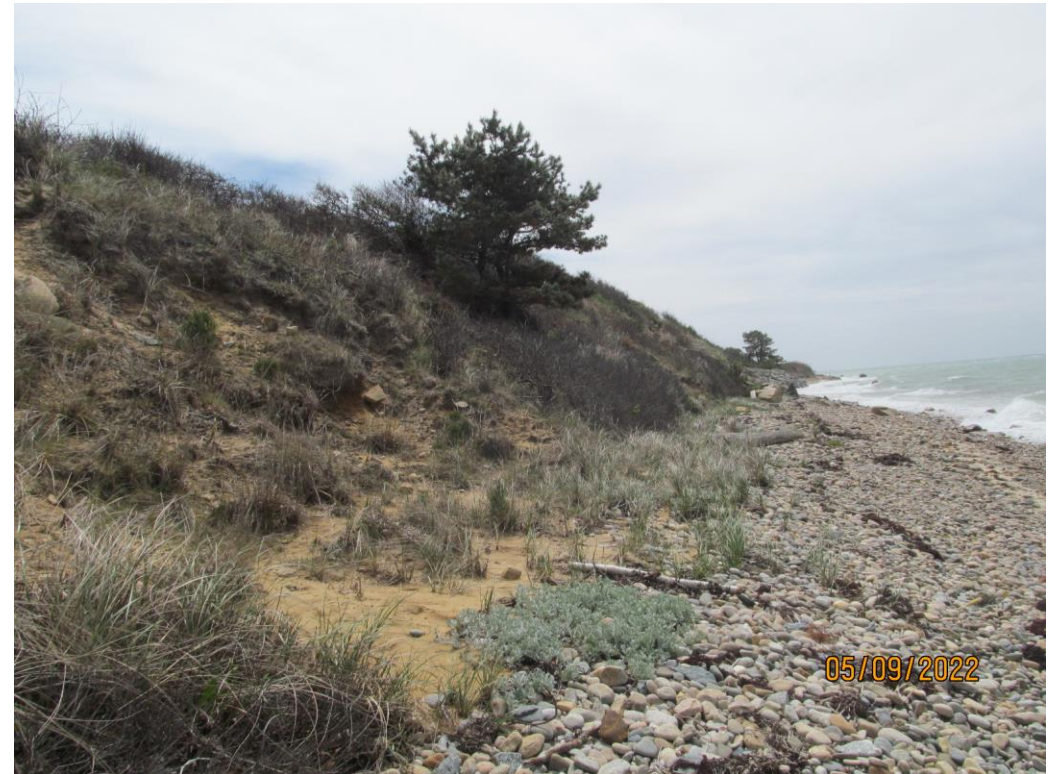
Face of bank looking west. The bank get steeper to the west but is better vegetated.

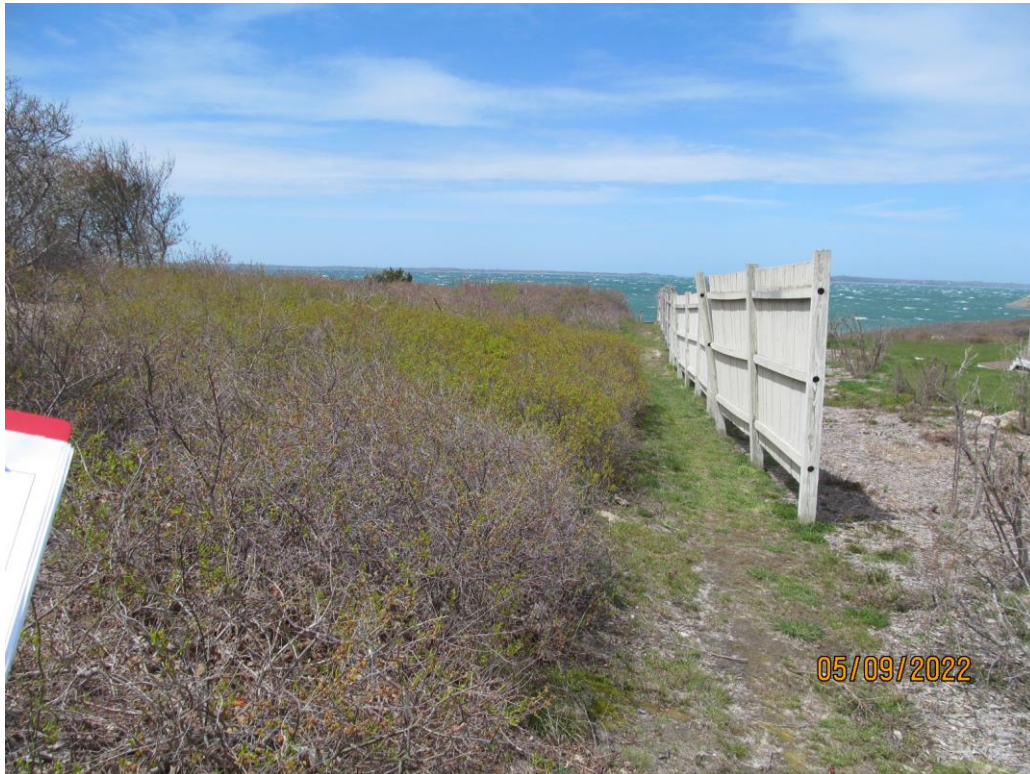
Existing path that straddles the property line. Ends at the stairs

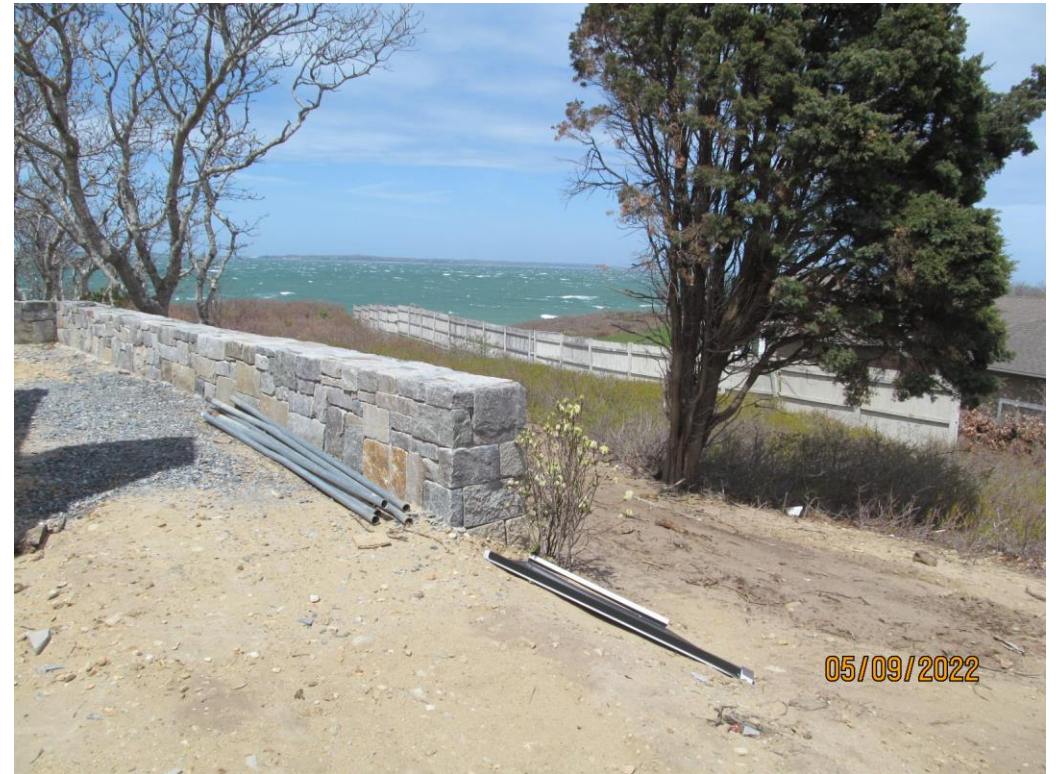
Oak and Cedar have to remain per Planning Board

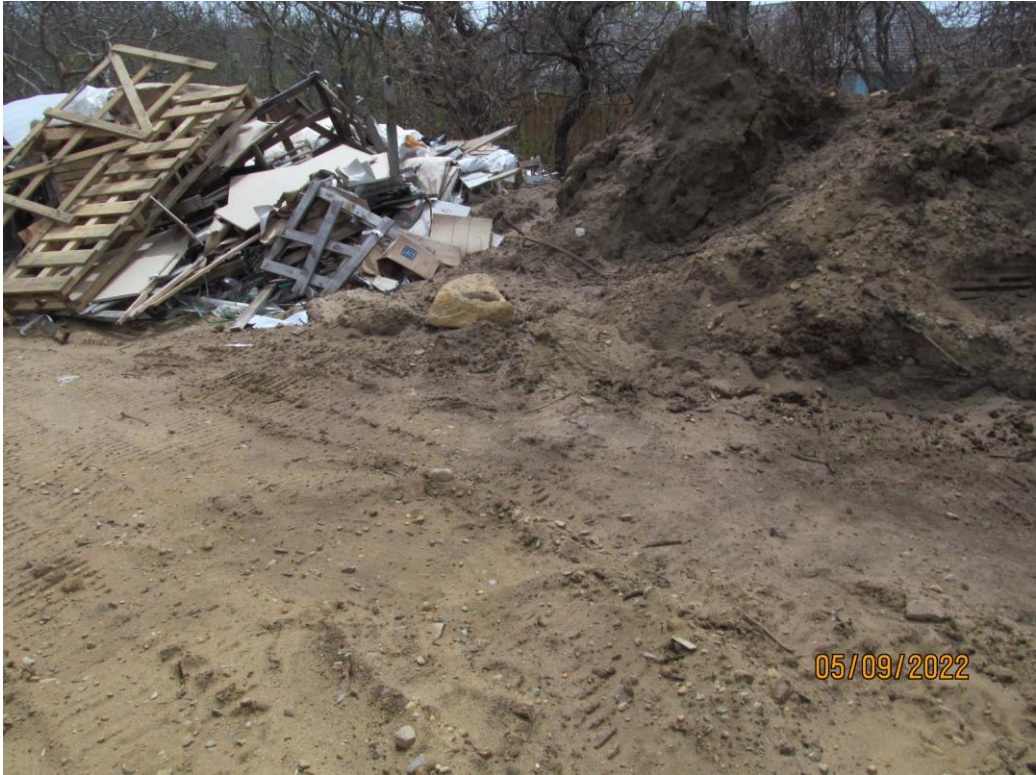
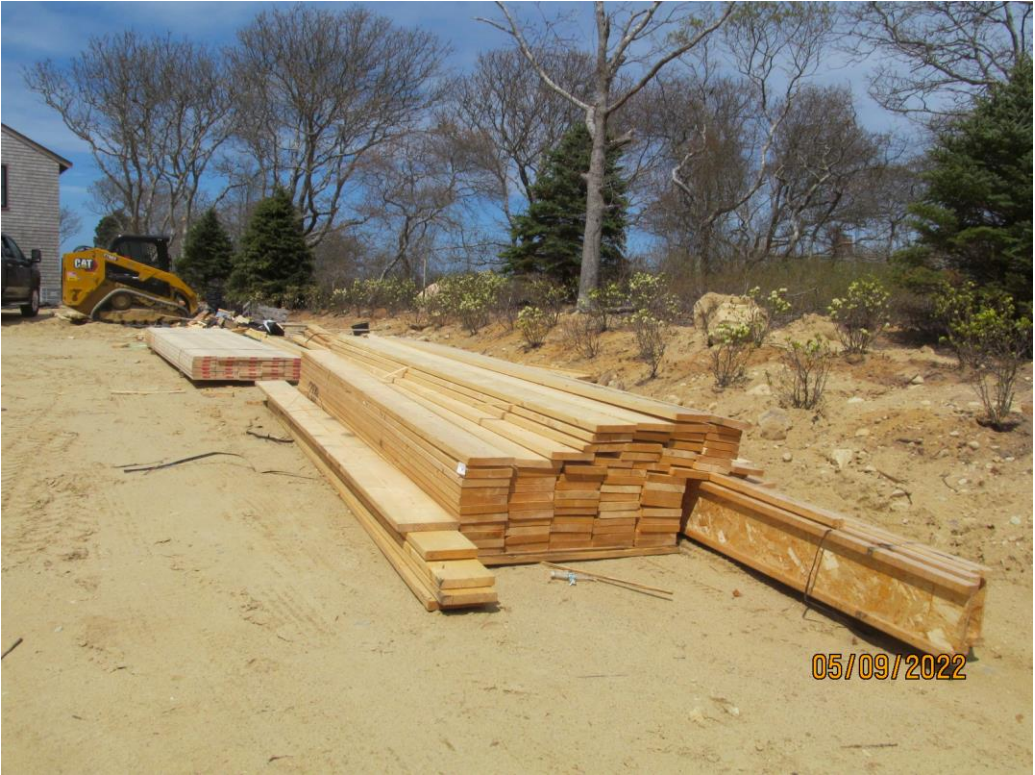
Site is not very clean. Wind blow debris

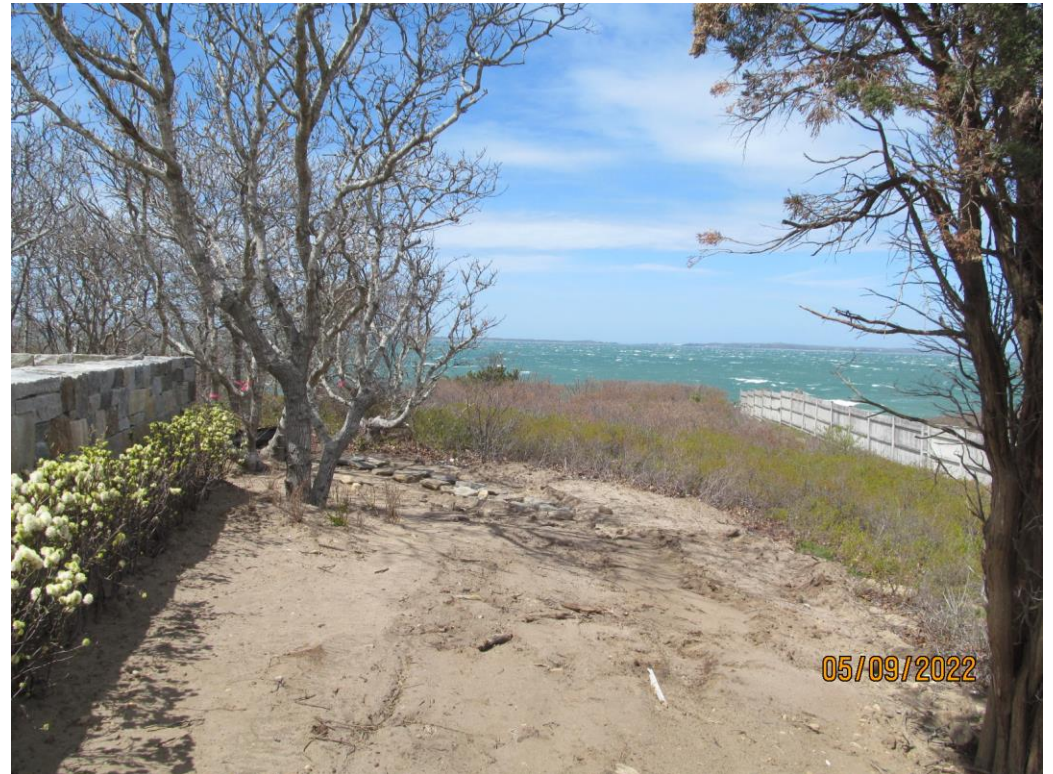
Path to top of bank where it is steeper.
