CERTIFICATE OF COMPLIANCE SITE VISIT SE79-261 Duarte's Pond and Blackwater Brook Land Bank properties

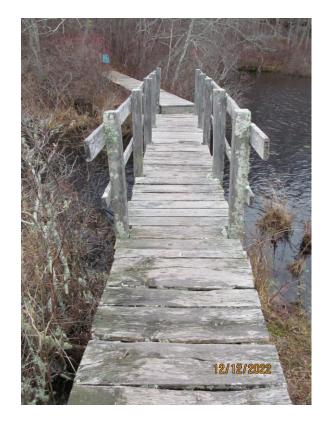
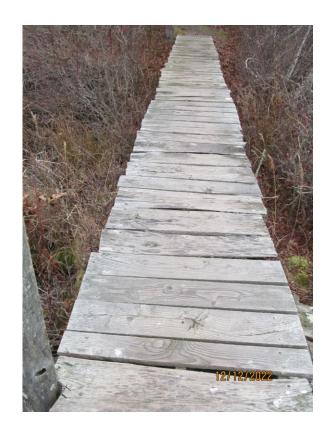
Causeway and elevated span

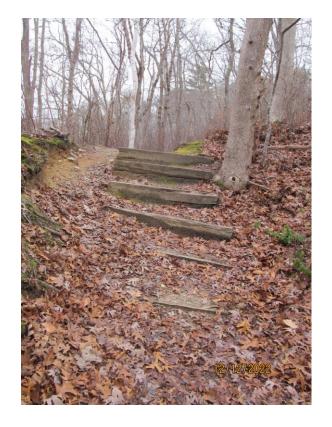
End of causeway crossing and 5 earthen stairs.

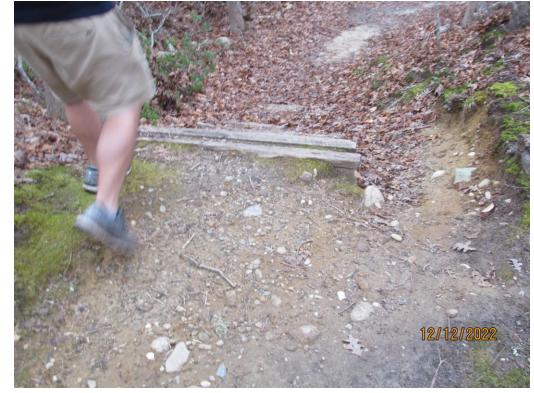
Side erosion most likely caused by mountain bikers

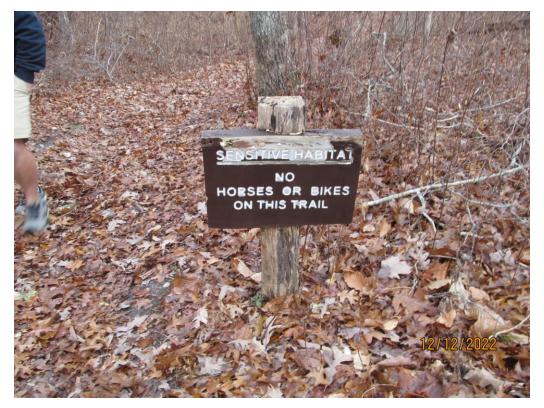
Start of Blackwater Pond
