July 27, 2023

TO: West Tisbury Conservation Commission
CC: George A. Sourati, P.E. (Sourati Engineering Group LLC)
FROM: Greg Berman, Coastal Processes Specialist (WHSG & CCCE)
RE: Site report for 271 John Cottle Road, West Tisbury, MA

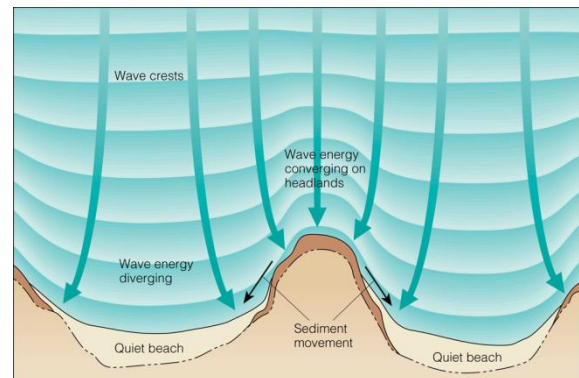
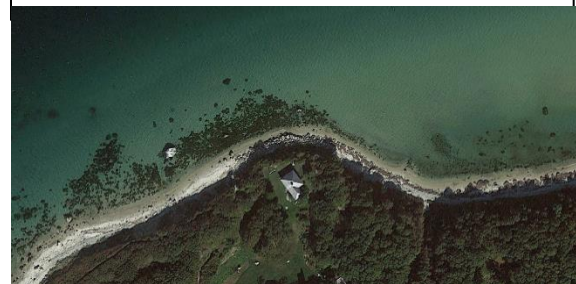
It is likely that wherever this revetment ends it will experience high potential erosion due to “normal” terminal effects of the revetment, combined with the wave energy converging on the headland-type shoreline. An important element of CES design is how the CES transitions to the native coastal bank material. This site is especially susceptible to terminal erosion, and the proposal does include a reasonable transition of gabion baskets and fiber rolls. Both of these should remain covered with beach compatible sediment in order to prevent the materials from breaking down too quickly and to reduce the wave impacts to the adjacent beach. If regulators determine there is a need to maintain the beach in front of the gabion/fiber rolls, then a triggered nourishment requirement (aka trigger) might be included in the Order of Conditions, either instead of, or in addition to the annual requirement. When the beach drops below an elevation-based marker for a designated period of time, nourishment would be brought in to bring the beach back up to design elevation. This type of nourishment strategy would require a monitoring plan. More information on monitoring plans, triggered nourishment, and beach

Above: Graphic showing how the bathymetry near a headland tends to converge wave energy onto the headland. Image from //science.kennesaw.edu

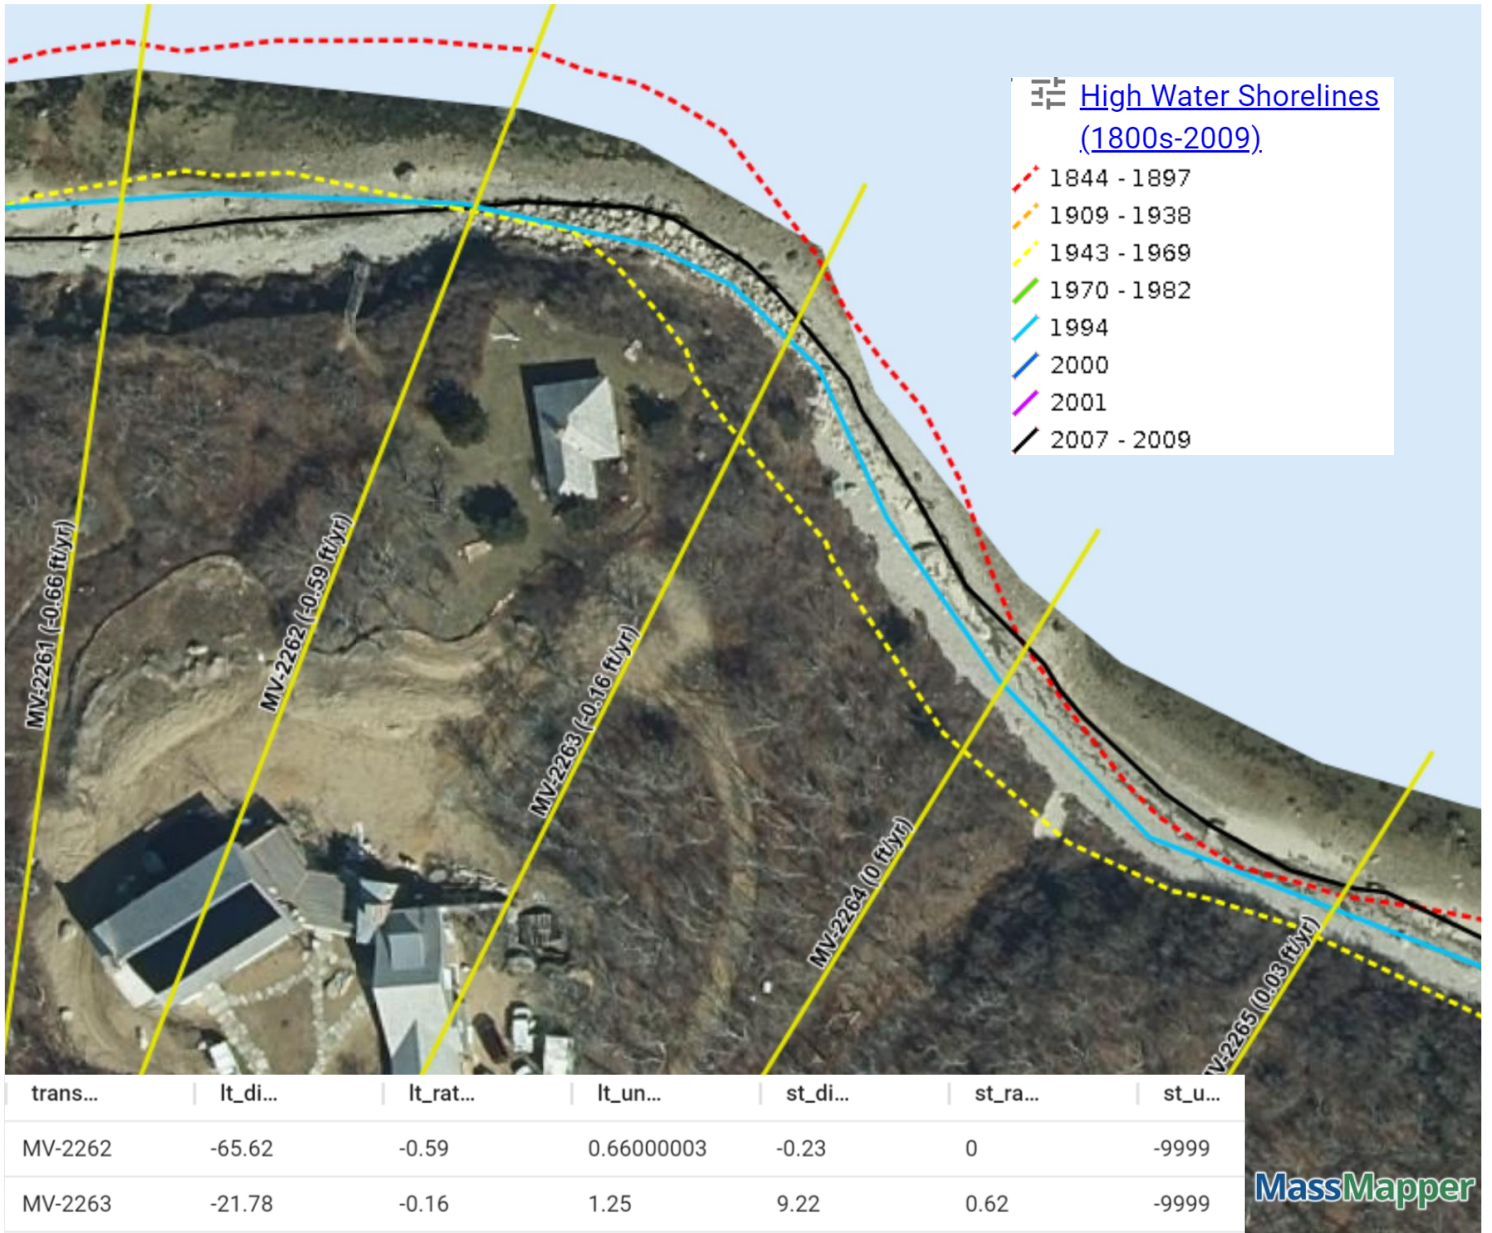
After the site visit, historic shoreline migration trends were examined through a time series of shorelines available from the Massachusetts Shoreline Change Project as shown on the Shoreline Change Viewer of the MassMapper website provided by Massachusetts Office of Coastal Zone Management. (Figure 2 , data available at <https://maps.massgis.digital.mass.gov/MassMapper/MassMapper-CZM-Shorelines.html>). At this location short term rates should not be used due to very high uncertainty (labeled -9999 on the table). The long term rates also have uncertainty values higher than the rates, indicating that the actual long term shoreline change rates could vary from 1.41'/yr of erosion to 1.09'/yr of accretion. The 1943-1969 shoreline is further landward than the current top of bank indicating coastal bank formation since that time, which is highly unlikely. This shoreline change data is not very accurate, but still may be the best available. The +/- 60 cubic yards of proposed annual sand nourishment is likely a sufficient volume to make up for the loss of eroded material supplying downdrift beaches.

Figure 2. Screenshot of data from the Massachusetts Shoreline Change Project as shown on the Shoreline Change Viewer of the MassMapper website provided by Massachusetts Office of Coastal Zone Management. (Data available at <https://maps.massgis.digital.mass.gov/MassMapper/MassMapper-CZM-Shorelines.html>). Short term rates should not be used due to very high uncertainty, and the long term rates also have high uncertainty. The 1943-1969 shoreline is further landward than the current top of bank indicating coastal bank formation since that time, which is highly unlikely.

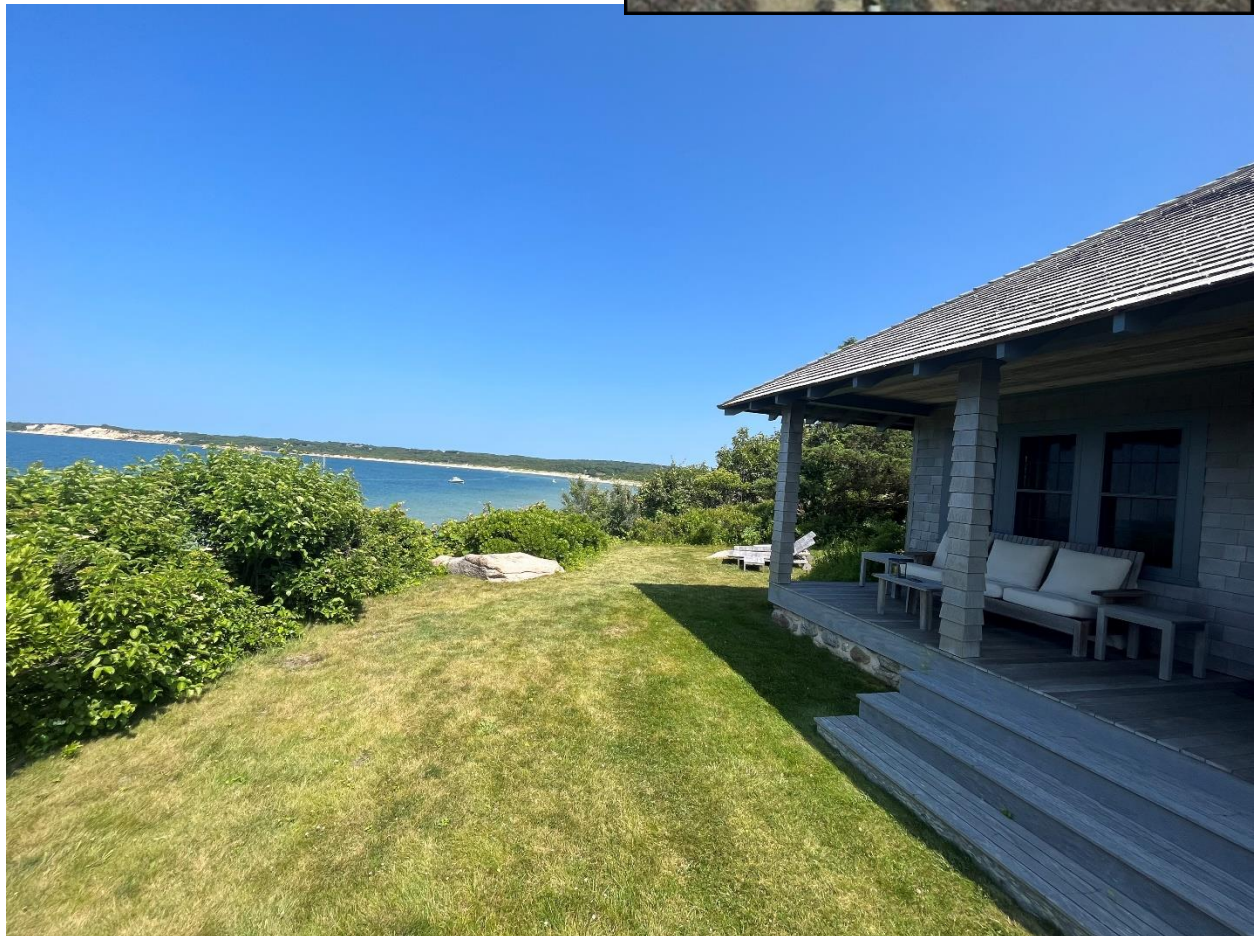
Photograph 1. The edge of the cottage is ~ 16' from the top of the bank. There was no observed surface runoff issue at the site despite lawn extending to the top of the bank.

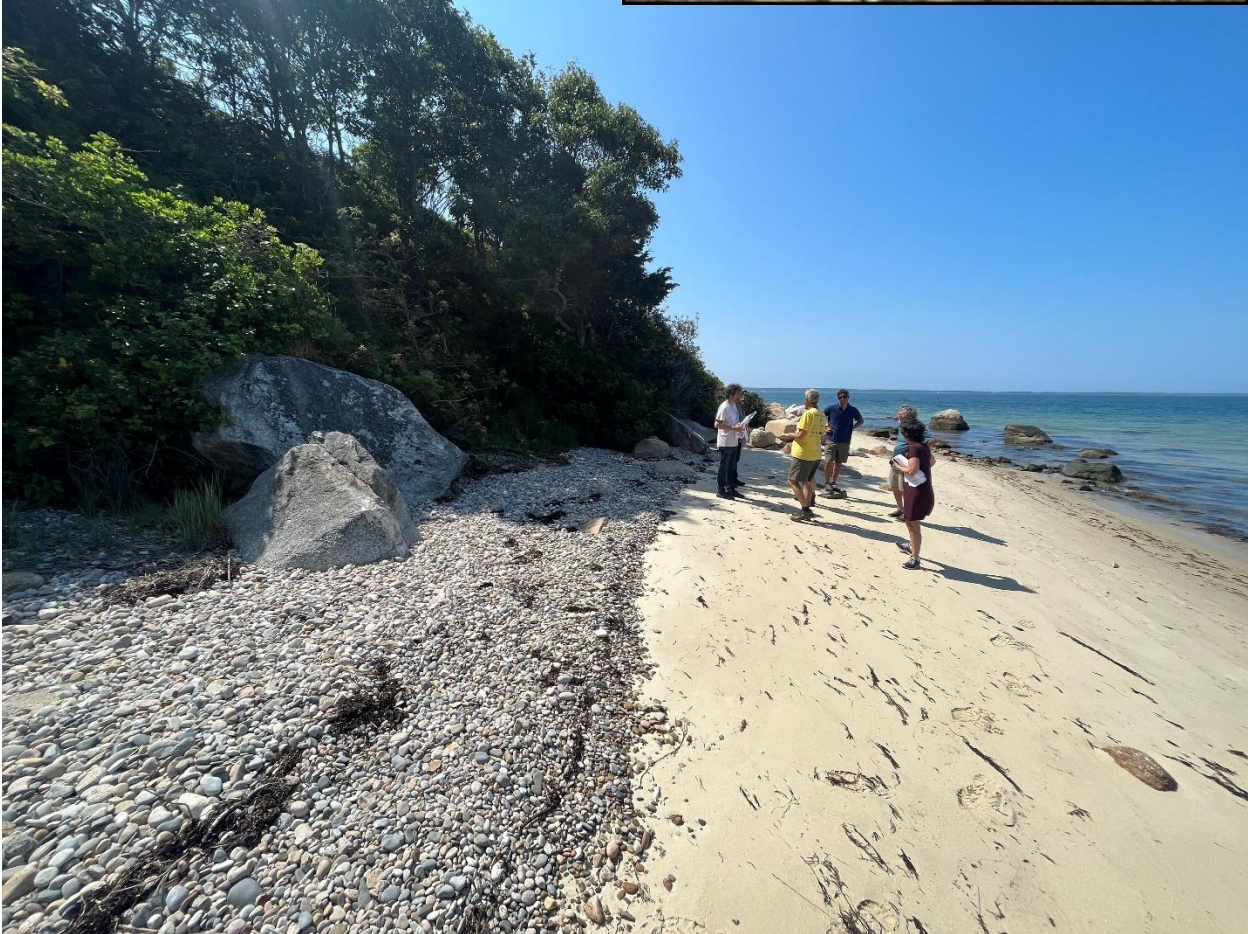
Photograph 2. The eastern end of the existing revetment extends further seaward than the adjacent shoreline. A cobble deposit extends 5-10' from the toe of the coastal bank.

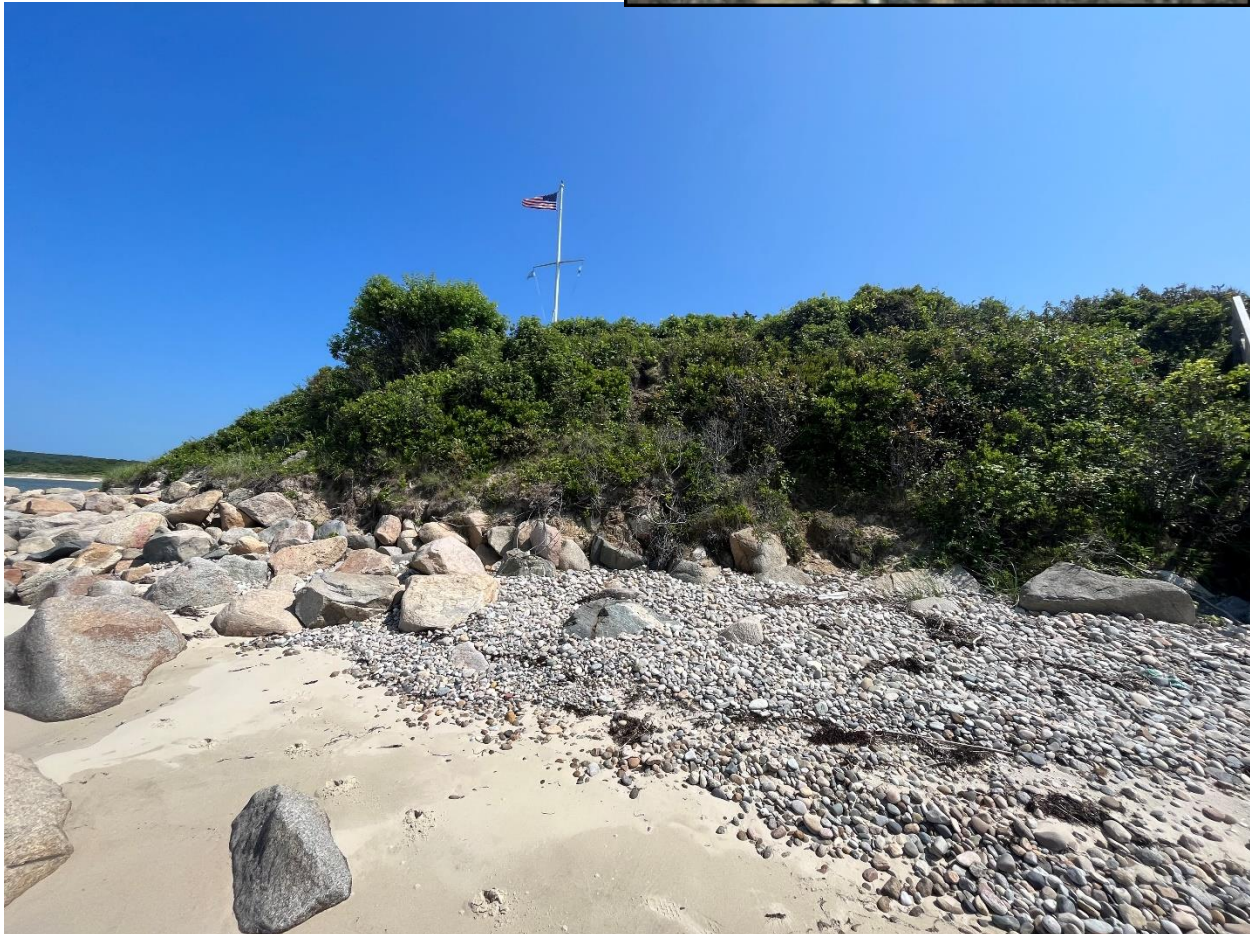
Photograph 3. The western end of the existing revetment also extends further seaward than the adjacent shoreline. A cobble deposit extends 5-10' from the toe of the coastal bank. The existing boulders from the revetment still provide some protection for the coastal bank, but will become less effective in the future.
