COASTAL PROCESSES SPECIALIST
WOODS HOLE SEA GRANT | CAPE COD COOPERATIVE EXTENSION
gberman@whoi.edu | gberman@barnstablecounty.org
508-289-3046 | 193 Oyster Pond Road, MS #2, Woods Hole, MA 02543-1525

TO: West Tisbury Conservation Commission
CC: George Sourati (Sourati Engineering Group)
FROM: Greg Berman, Coastal Processes Specialist (WHSG & CCCE)
RE: Site visit to Makonikey, West Tisbury, MA – 03/04/2022

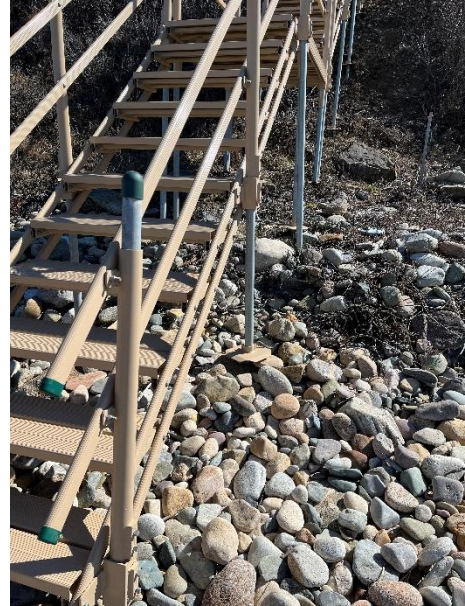
After Makonikey, the group examined a nearby site in Menemsha, that had a stair system similar to the one proposed (see image to the right). The stair system was secured with adjustable 2" poles, with segments of the system removable. For example, the proposed system is to have the lowest segment removed during the winter to prevent storm damage. While the stairs are opaque, the proposed height (18"+) off the bank and the spacing appears to allow sufficient light to the underlying bank. While there is no substantial vegetation currently on the coastal bank at Makonikey, this system appears to provide space for vegetation to establish itself underneath the stairs. The installation company has indicated that *"If the stairs ever need to be serviced, i.e., bank washed away, reconfiguration, sand coverage, we can work up a yearly service plan to keep the stair system maintained and accessible."* A monitoring and maintenance plan is likely important, as it could lead to extended lifespan of the stairs, as well as less frequent/intensive activity on the bank if the entire system were to fall.

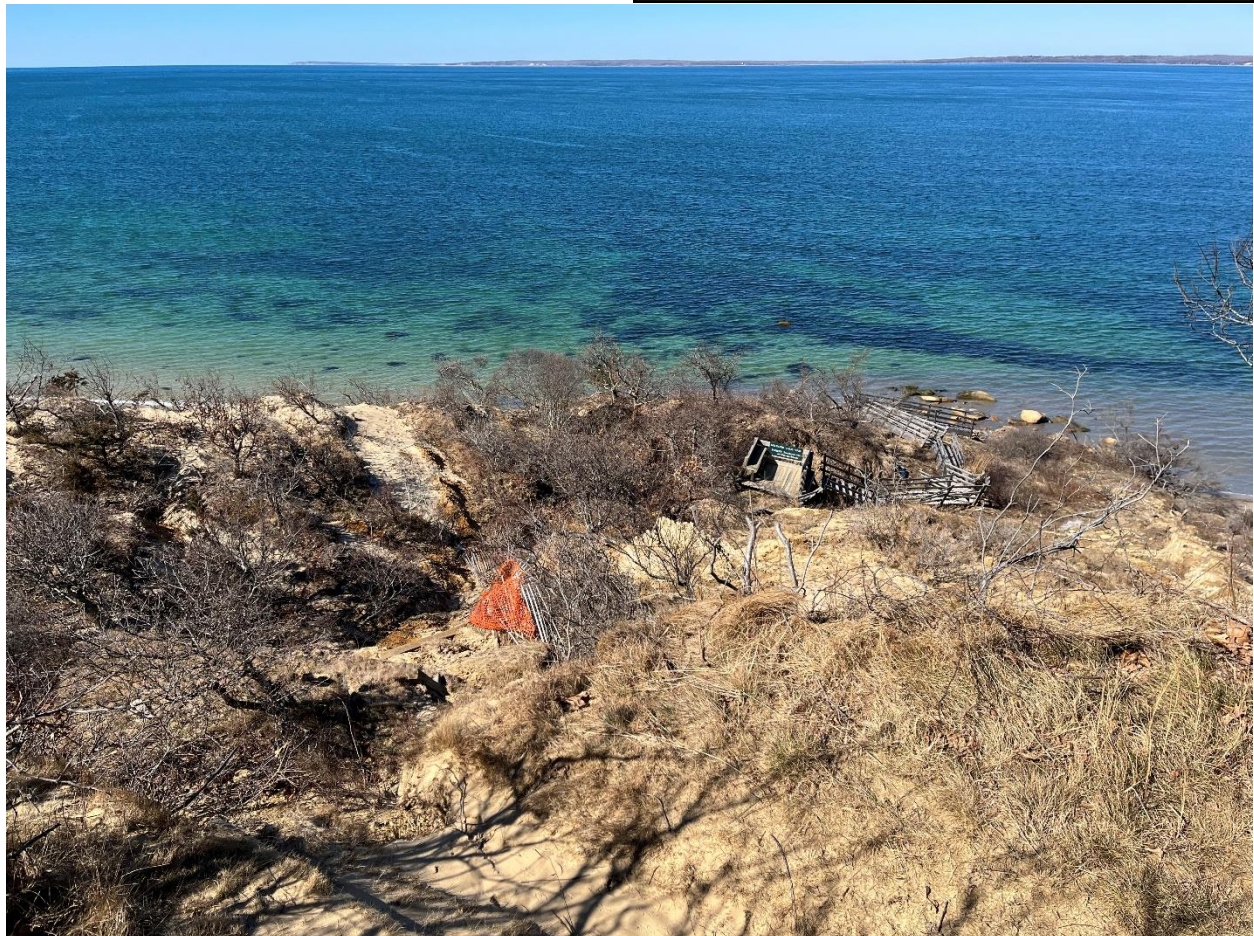
A series of photographs was taken during a site visit on 03/04/2022. Photograph 1 shows the coastal bank that is eroding and providing sediment to the beach at the site. The bank appears to have undergone recent collapse. A large portion of the vegetated bank, including some trees, has slumped down the face of the bank and deposited material on the beach. The slumping of the coastal bank at the site has compromised the wooden stairway system to access the beach. While it was not observed during the site visit, it was shared during the site visit that groundwater seeps out of the coastal bank near the elevation of the beach. It was speculated that this seep may have created instability in the bank and lead to the collapse. Photograph 2 shows the coastal bank, to the south of the destroyed stairs, has eroded and much of the bank is unvegetated save for the sections of bank that have slid down relatively intact. The proposed location (Photograph 3) for the new stairs is also in an area that has experienced erosion, but not quite as severe as the rest of the bank.

That Massachusetts Shoreline Change Project indicates a long term erosion rate of 0.72' per year. However, this estimate is not very useful as the long term uncertainty is quite high (+/- 0.85' per year), with the short term rate too uncertain to even quantify. This bank is likely characterized by long periods of relatively slow erosion, punctuated by large bank collapse events such as the one that just occurred.

Photograph 1. Slumping of the coastal bank at the site has compromised the wooden stairway system to access the beach.

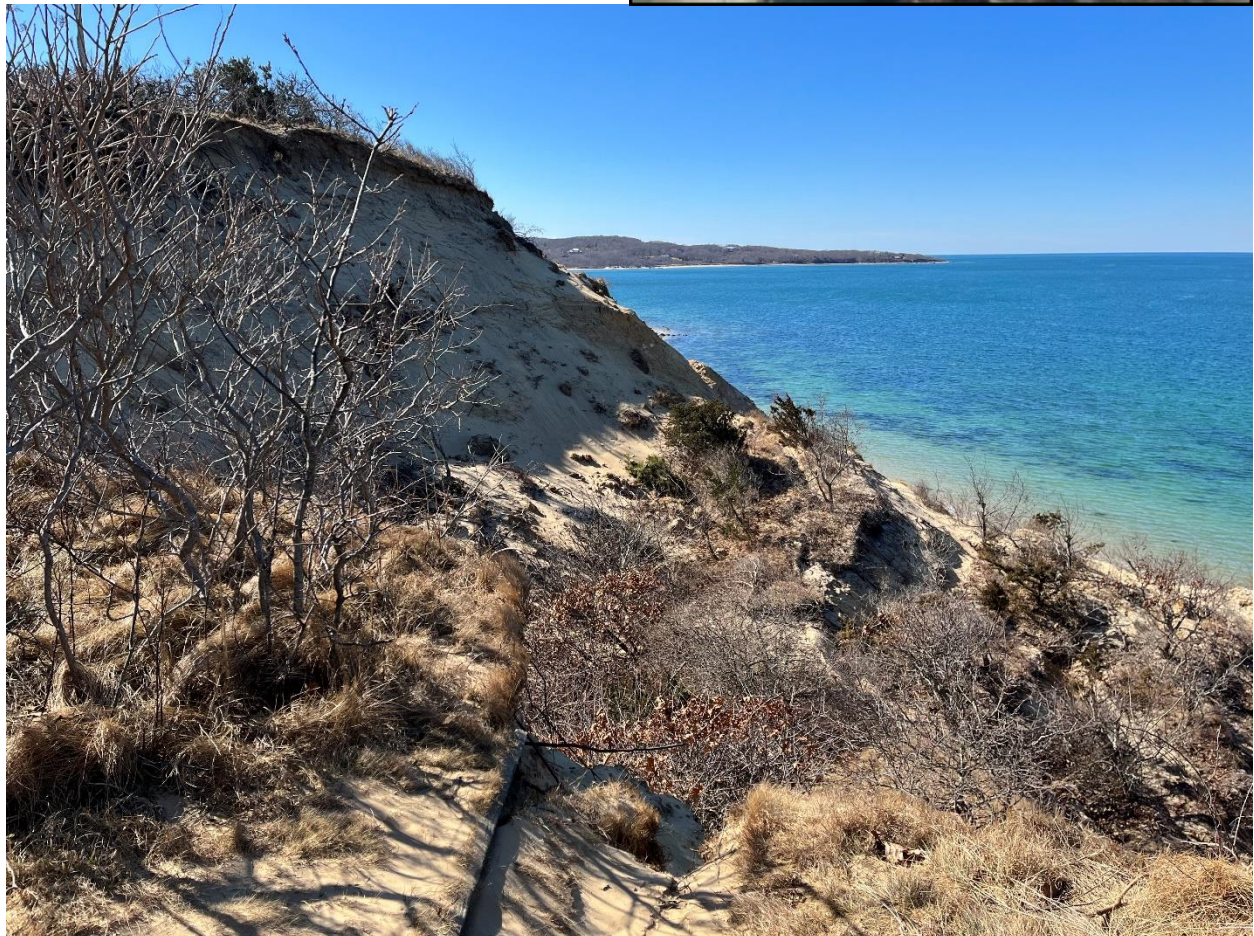
Photograph 2. The coastal bank, to the south of the destroyed stairs, has eroded and much of the bank is unvegetated, save for the sections of bank that have slide down relatively intact.

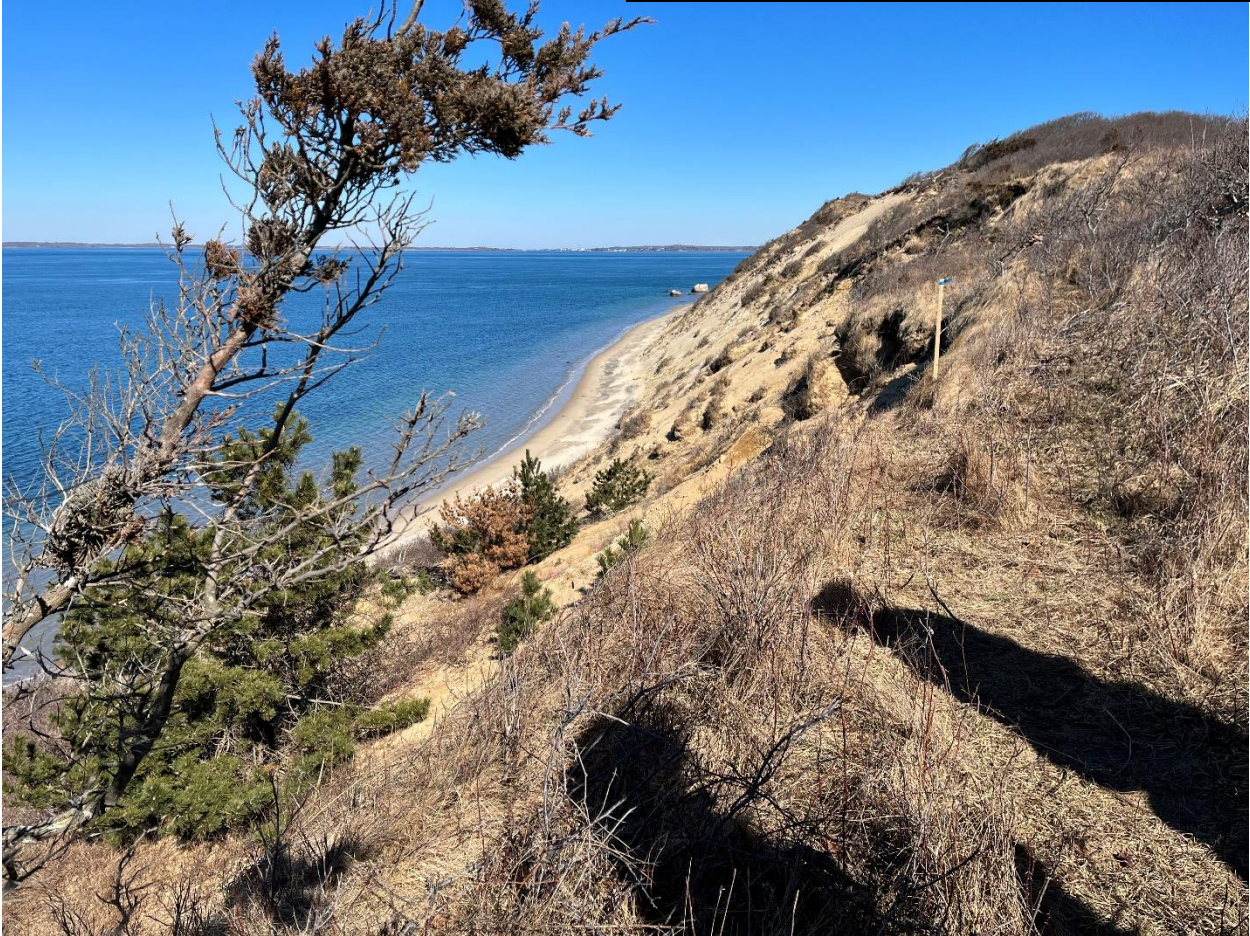
Photograph 3. The proposed location for the new stairs is also in an area that has experienced erosion, but not quite as severe as the rest of the bank.

- While the proposed site does not appear to be entirely stable, it is likely the most stable area on this property.
- The adjustable stair system appears to be designed to have minimal impact to the coastal bank and beach.
- Surface runoff does not appear to have been an impact in the past. However, the area leading to, and under, the stairs should be examined periodically after installation.
- A well designed monitoring and maintenance plan could lead to extended lifespan of the stairs, as well as less frequent/intensive activity on the bank if the stair system were to collapse.
