PEER REVIEW

TO: Town of West Tisbury Conservation Commission
FROM: Stan Humphries & Cameron Larson @ ECR
DATE: February 6, 2024
RE: 130 Plum Bush Point Road, West Tisbury

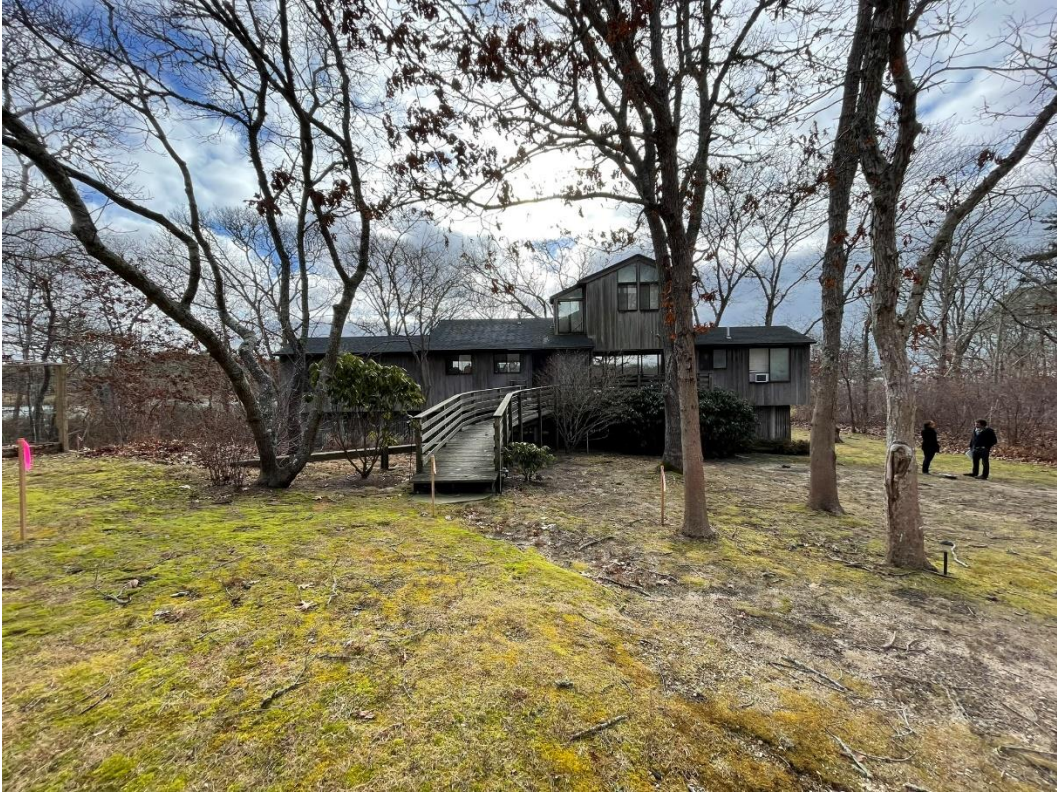
Photograph #1 – View east toward the front of the existing home.

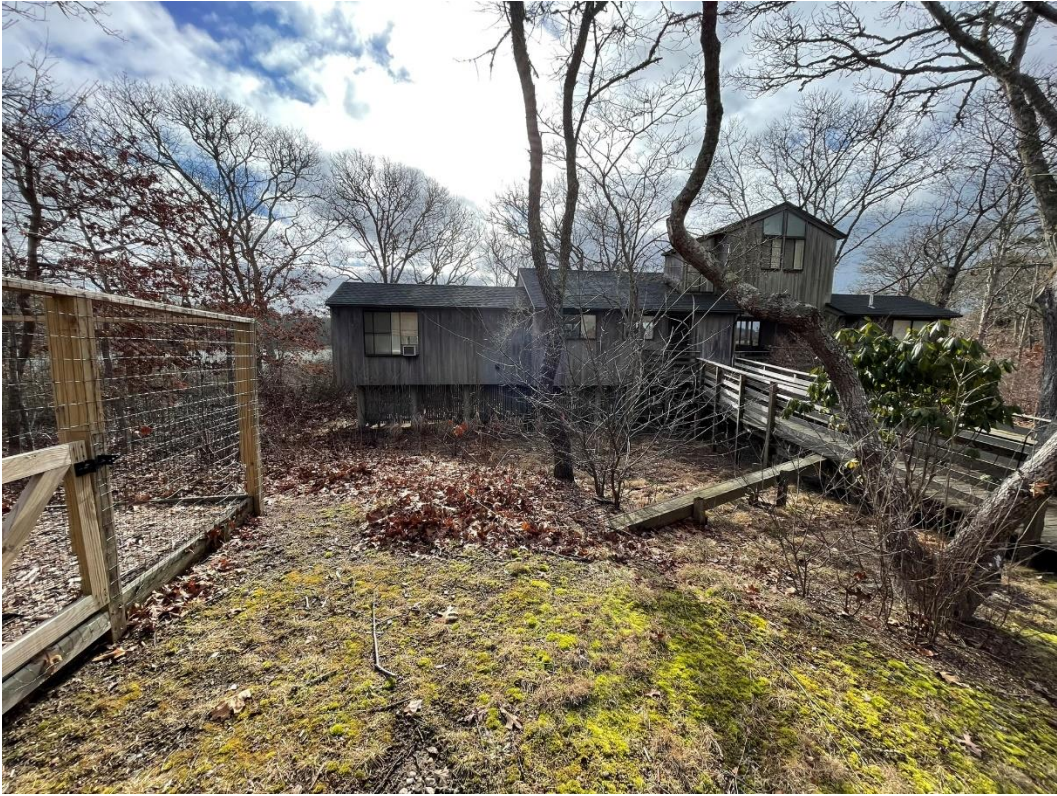
The Coastal Bank is depicted on the site plan as a fragmented Bank that exists immediately north and west of the existing home. A change in slope, while not drastic, was obvious in the field in this portion of the site. As part of ECR's review, the memo prepared by Epsilon Associates regarding the Coastal Bank Assessment was reviewed. It is ECR's professional opinion that Epsilon Associates (Epsilon) applied the appropriate methodology for delineating the Coastal Bank and the Coastal Bank has been accurately depicted on the site plans. As noted in Epsilon's memo, MA DEP has established guidance for delineating a Coastal Bank based on the slope of a landform and the FEMA flood zone. This guidance provides clear and objective criteria to determine the presence of a Coastal Bank and in the case of 130 Plum Bush Point Road, the criteria are met. ECR notes that in Epsilon's memo, the profile view of Transect A did omit a small section of Coastal Bank from elevation 7 to elevation 8; this appears to be a clerical error as the Coastal Bank is correctly depicted on the site plan from elevation 7 to elevation 11 along Transect A.

Photograph #2 – View east of toward the existing home and the Coastal Bank.

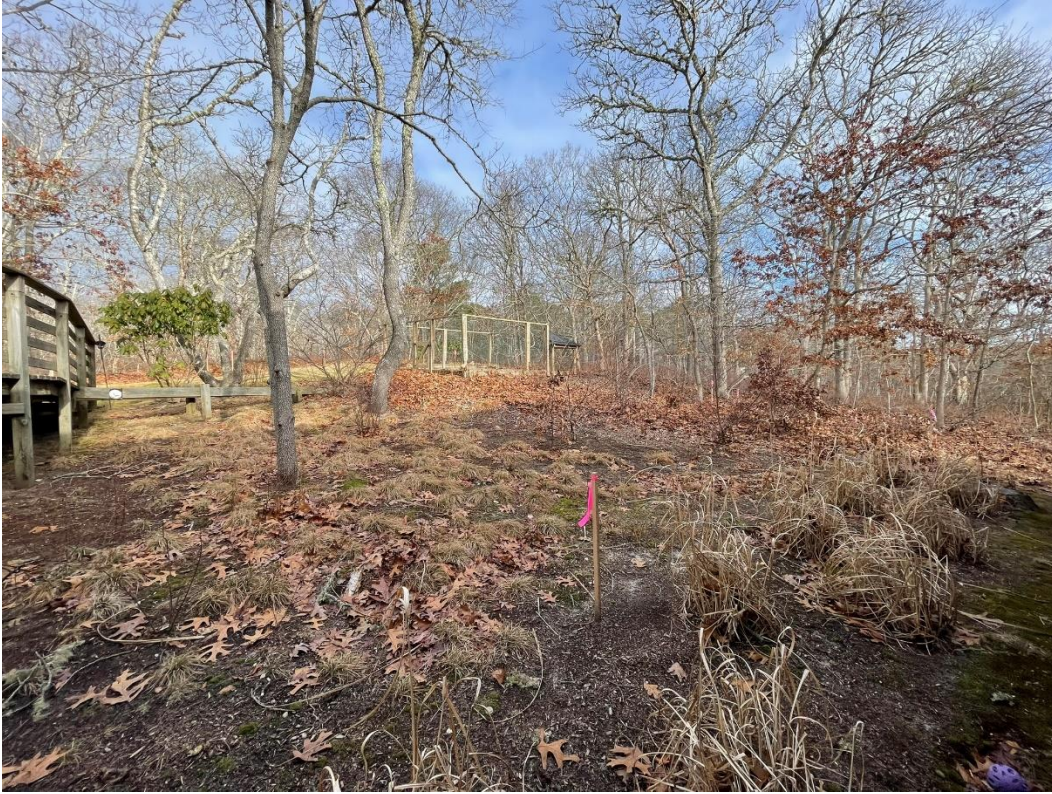
Photograph #3 – View northwest of the Coastal Bank and the location of the proposed addition.

Assuming the West Tisbury Conservation Commission agrees that the applicant has not clearly shown that the Coastal Bank does not play a role in storm damage prevention or flood control, ECR believes there are options the applicant could propose to meet the performance standards for work on a Coastal Bank as set forth by the MA WPA Regulations and the local Regulations. Firstly, the proposal to utilize piers to support the new addition that will span the Coastal Bank (as detailed on the Additional Information Page in the NOI Submittal) is an excellent way to avoid an adverse effect to the Bank as required by 310 CMR 10.30(6). However, the impacts of shading on the existing vegetation under the proposed addition must be considered. ECR observed the areas under the existing home to be completely void of vegetation (see the attached photograph pages). It is likely that over a very short period of time the vegetation that is being shaded by the new addition would die back and ultimately lead to exposed soils – adversely affecting the stability of the bank. ECR recommends that the applicant consider a design that will stabilize the area under the proposed addition, which may include crushed stone, coir fabric, a combination of the two, or other innovative solution. If the applicant can demonstrate that the Coastal Bank will remain stable in the long-term, the Commission may find no adverse effect is caused by the proposed project.

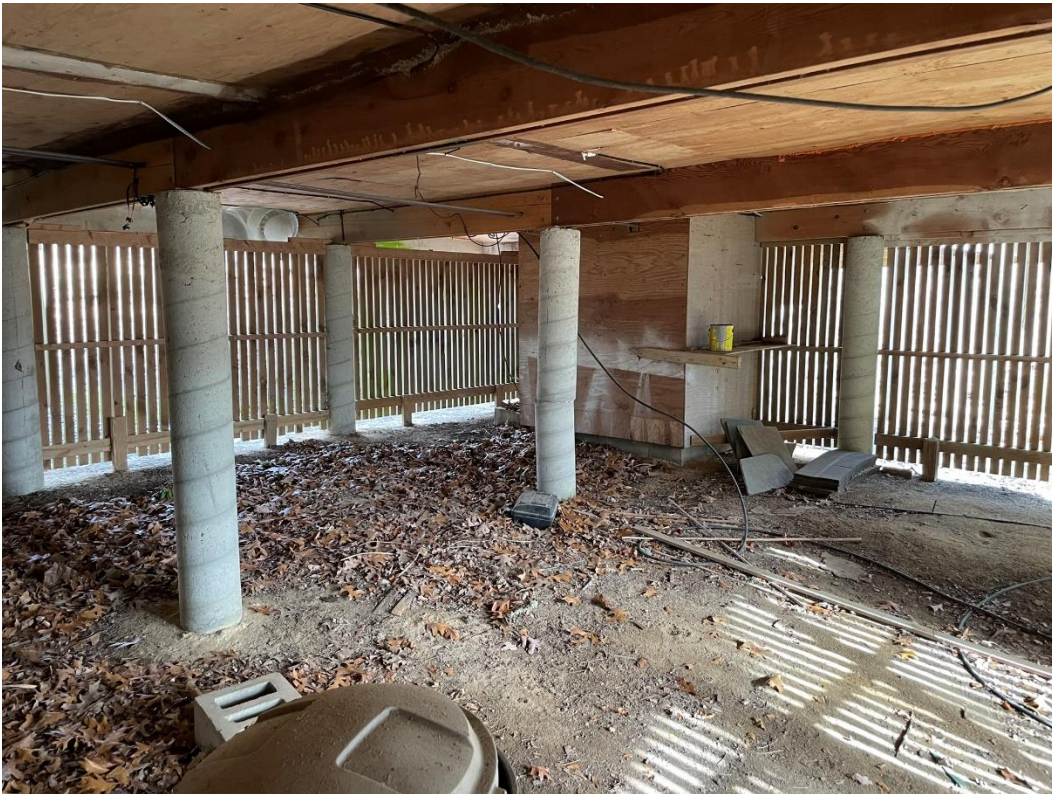
Photograph #4 – View under the existing home that shows the exposed soils and lack of vegetation.

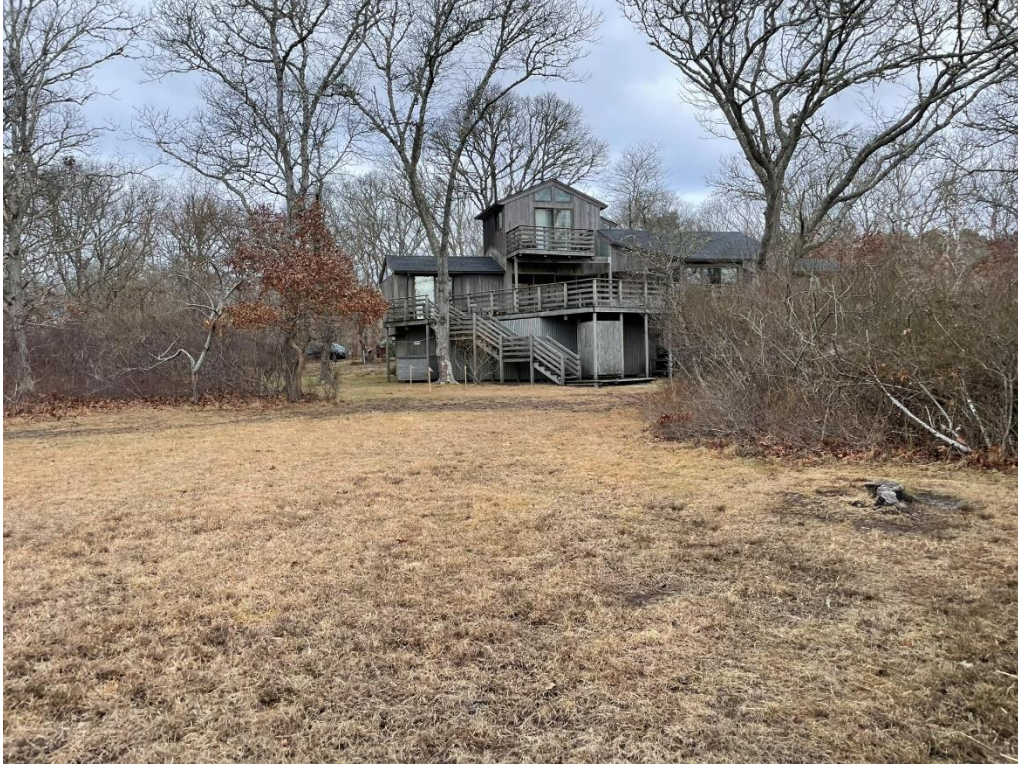
Photograph #5 – View to the rear of the home across the maintained lawn that abuts the BVW and Salt Marsh.

Lastly, if the Commission is seeking additional improvements to the site conditions to offset the proposed work within the wetland resource areas and associated buffer zones, the applicant may consider restoring portions of the site to a native buffer. ECR observed an area of maintained lawn within the southeastern corner of the lot, immediately west of the existing pier. While its likely the property owner utilizes this area for recreation, as it is really the only area of maintained lawn on the site, it does provide an opportunity to expand the existing buffer to BVW and Salt Marsh as well as enhance LSCSF. The applicant may consider removing the lawn, or a portion of the lawn, and planting native, salt-tolerant plant species to enhance the buffer, improve wildlife habitat, improve flood control, etc. While the performance standards for the resource areas impacted by the project do not specifically require mitigation, the local regulations

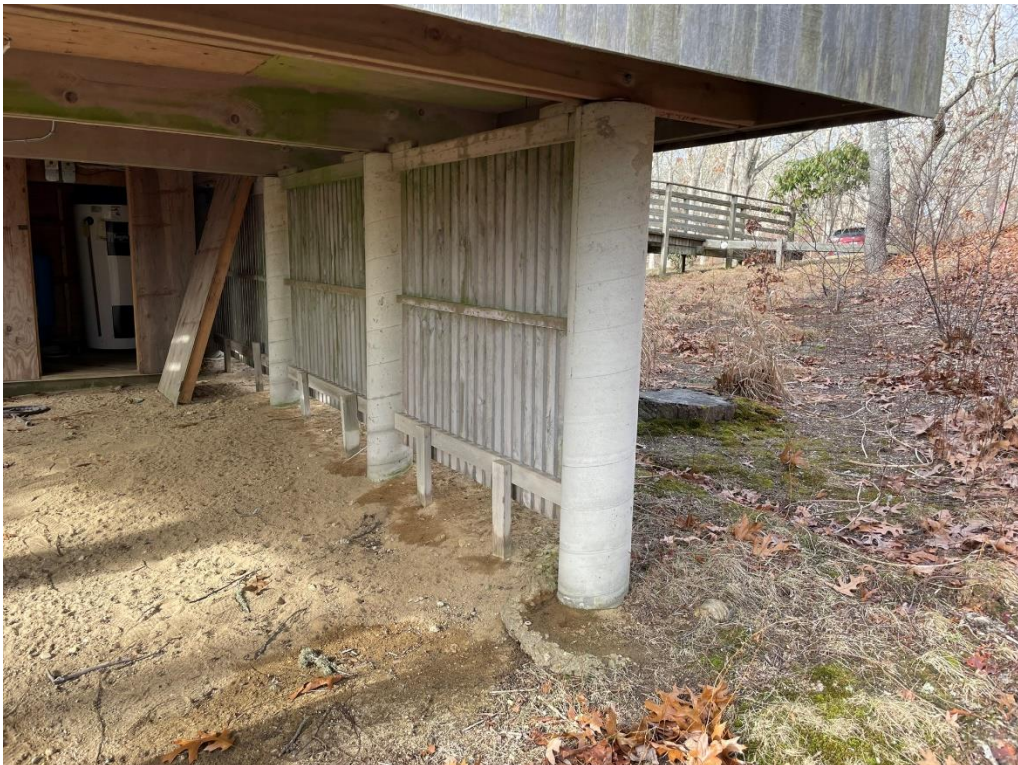
- 2) Epsilon Associates argues in their memo that the Coastal Bank cannot possibly buffer incoming floodwaters because the Bank is located landward of the existing residence. While the Bank is located on the landward side of the existing home, the existing home is constructed on piles and therefore floodwaters would certainly flow under the existing home and be buffered by the Coastal Bank.

Photograph #6 – View of the piles that support the existing home. Flood waters can travel under the home and be buffered by the Coastal Bank.
