FACILITY CONDITION ASSESSMENT

HOWES HOUSE 1042 State Road

West Tisbury, Massachusetts 02568

EMG

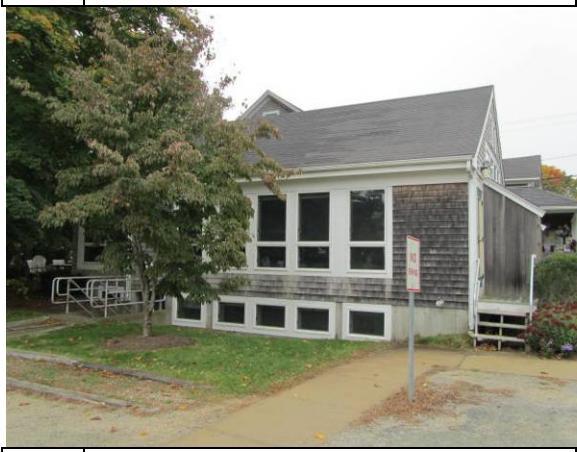
Photo Rear elevation and pitched roof overview #5:

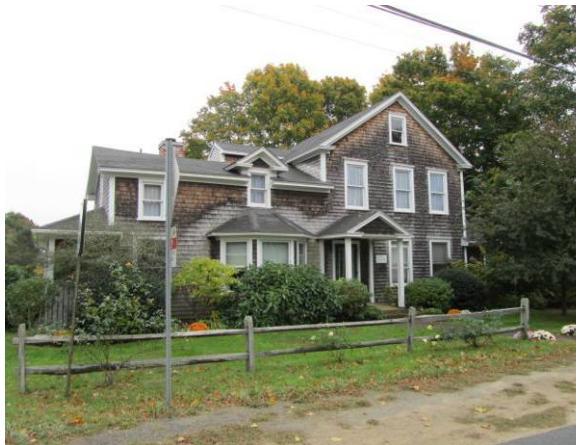
Photo Front elevation (State Road elevation); #2: note lower roof section deflection

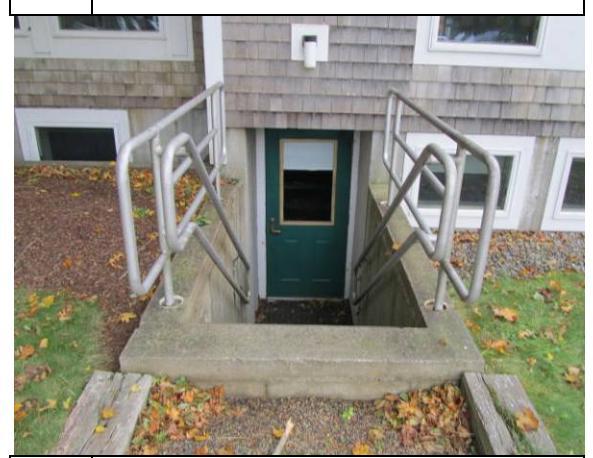
Photo Exterior basement egress; note high step #11: up to stair well from pea-gravel walk

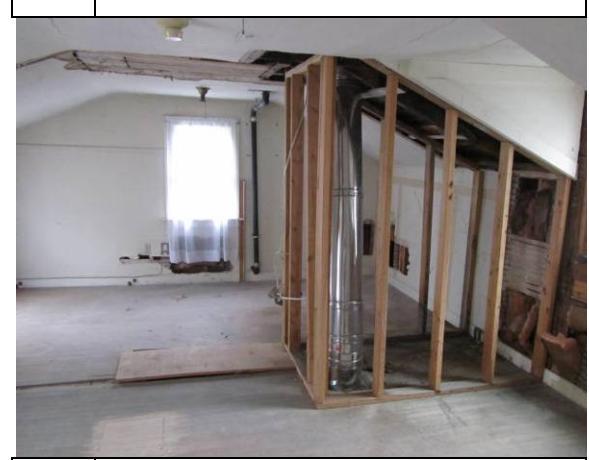
Photo Second floor vacant area; note framing #18: around chimney flue pipe

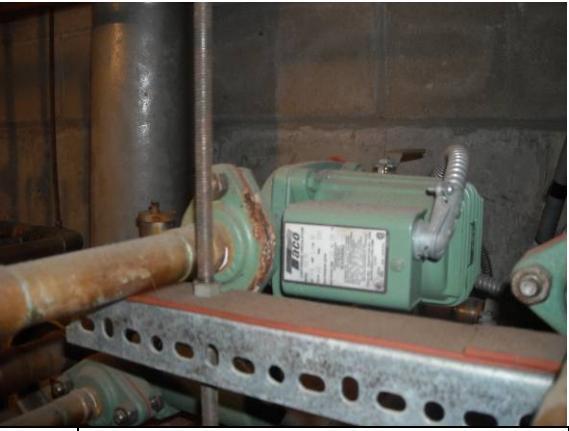
Photo Circulating pump with flange corrosion #22:

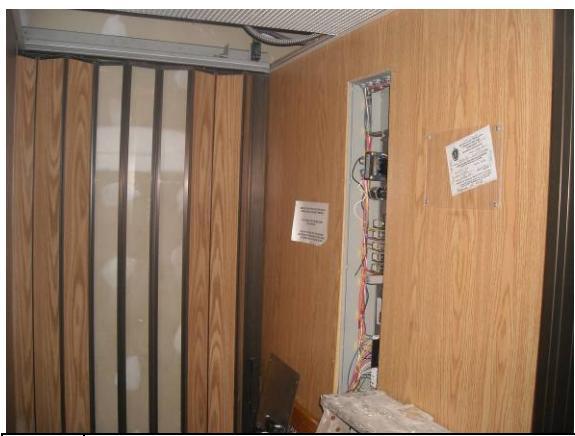
Photo Elevator lift interior; repairs in progress #31:

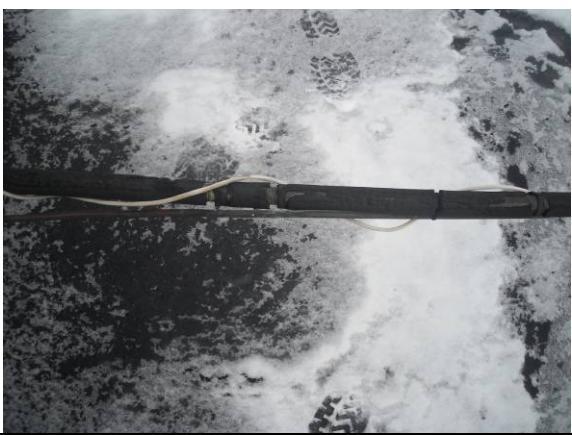
Photo Deteriorated insulation on line set from #37: five-ton condensing unit

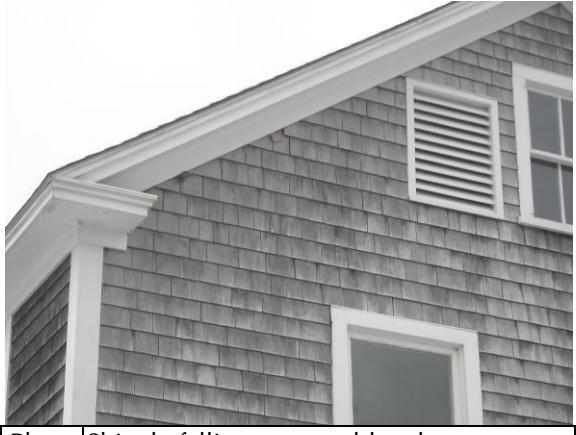
Photo Shingle falling out at gable rake #39:

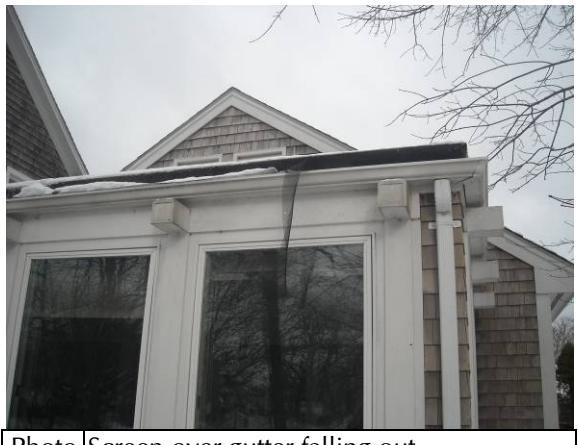
Photo Screen over gutter falling out #41:

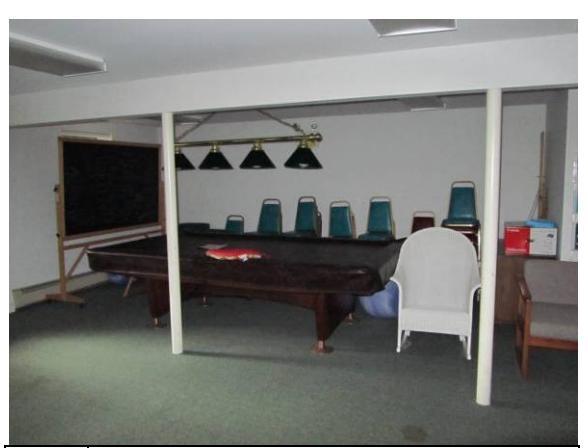
Photo Stained carpet in basement #38:

8.1	Carpet. Replace.	10	8	2	178	SY SY	\$51.50	\$9,167	200%	\$0	\$9,167	\$0	\$0	\$0	\$0	\$0	\$0	\$0	\$0	\$0	\$0	\$0	\$0) \$0	\$0	\$0	\$9,167	\$0	\$0	\$18,334

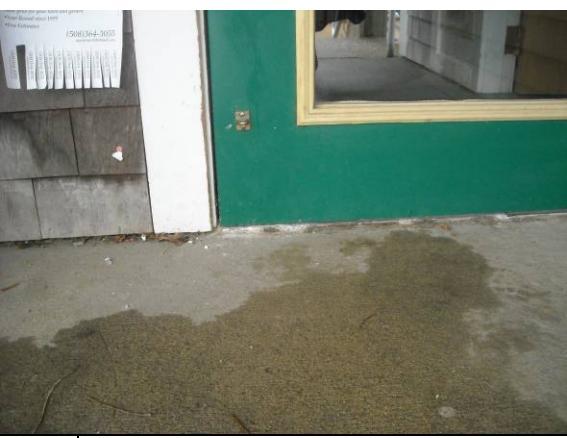
Photo Main entry door dragging on threshold #40:
