ZERO CARBON-READY RETROFIT STUDY

**WEST TISBURY ELEMENTARY SCHOOL
WEST TISBURY, MA**

PREPARED FOR
UP-ISLAND REGIONAL SCHOOL DISTRICT
SEPTEMBER 09, 2022

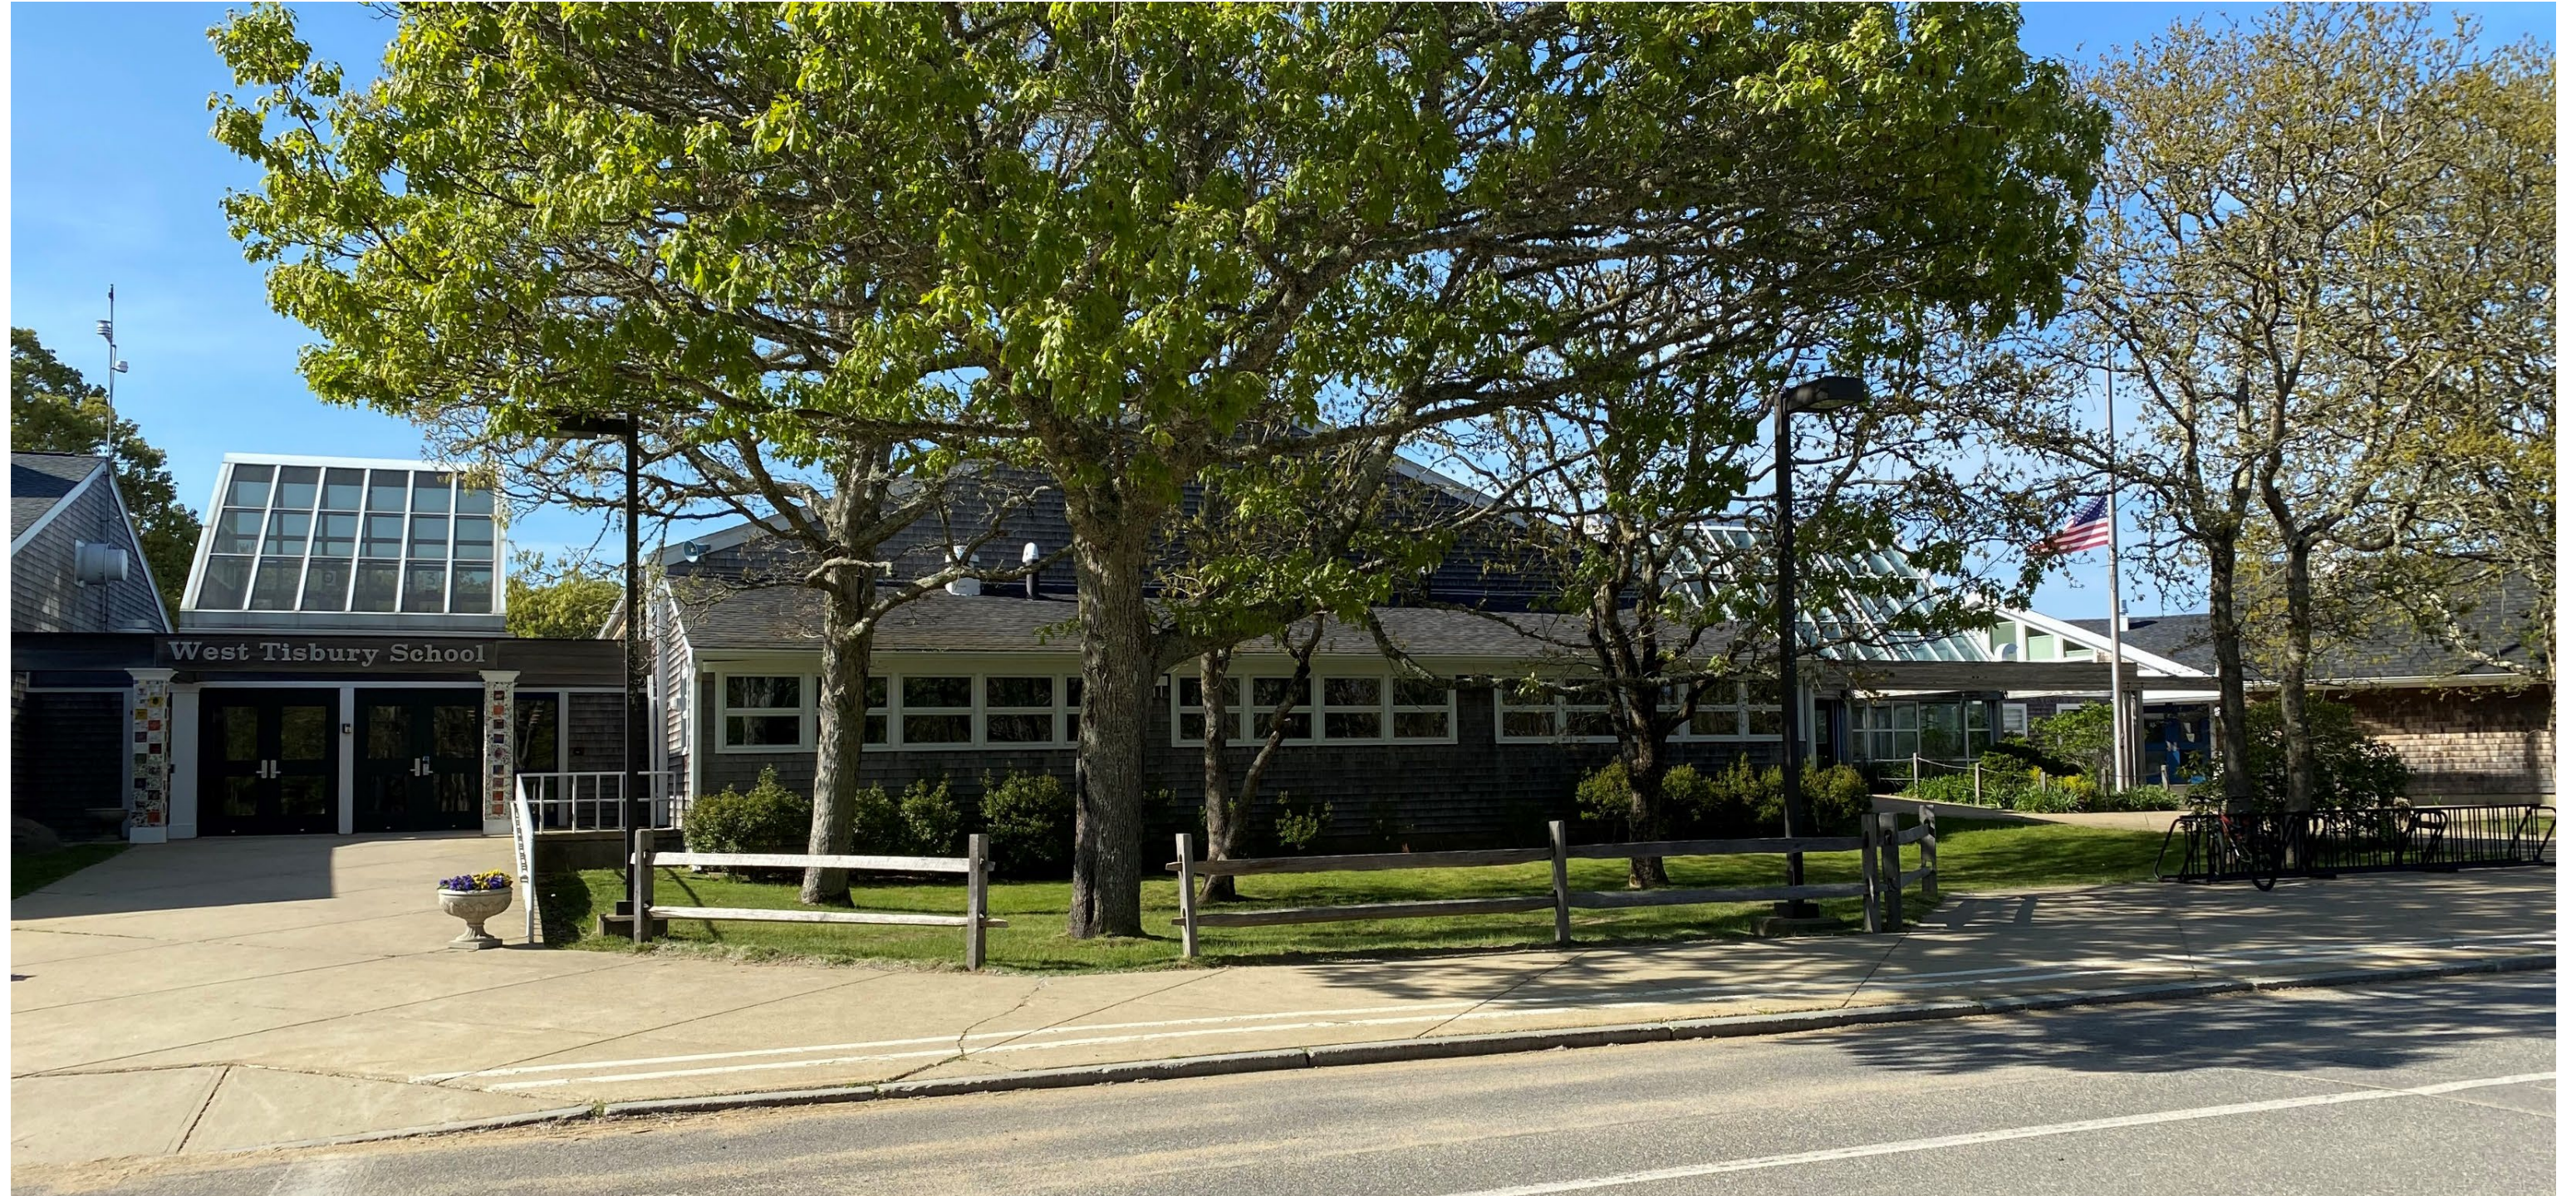
CURTAINWALL ENTRANCES.

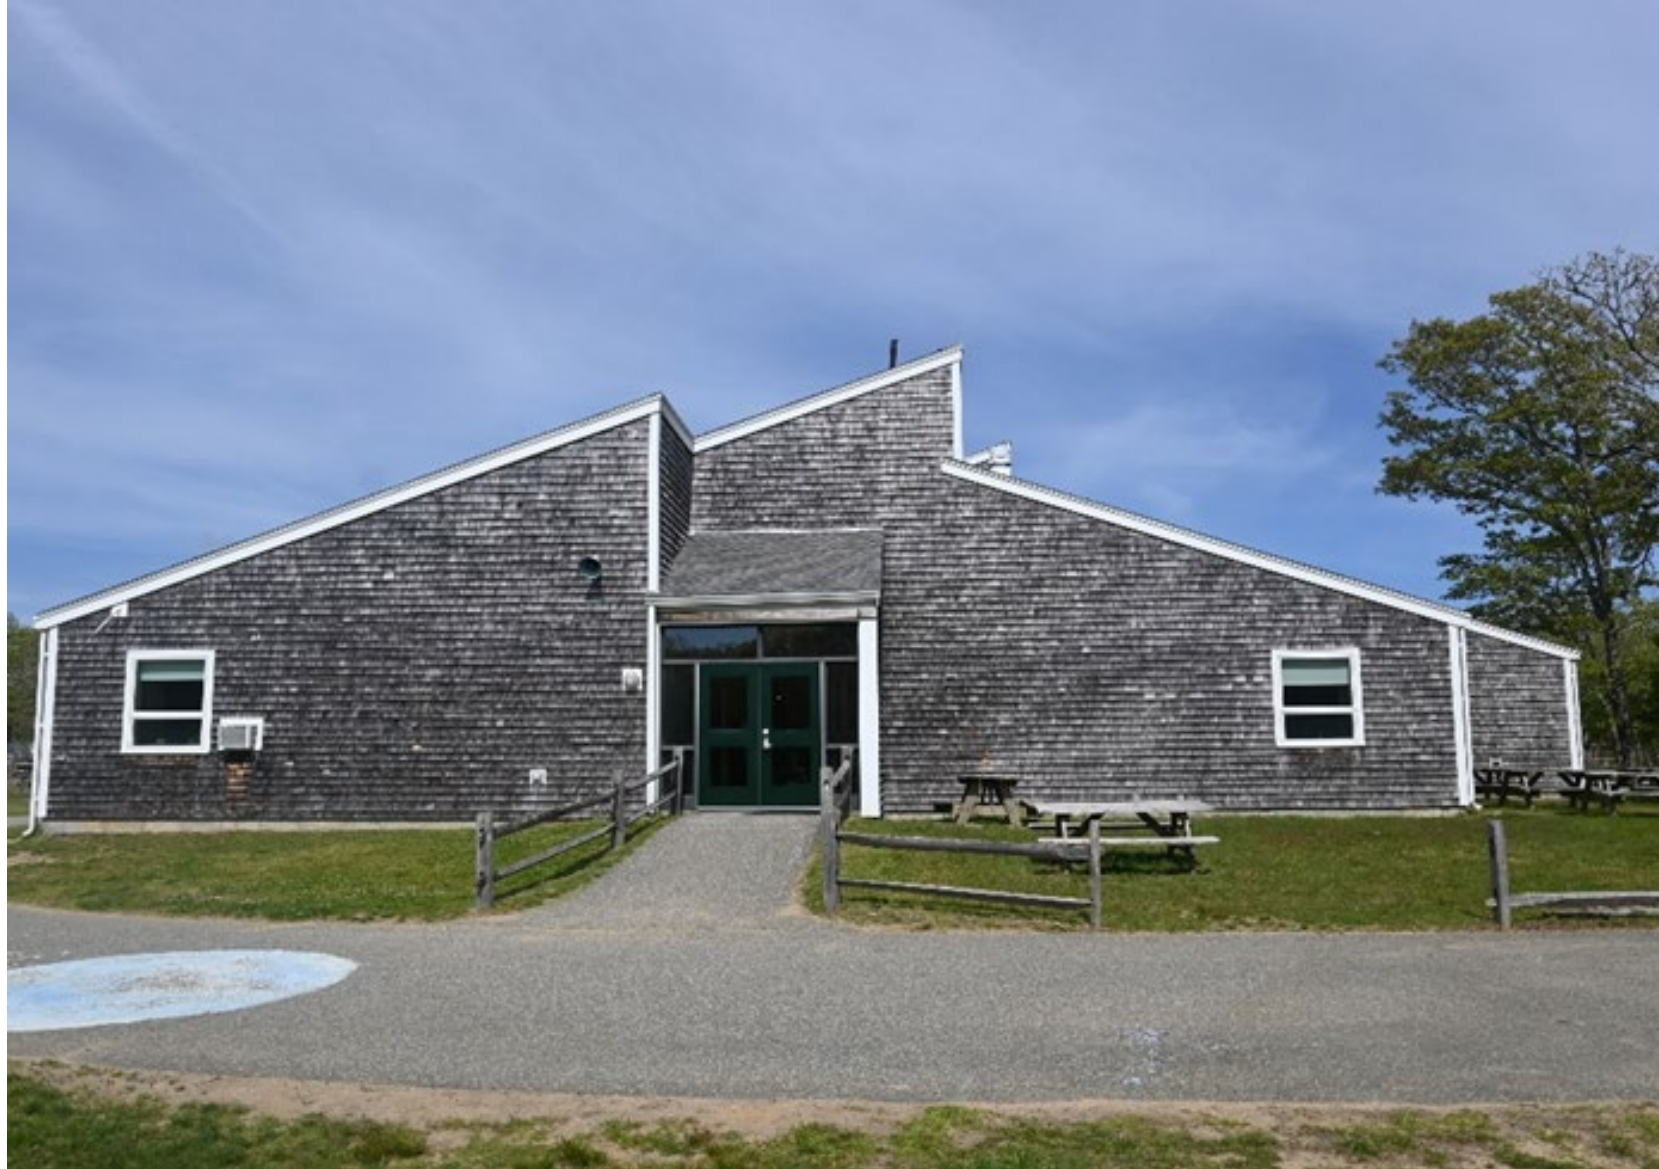
TYPICAL EXTERIOR WALL.

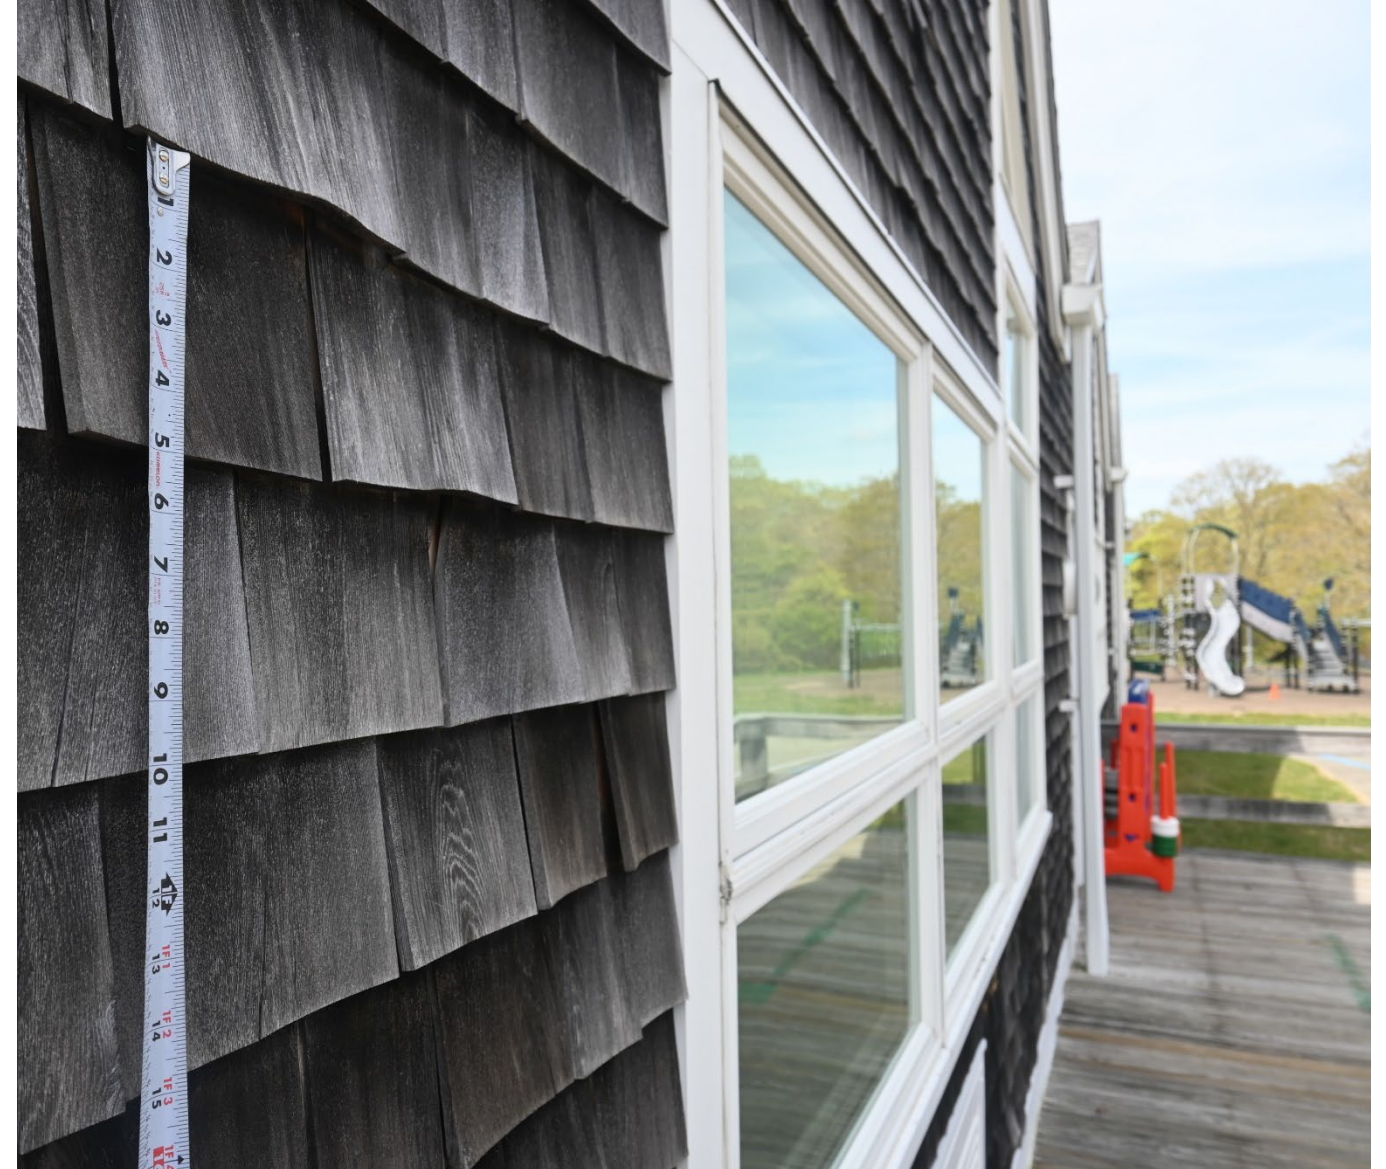
WARPED AND WEATHERED CEDAR SHINGLES NEARING THE END OF THEIR LIFE.

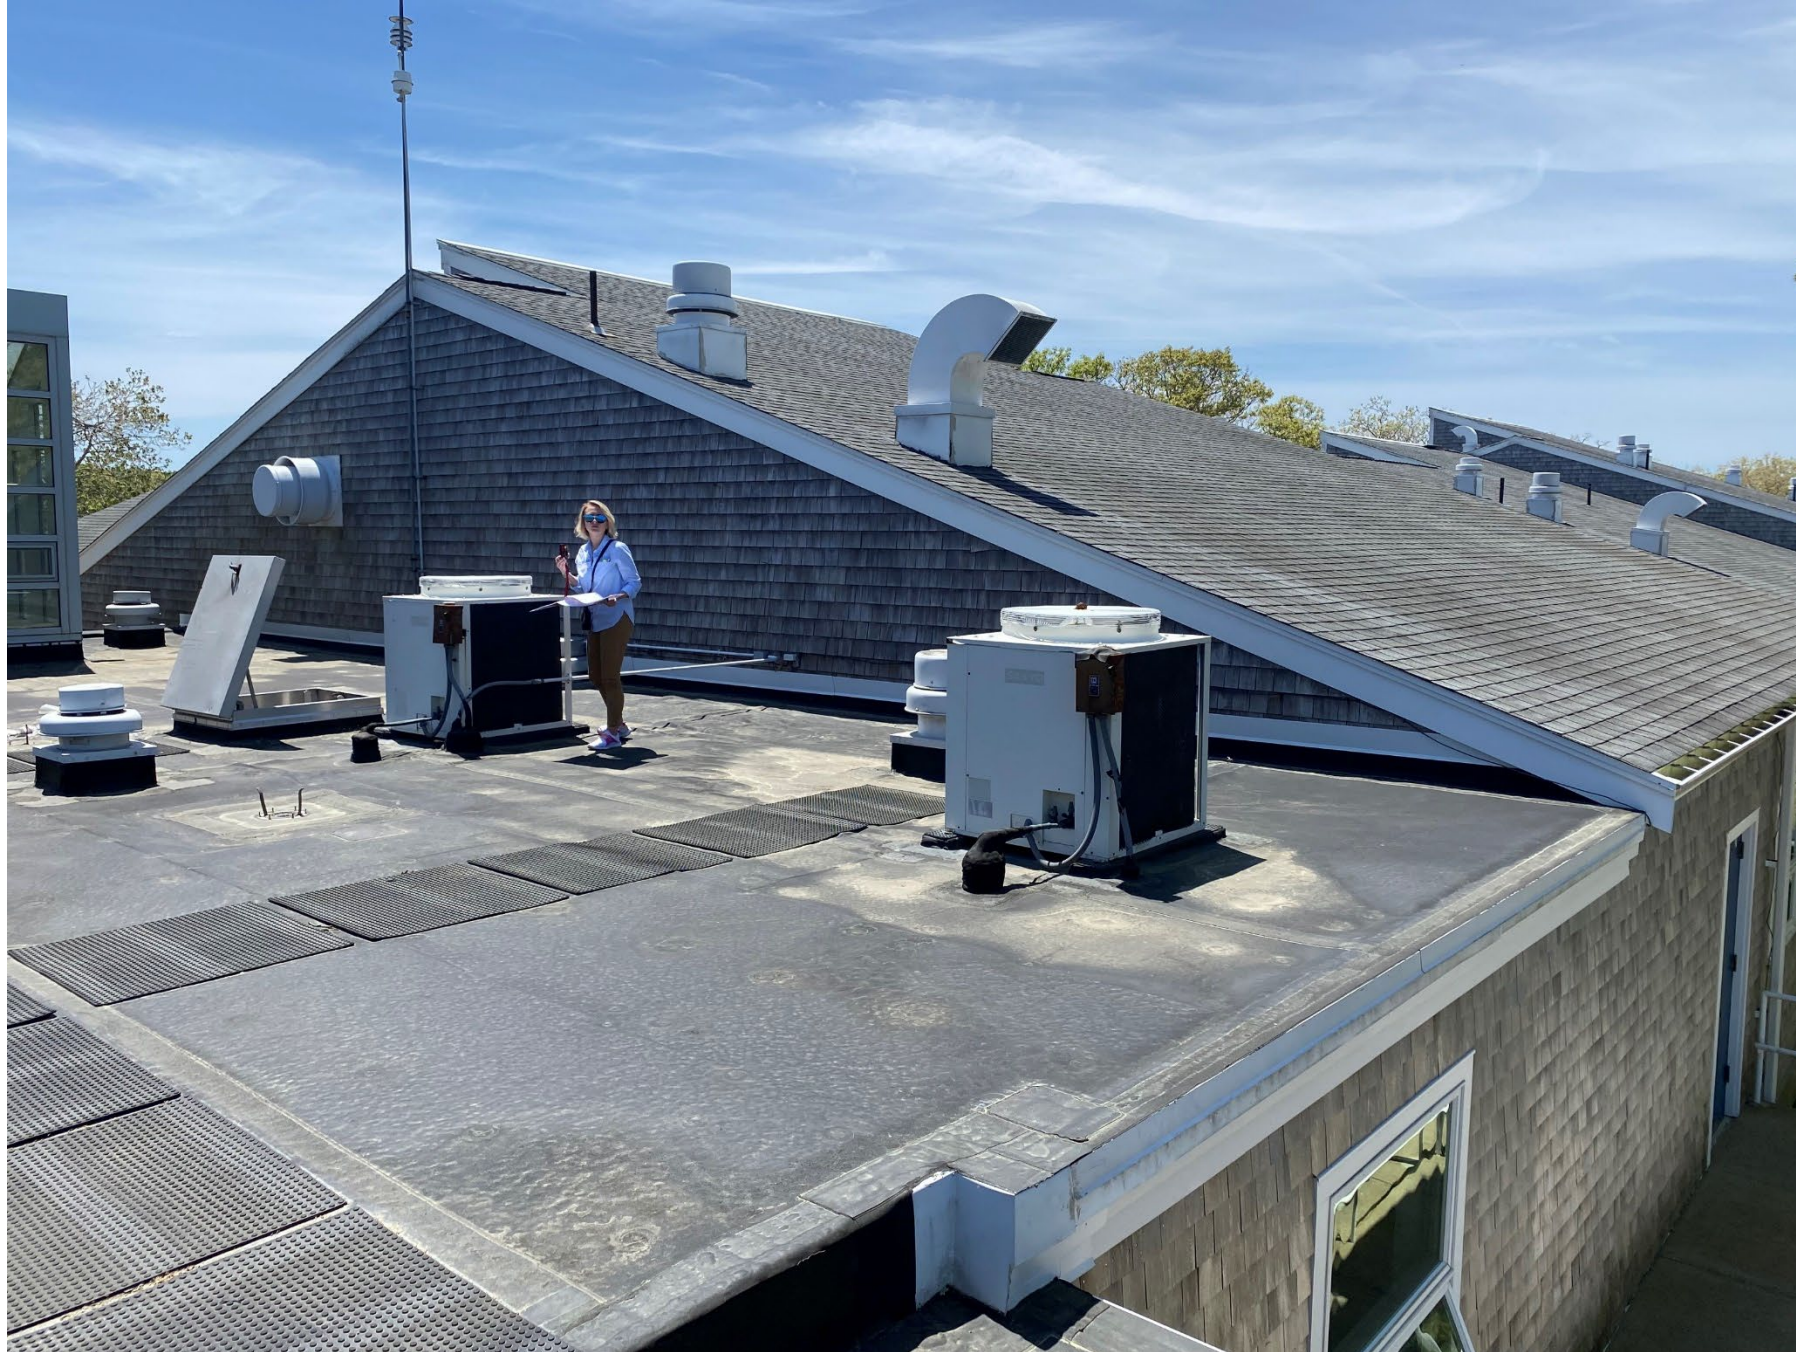
STEEP SLOPE AND LOW SLOPE ROOFING.

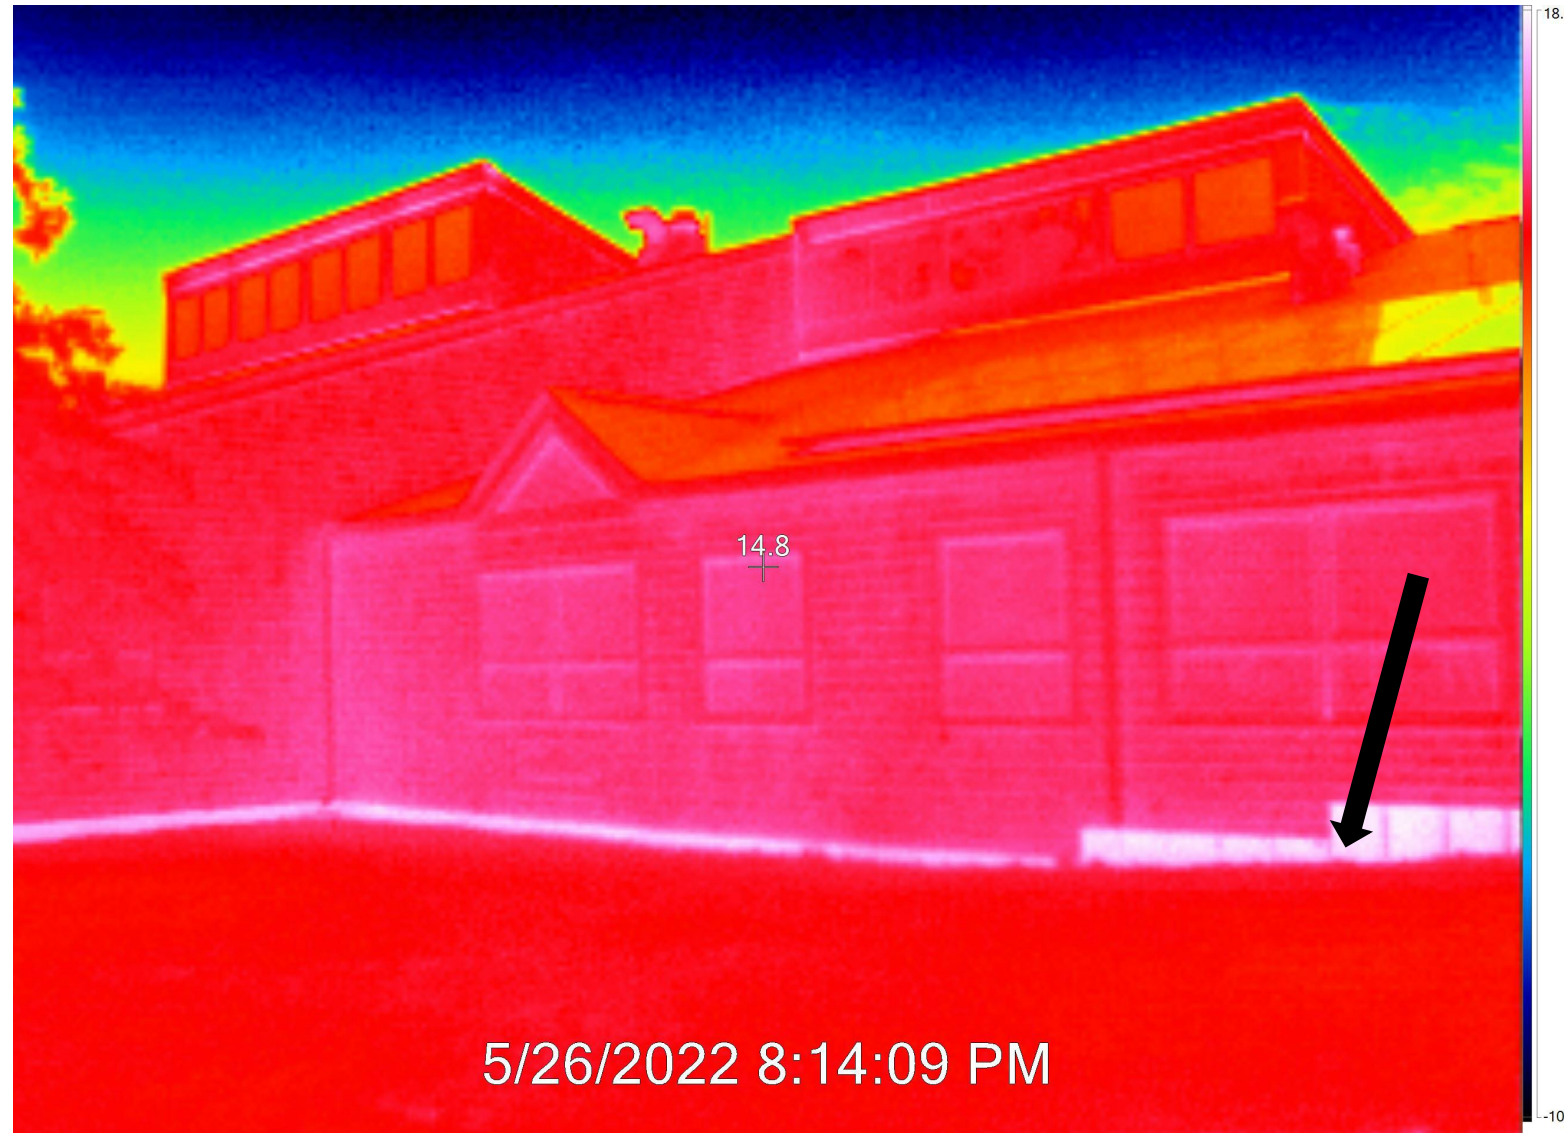
THERMAL ANOMOLIES INDICATING LIKELY THERMAL BRIDGING AT EXPOSED FOUNDATION WALL AND EDGE OF SLAB.

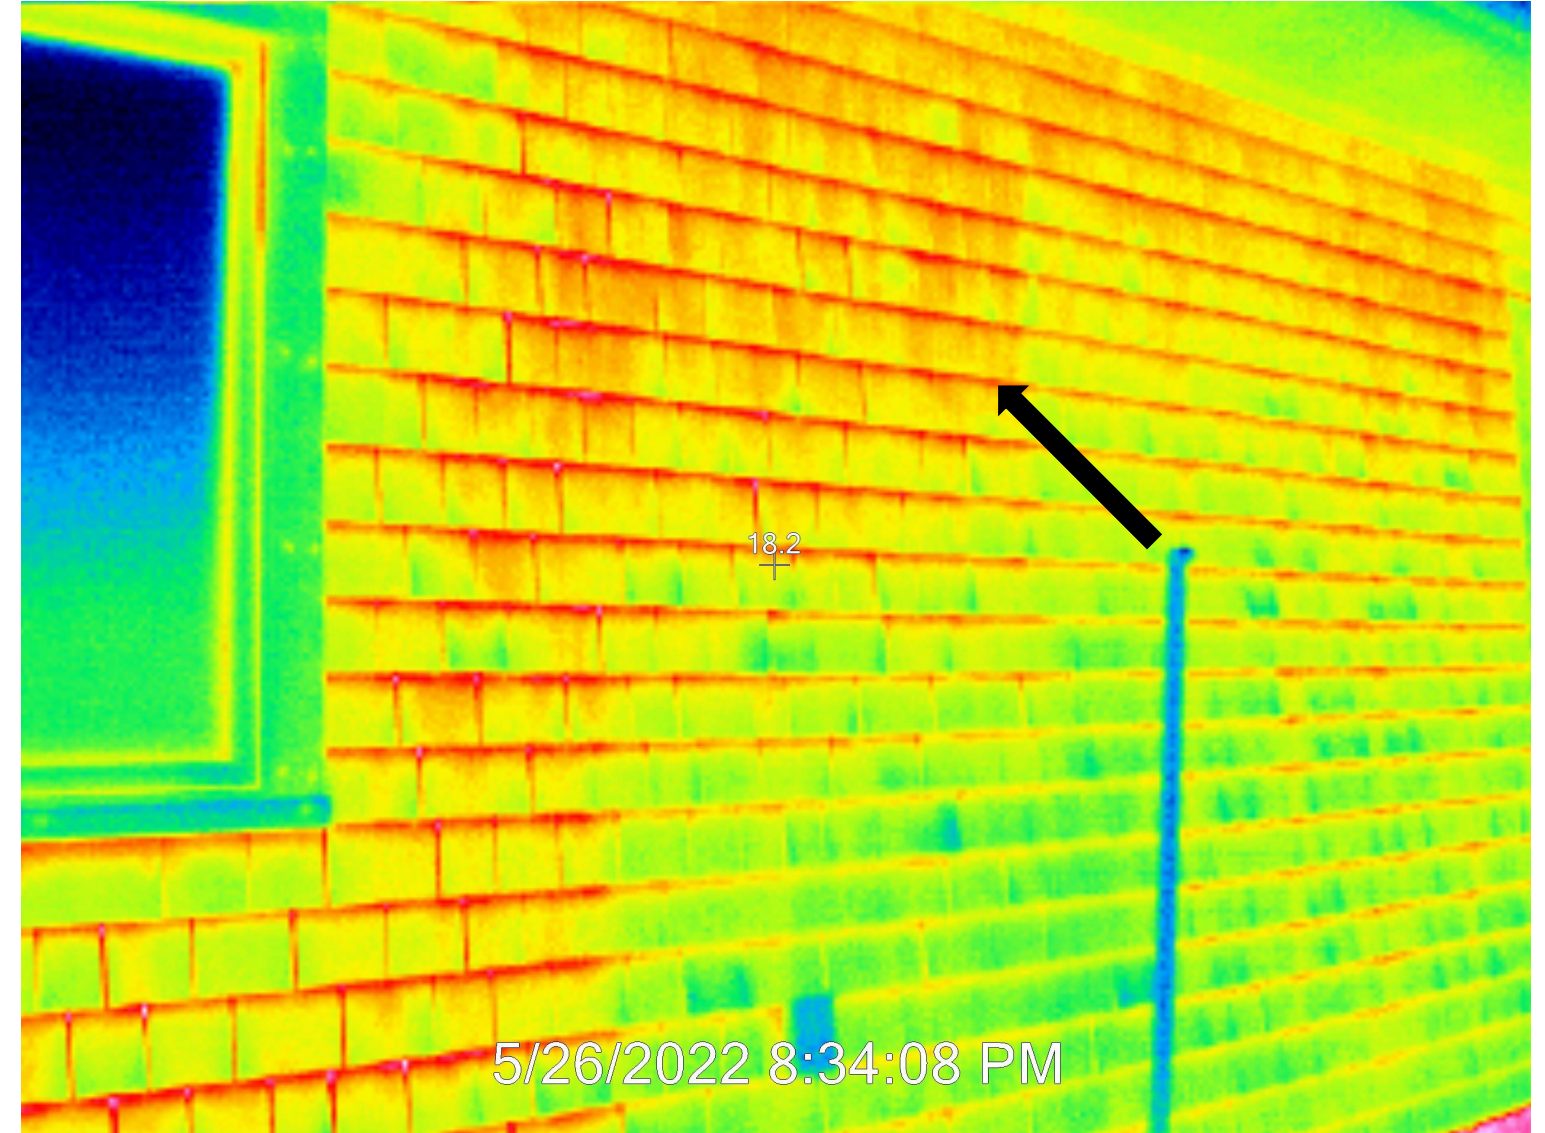
THERMAL ANOMOLIES AT TYPICAL EXTERIOR WALLS AT 1985 WING CLASSROOM. IMAGE DEPICTS LIKELY AIR LEAKAGE AT ROOF TO WALL CONNECTION. IMAGE TAKEN WHILE CLASSROOM WAS UNDER POSITIVE PRESSURE FROM BLOWER DOOR IN EXTERIOR DOOR OF CLASSROOM.

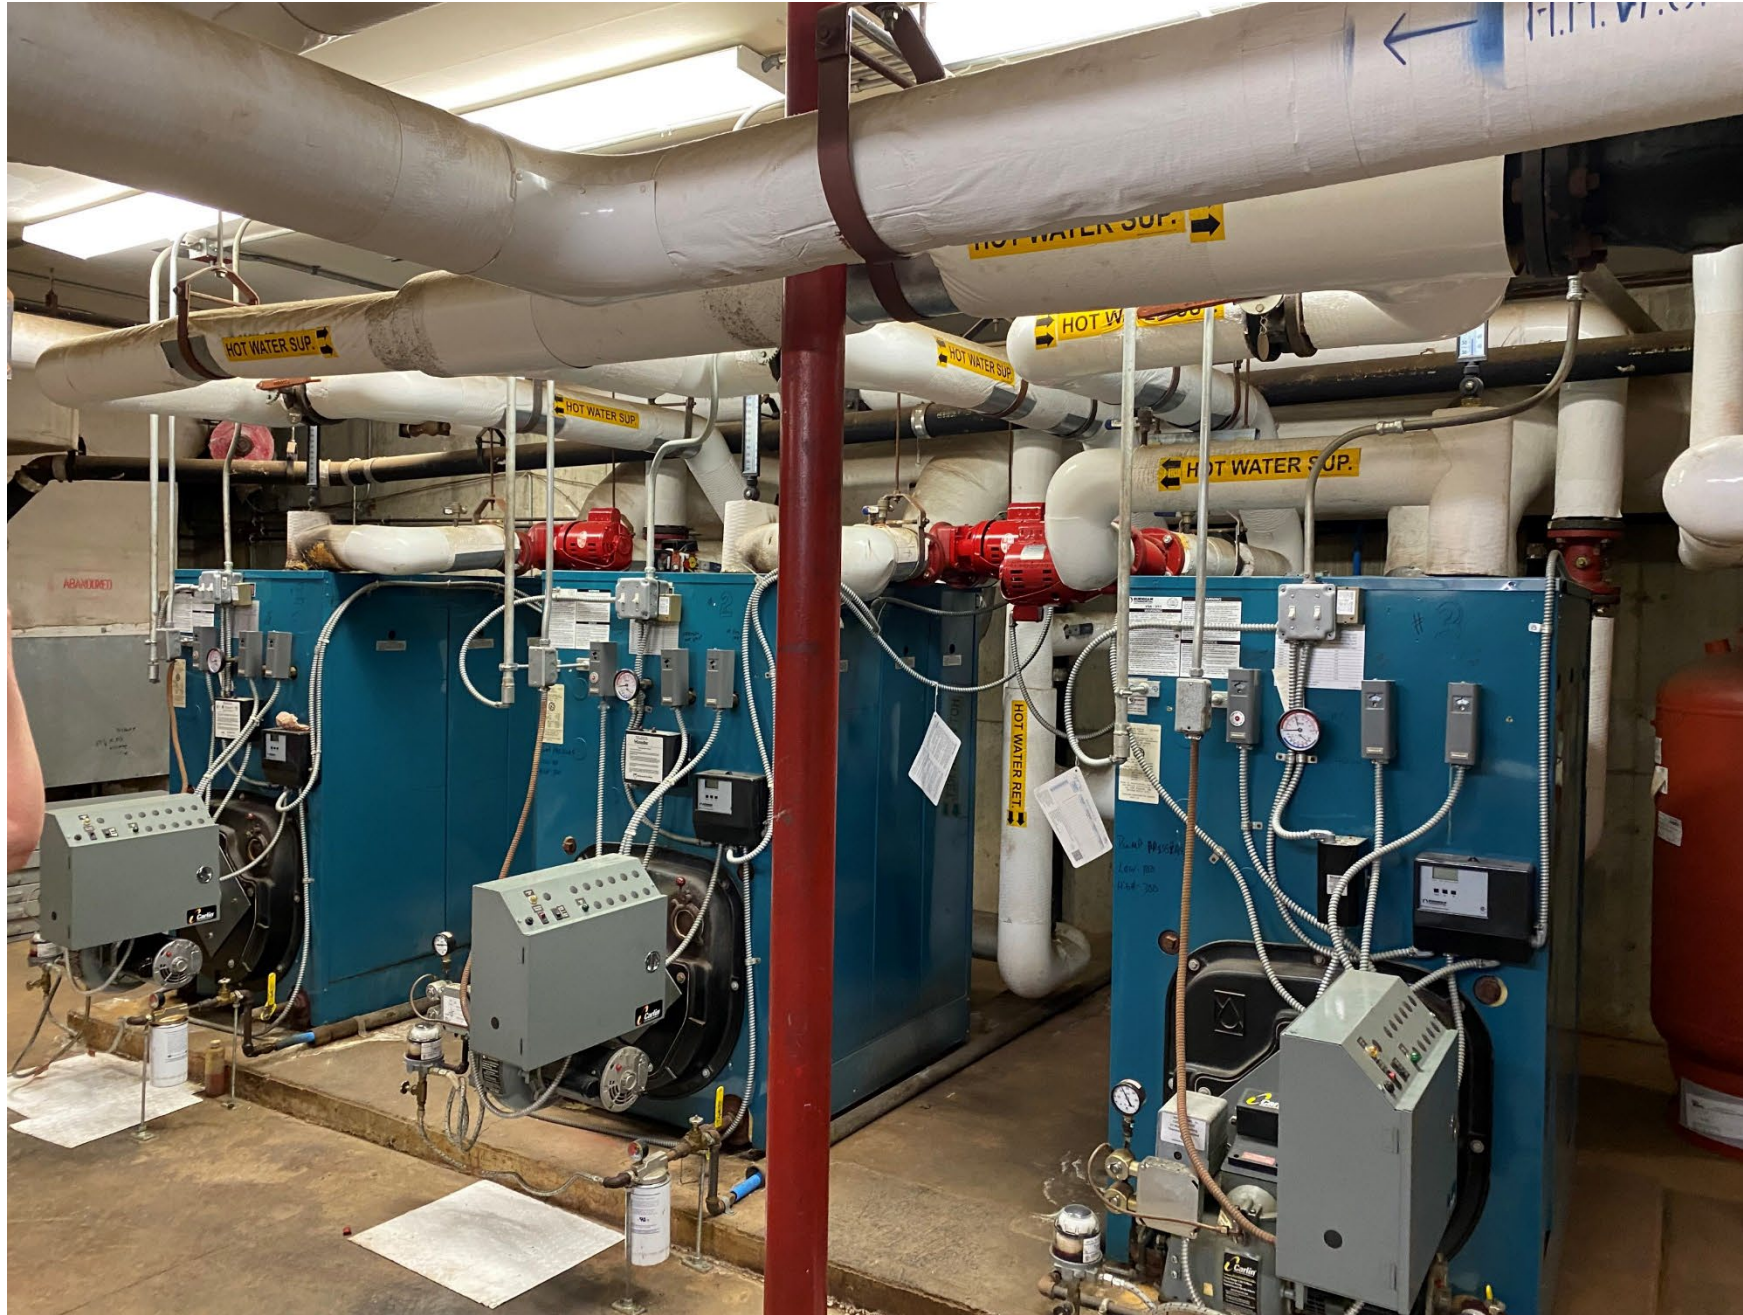
THREE EXISTING BOILERS, ONE NOT WORKING.

Heating is provided by three standard efficiency oil boilers, with 2-pipe unit ventilators providing heating and ventilation to the classrooms. We understand that one of the oil boilers is currently not in operation and that the unit ventilators only run during the heating season and are turned off for the cooling season. Heated water is distributed to hydronic baseboard perimeter heaters in the corridors. One heat pump provides the heating and cooling in the computer lab while two air-conditioning (AC) units provide cooling to the office/admin area. There are air-conditioning units serving the library as well.

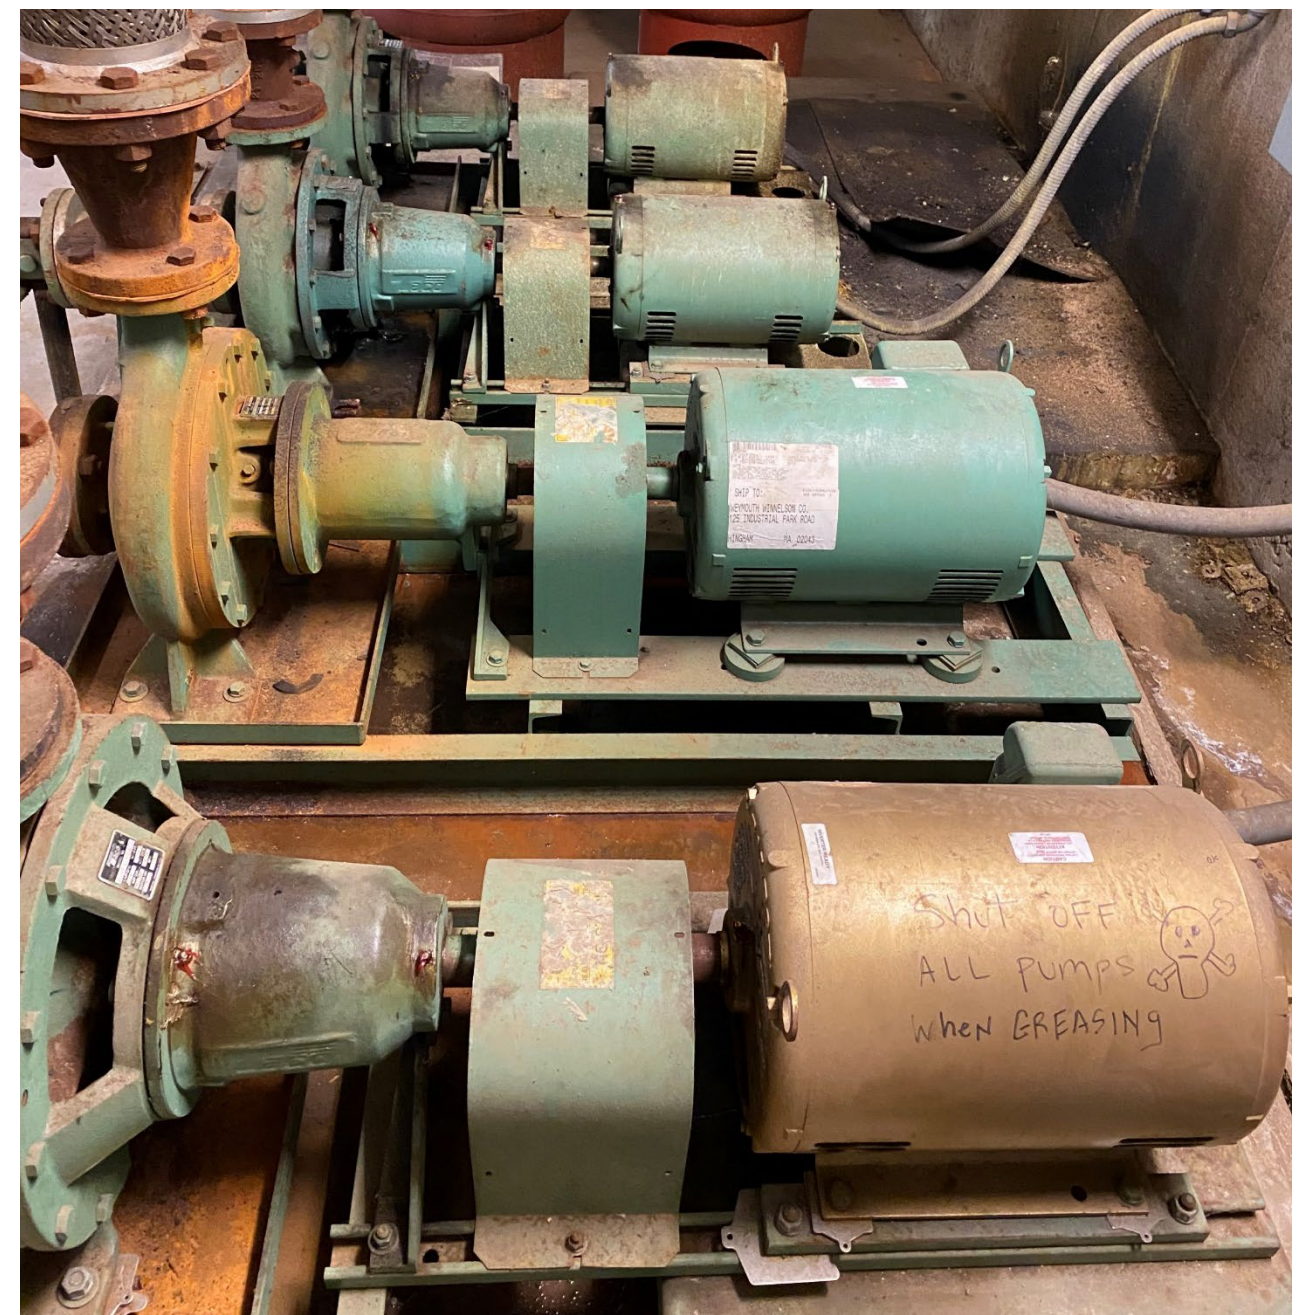
FOUR EXISTING PUMPS, TWO NOT WORKING.

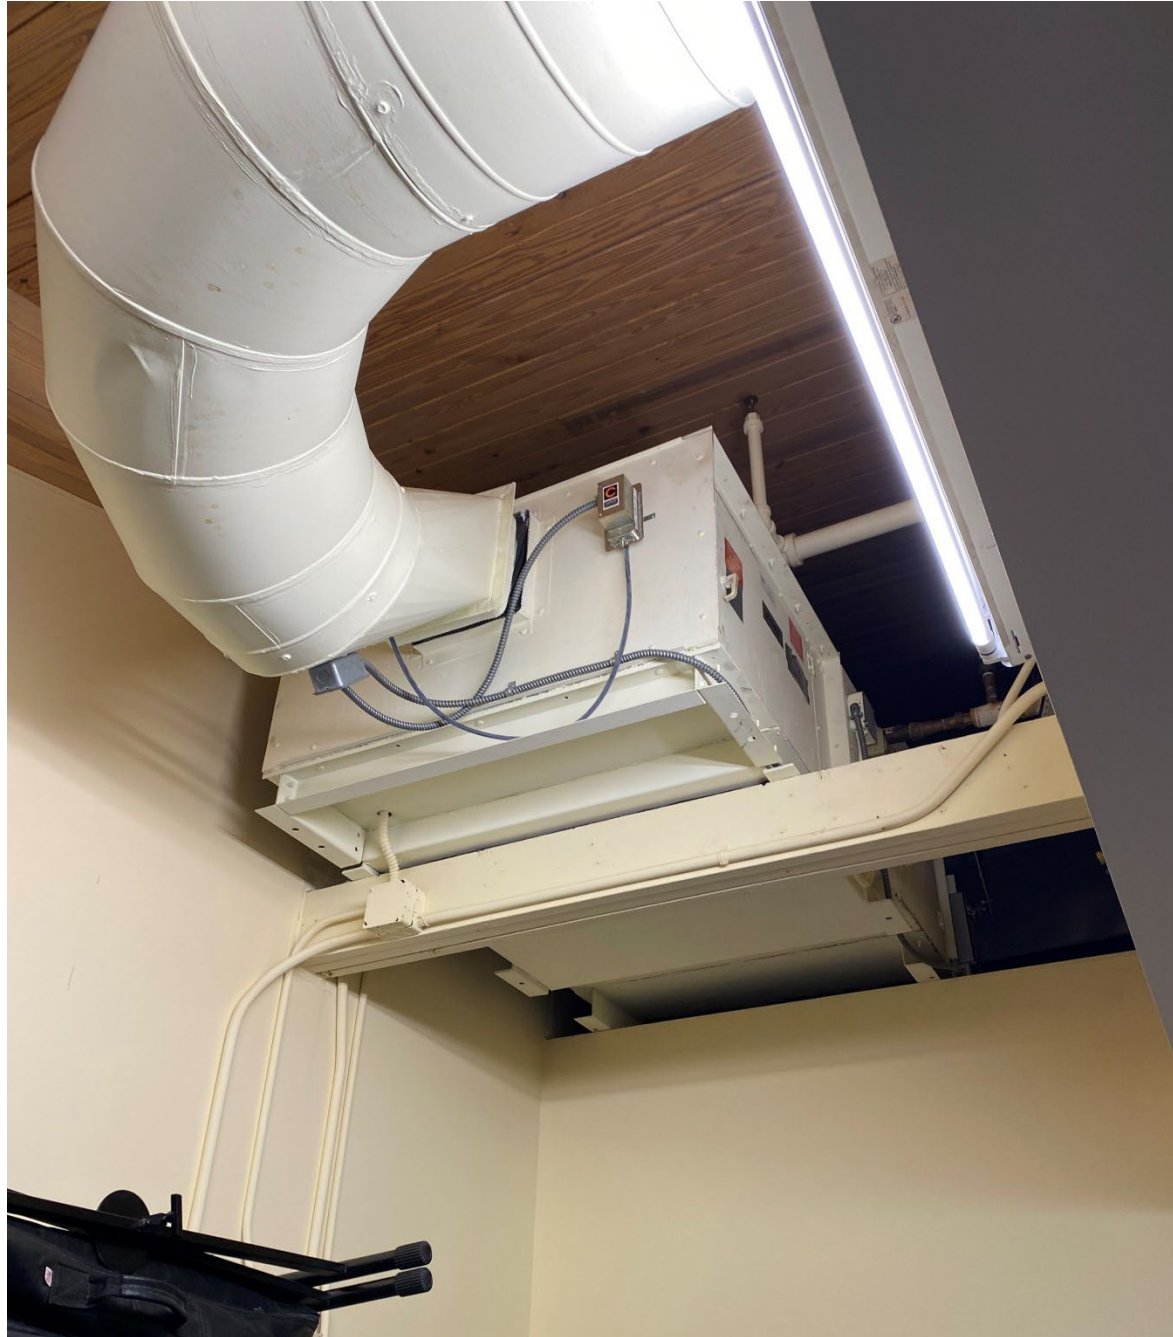
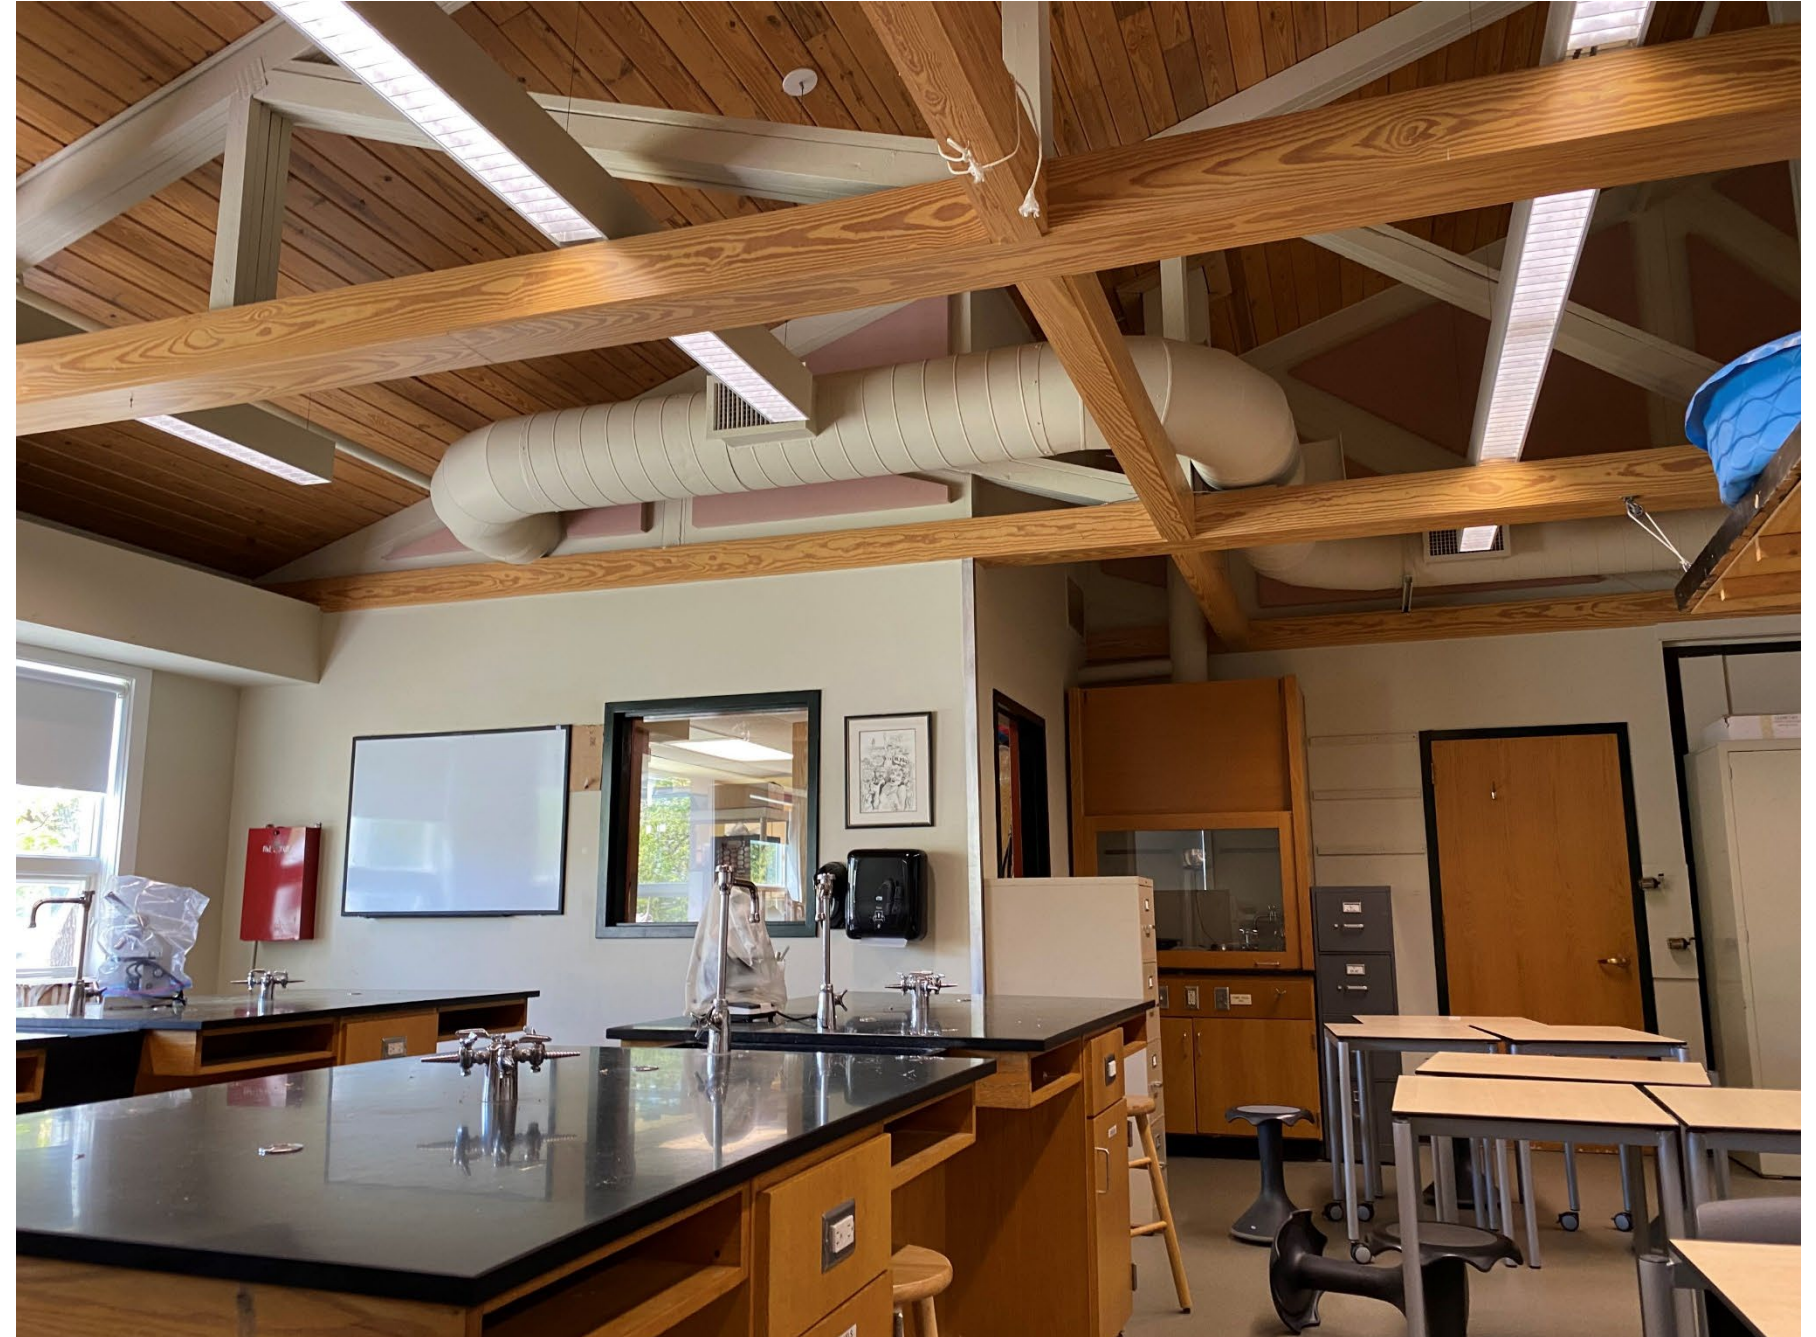
EXISTING AIR HANDLERS THAT REMAIN TURNED OFF BECAUSE THEY ARE BROKEN OR ARE TOO LOUD FOR CLASSROOMS. MUSIC ROOM AND SCIENCE ROOM SHOWN, GYM AIR HANDLERS ALSO TOO LOUD TO OPERATE.

Two air handling units (AHUs) are located in the gym, two AHUs in the band/music room, and one AHU in the cafeteria. Two smaller AHUs are also located in the science labs. We understand that the AHUs are not currently in operation, as they are either in need of repair or have been turned off due to noise concerns. A propane-fired make-up air unit (MAU) serves the kitchen.
