ZERO CARBON-READY RETROFIT STUDY

**WEST TISBURY ELEMENTARY SCHOOL
WEST TISBURY, MA**

PREPARED FOR
UP-ISLAND REGIONAL SCHOOL DISTRICT
SEPTEMBER 09, 2022

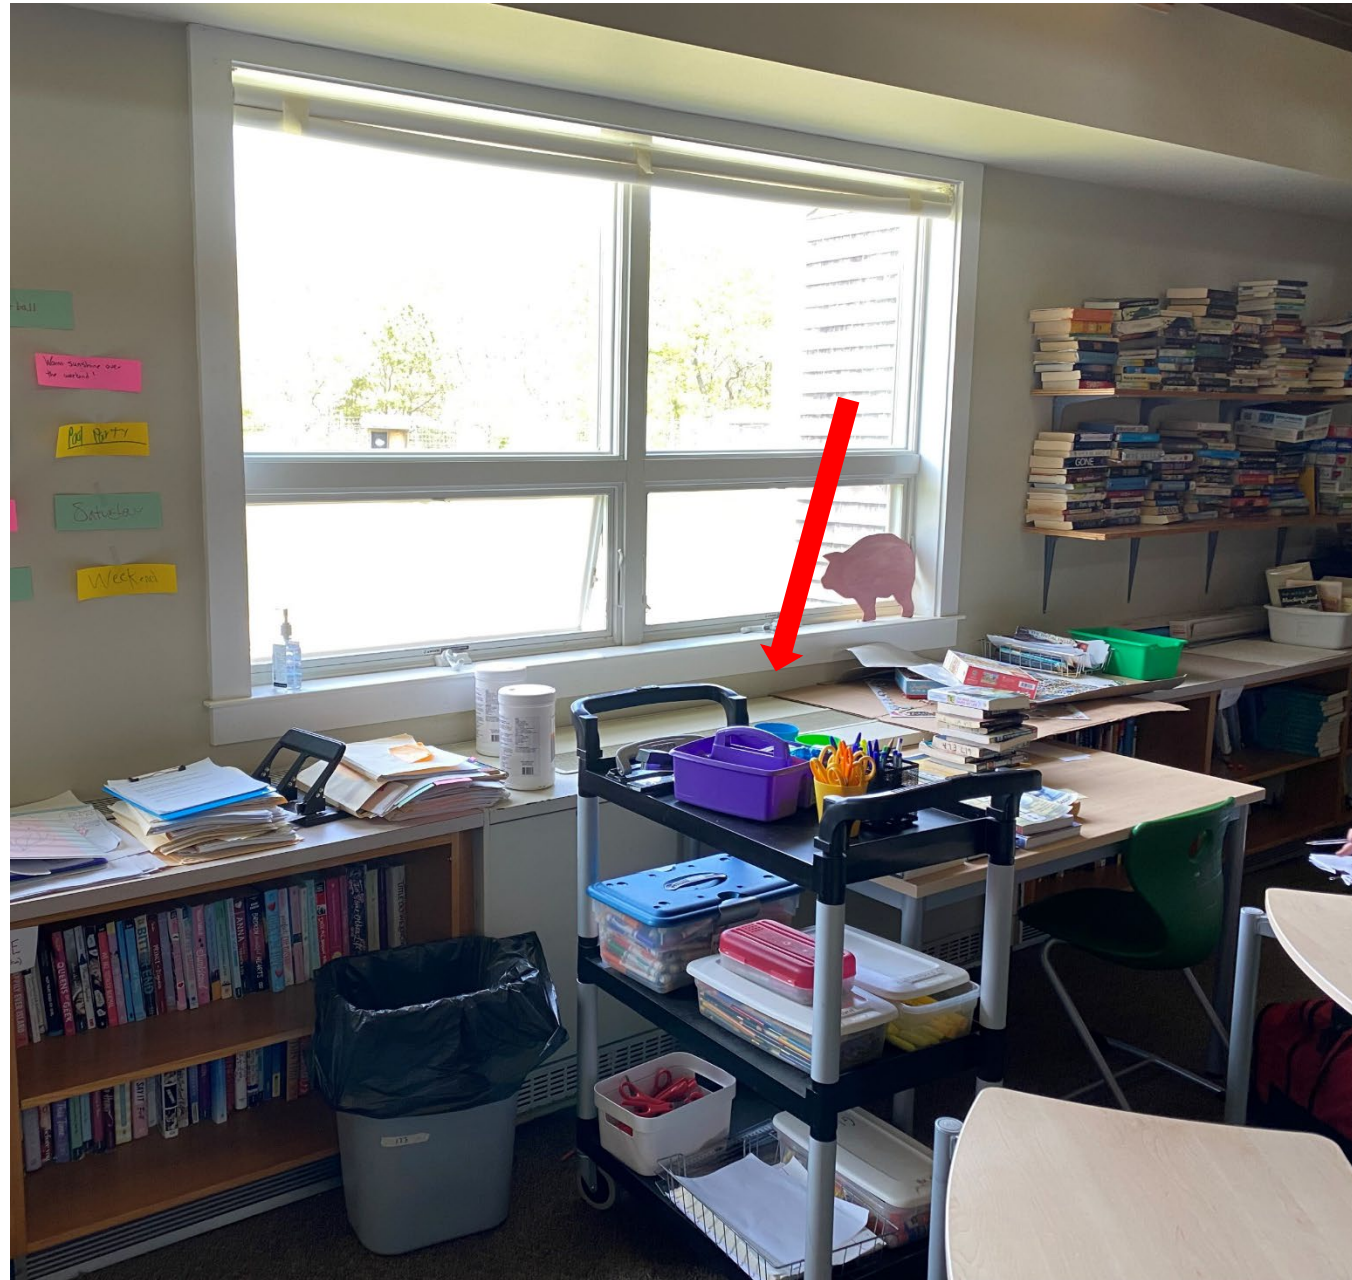
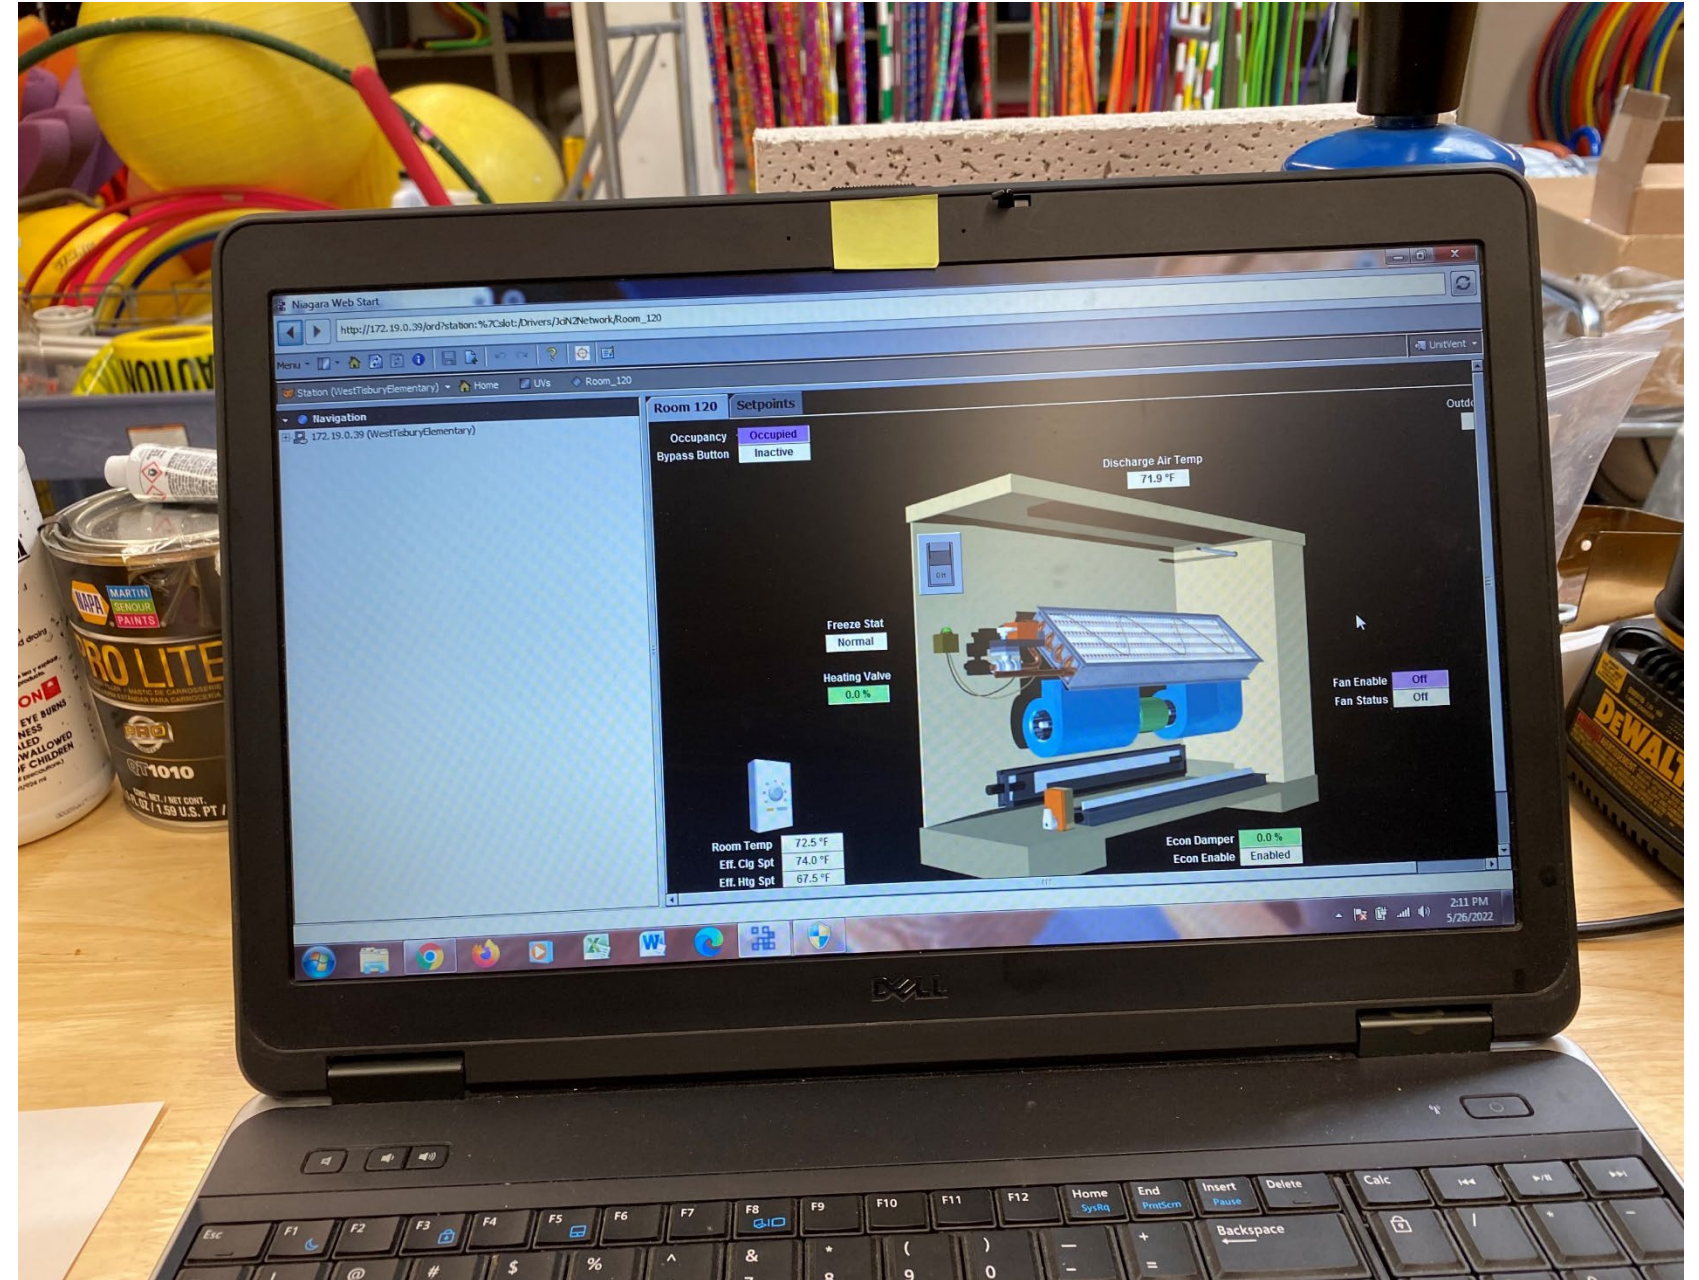
HEAD CUSTODIAN, JAMIE LABBE, MANUALLY CONTROLS EACH CLASSROOM'S THROUGH-WALL HEATING AND VENTILATION UNIT DEPENDING ON HOW OVERHEATED EACH CLASSROOM IS, BASED ON FREQUENT FEEDBACK FROM TEACHERS AND STAFF. THROUGH-WALL UNIT THERMOSTATS MIS-READ CLASSROOM TEMPERATURE BECAUSE WINDOWS ABOVE UNITS ARE SOMETIMES OPEN FOR ADDITIONAL DESIRED DIRECT OUTSIDE VENTILATION AIR. THESE UNITS ARE NOT OPERATING AS INTENDED AND REQUIRE AN INORDINATE AMOUNT OF MANUAL MONITORING BY JAMIE.

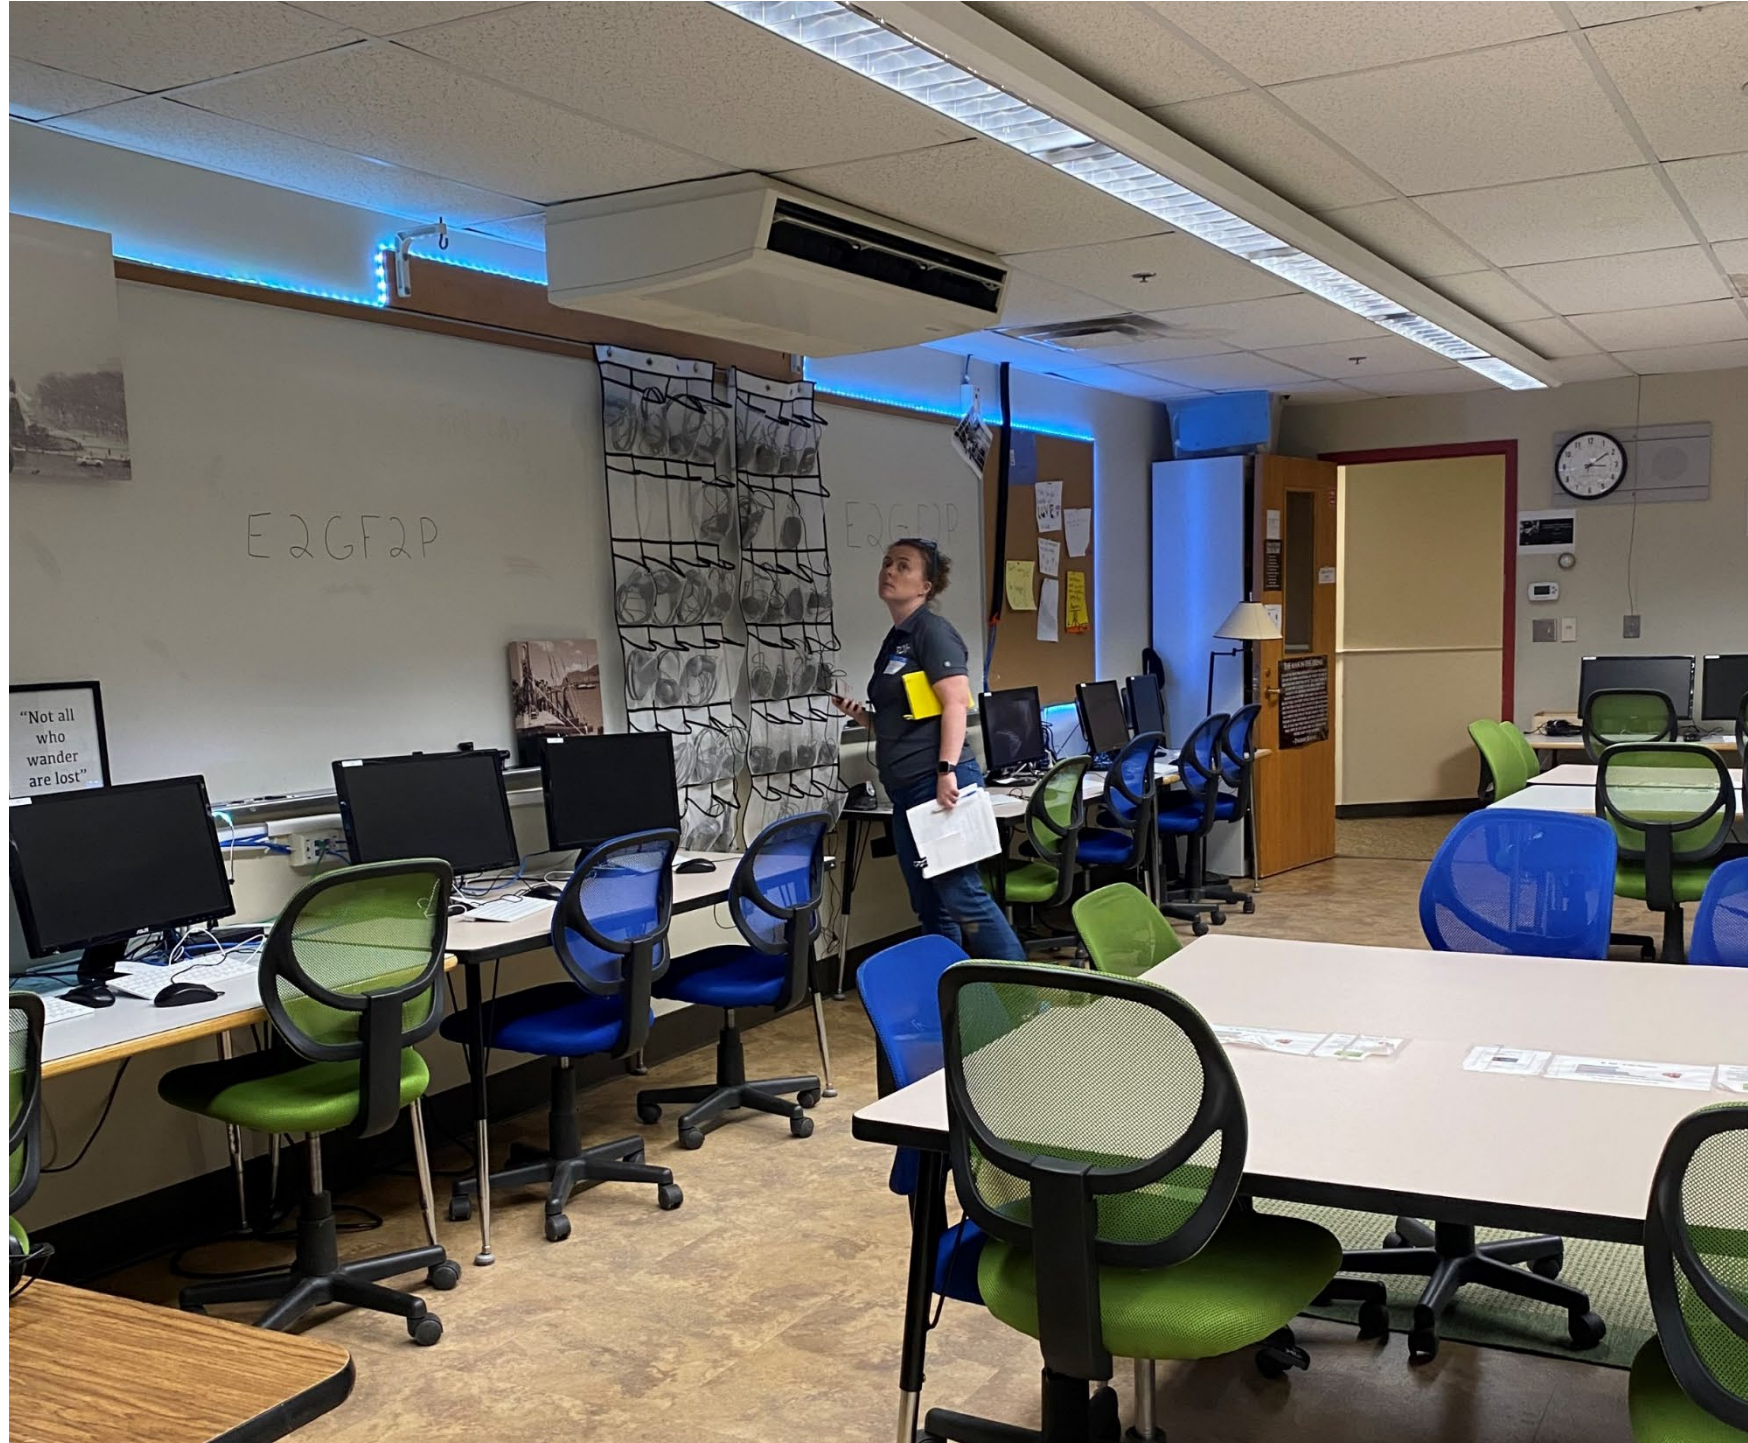
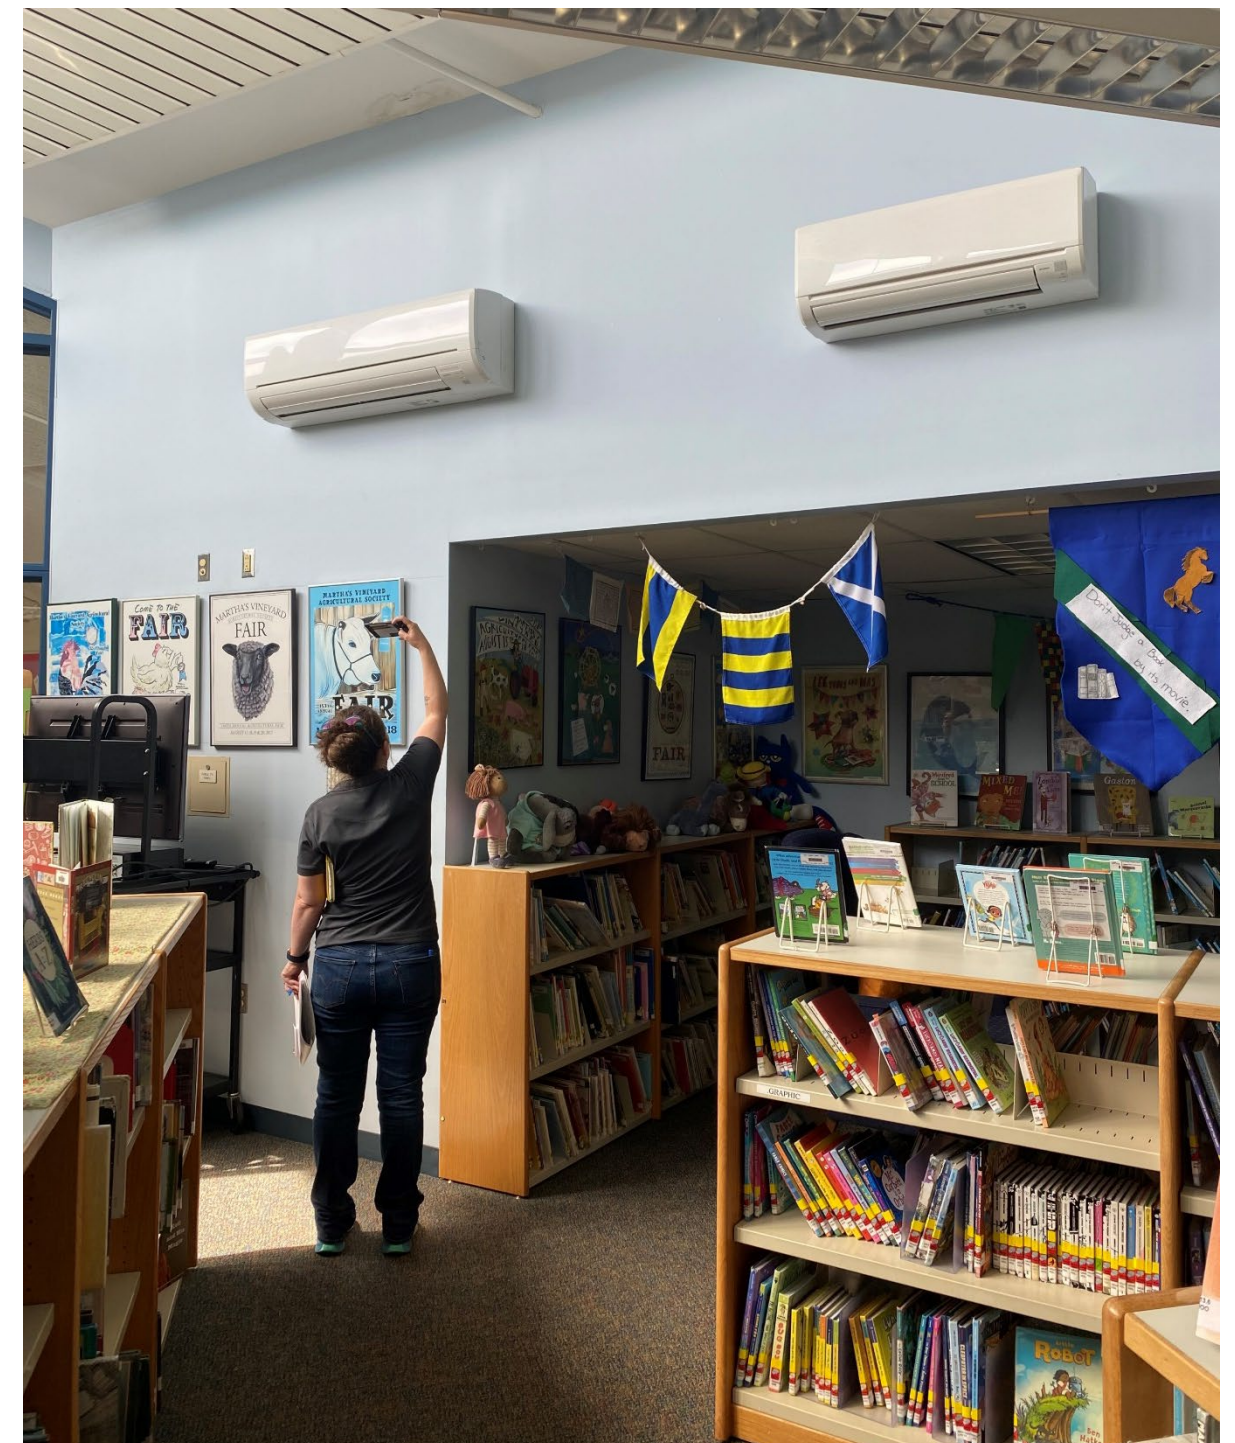
AIR SOURCE HEAT PUMPS IN COMPUTER LAB AND LIBRARY PROVIDE COOLING AND DEHUMIDIFICATION. WE UNDERSTAND COOLING IS DESIRABLE THROUGHOUT THE SCHOOL BUILDING, NOT JUST IN THESE LIMITED SPACES.

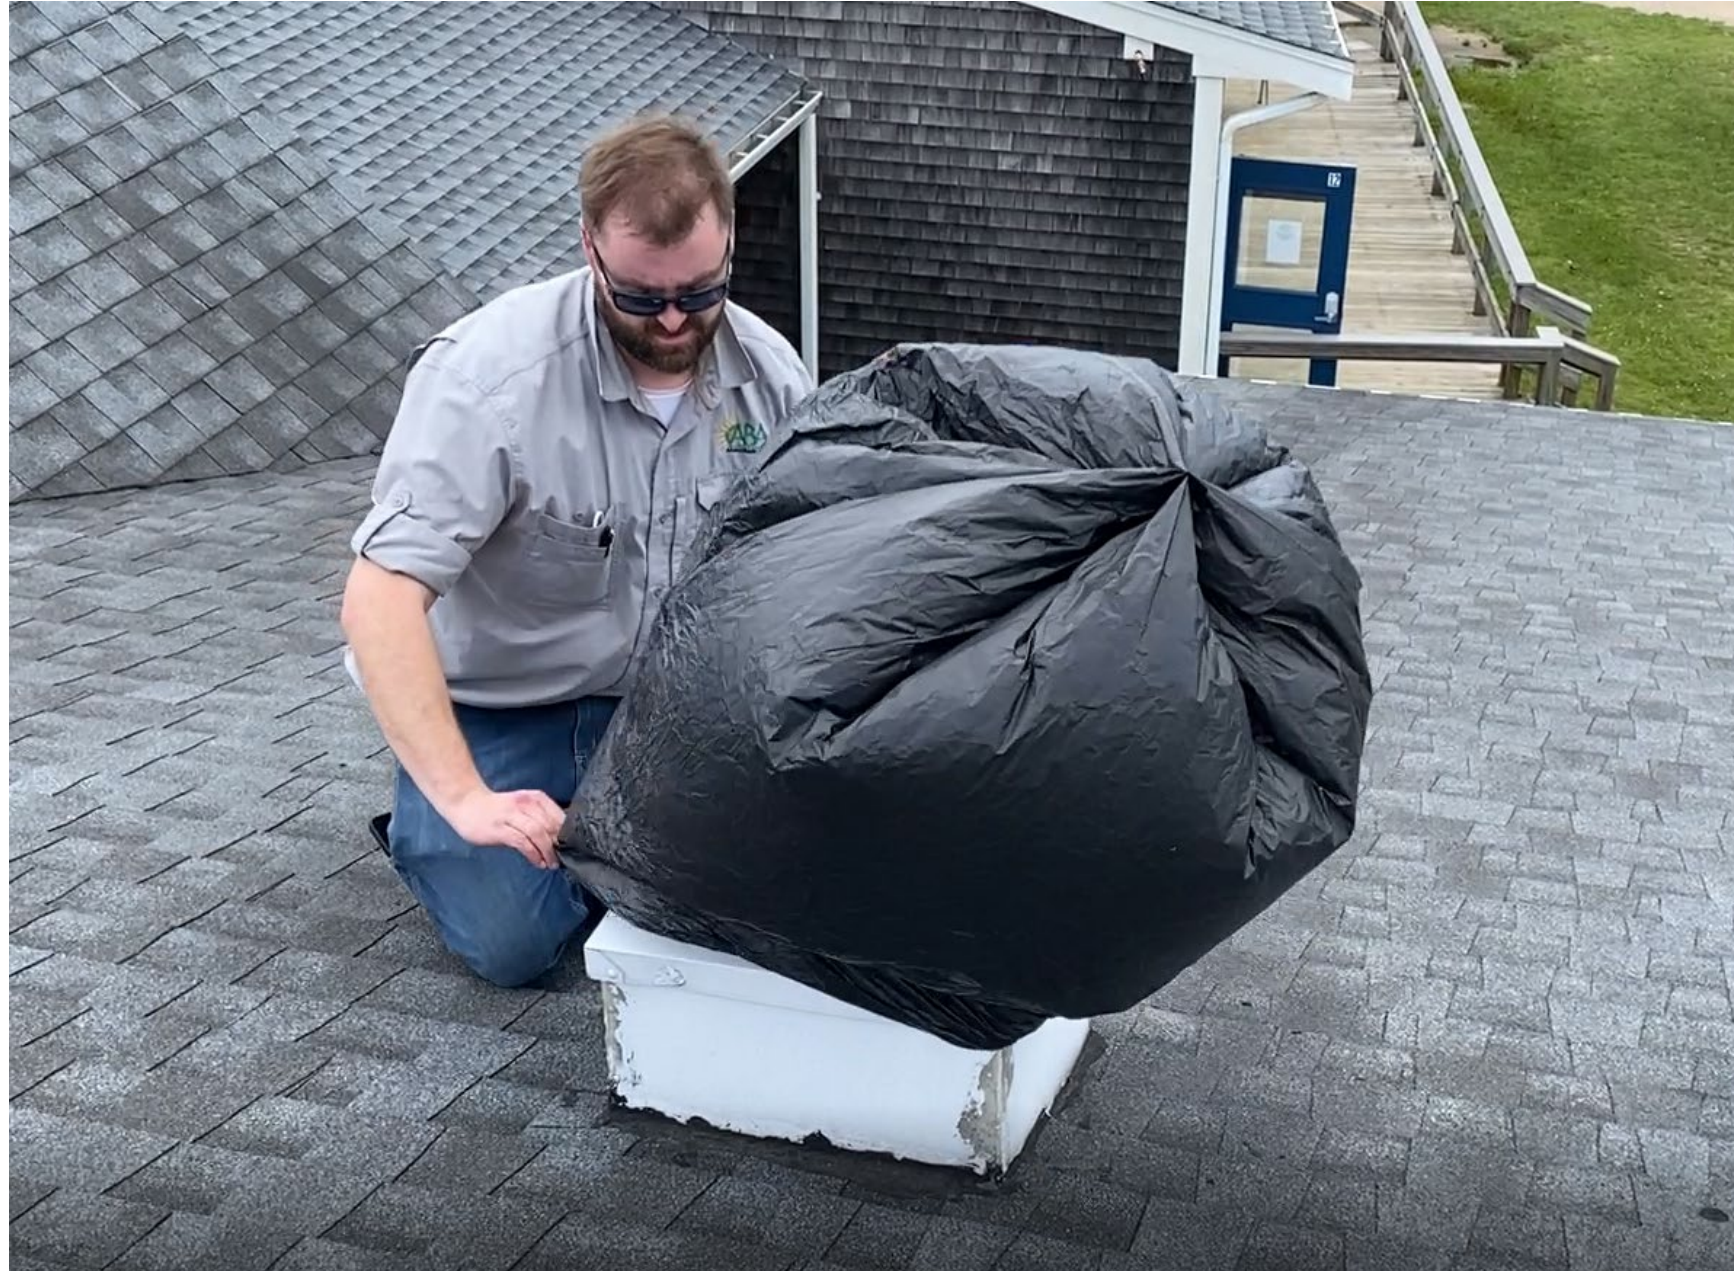
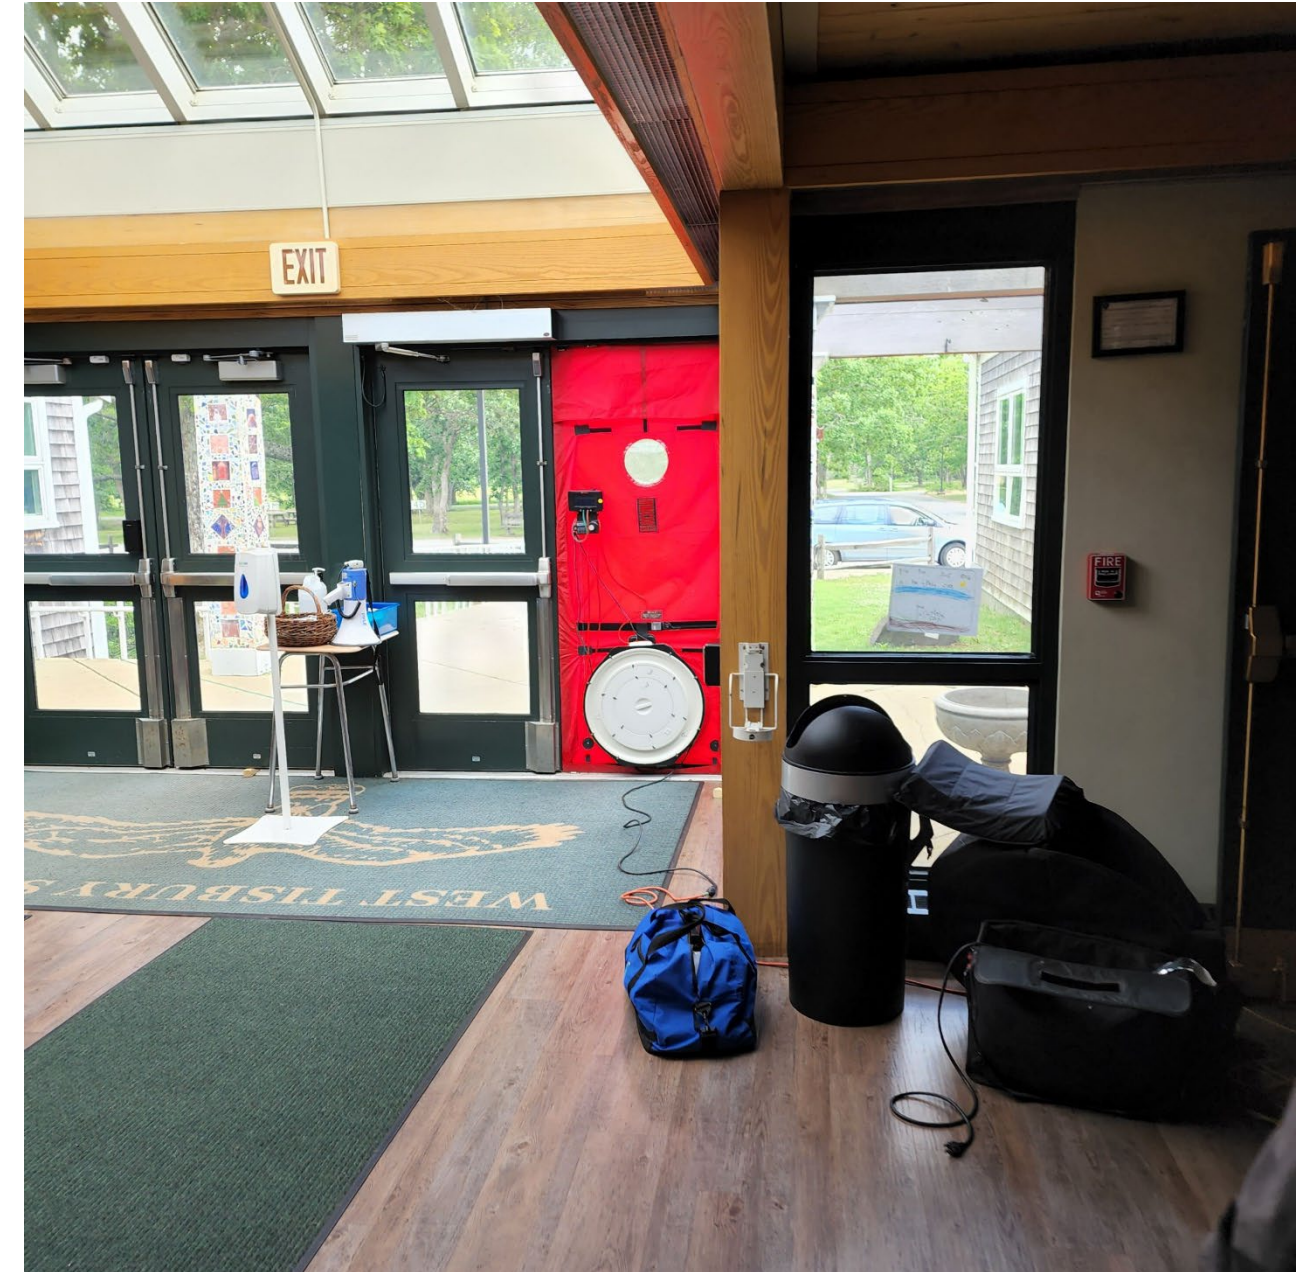
THE BUILDING WAS TESTED WITH AND WITHOUT ALL MECHANICAL PENETRATIONS SEALED AND AIRTIGHTNESS LEVELS WERE USED AS INPUTS IN THE BASELINE ENERGY MODEL.

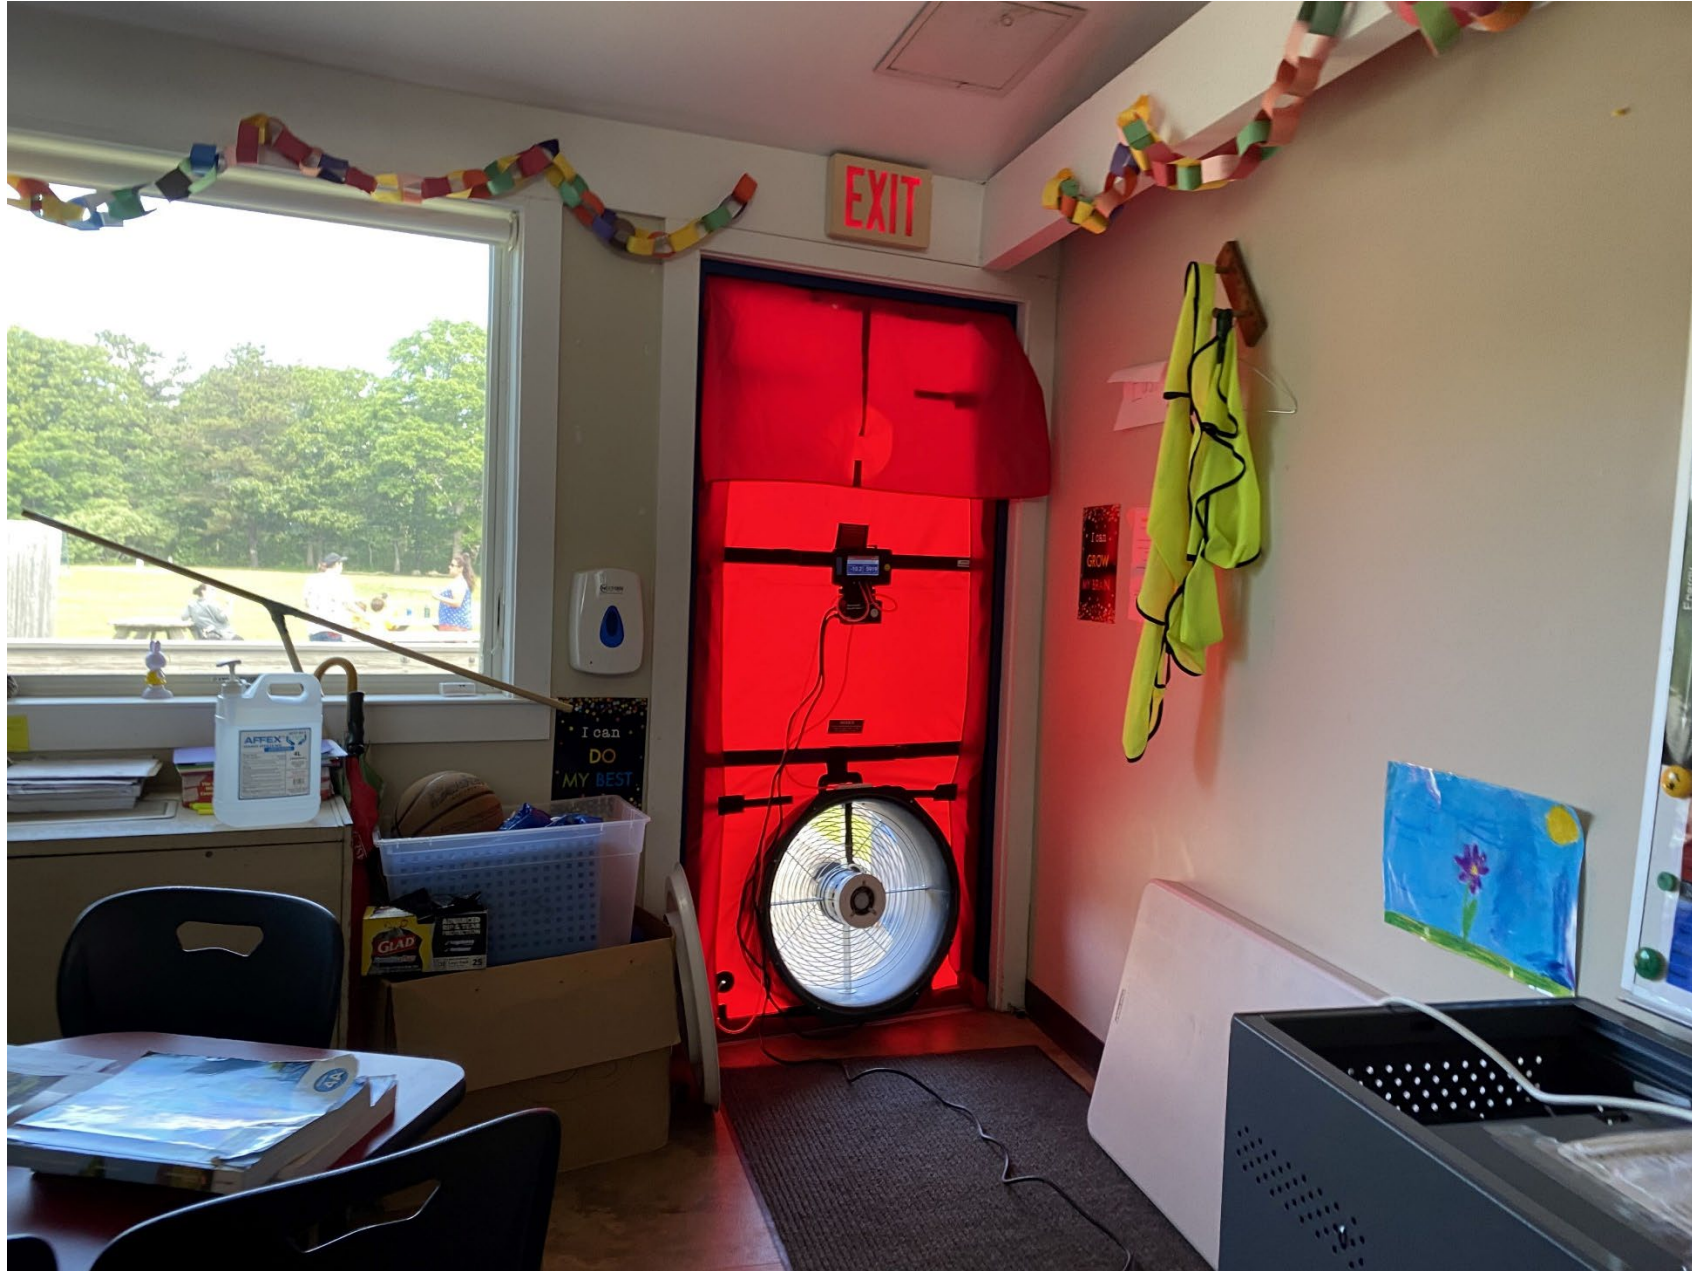
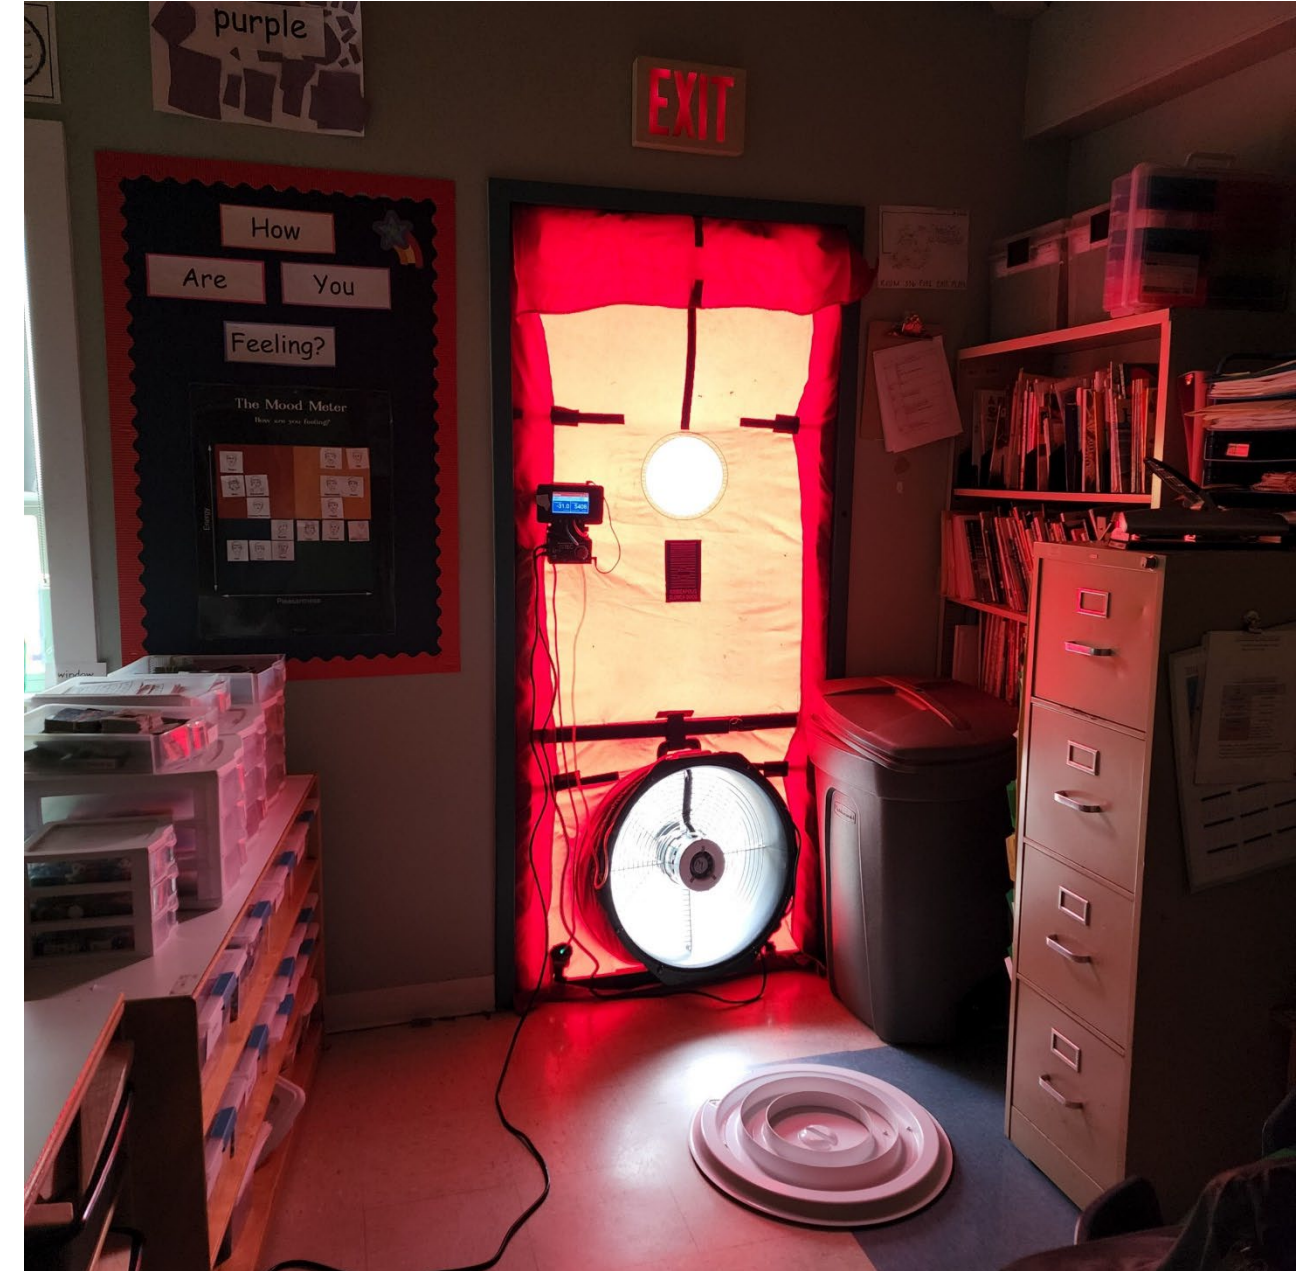
A TOTAL OF FIVE BLOWER DOORS WERE SET UP AROUND THE SCHOOL TO PRESSURIZE THE WHOLE BUILDING.

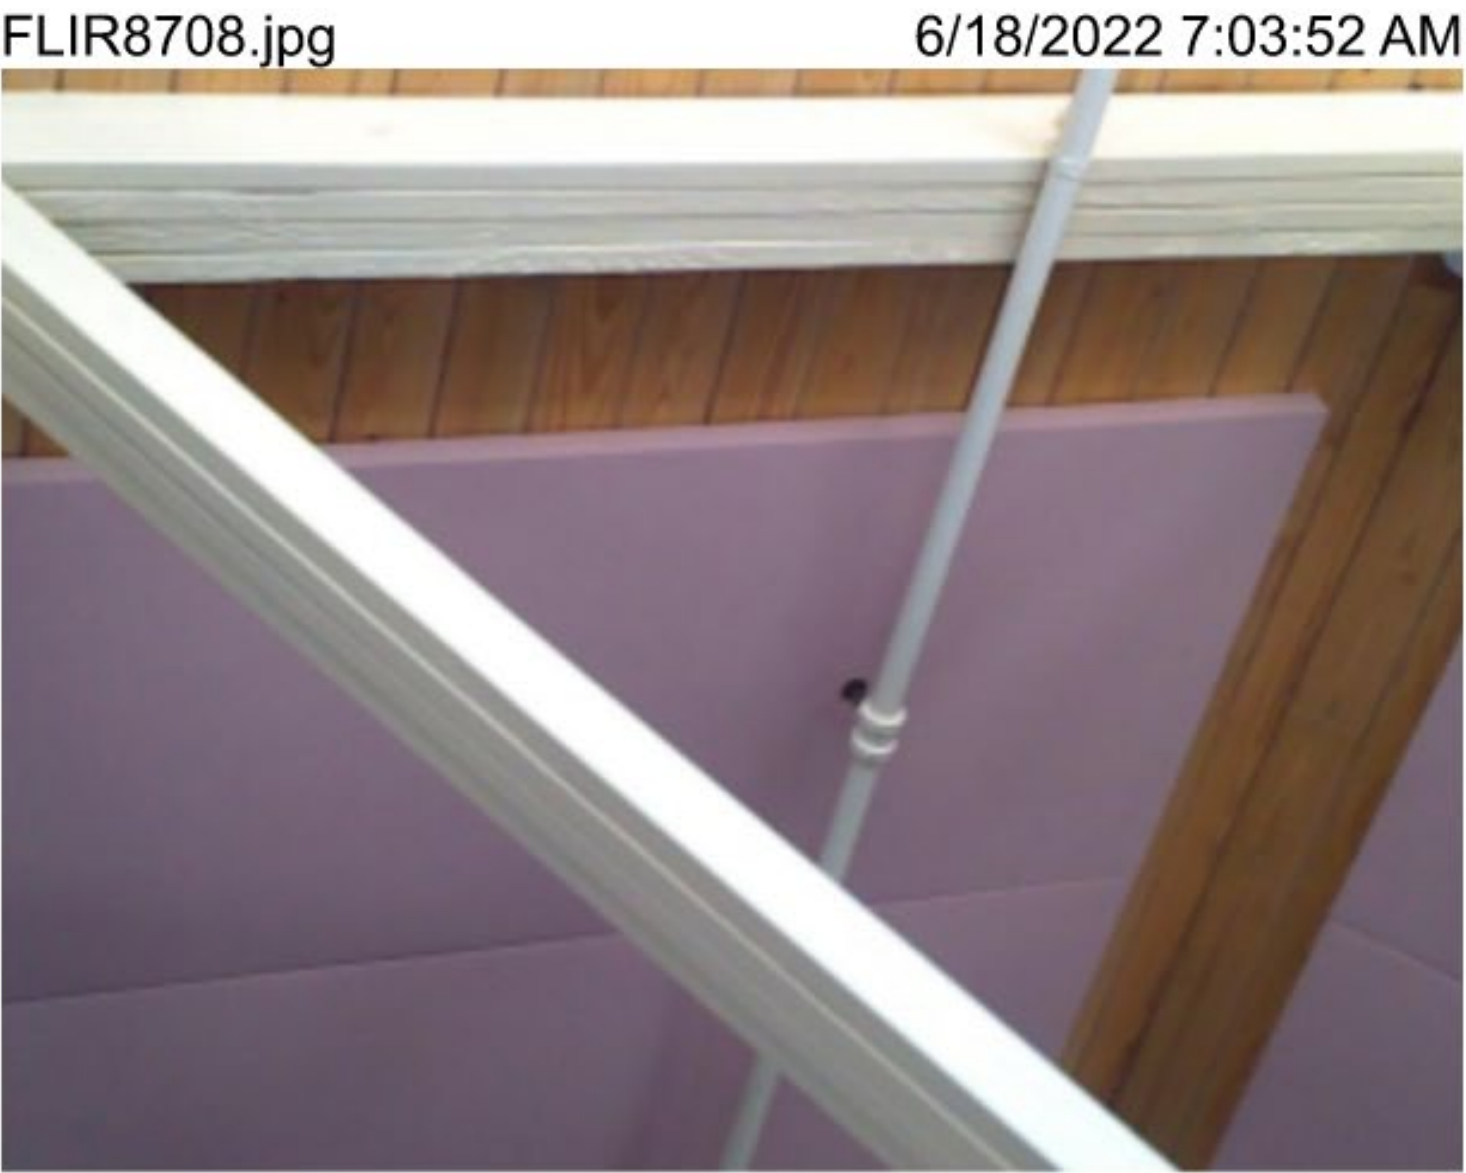
LIKELY AIR LEAKAGE WAS OBSERVED WITH THERMAL IMAGING, AT ROOF GEOMETRY INTERSECTIONS, INCLUDING ROOF RIDGES, WHILE WHOLE BUILDING WAS UNDER NEGATIVE PRESSURE.

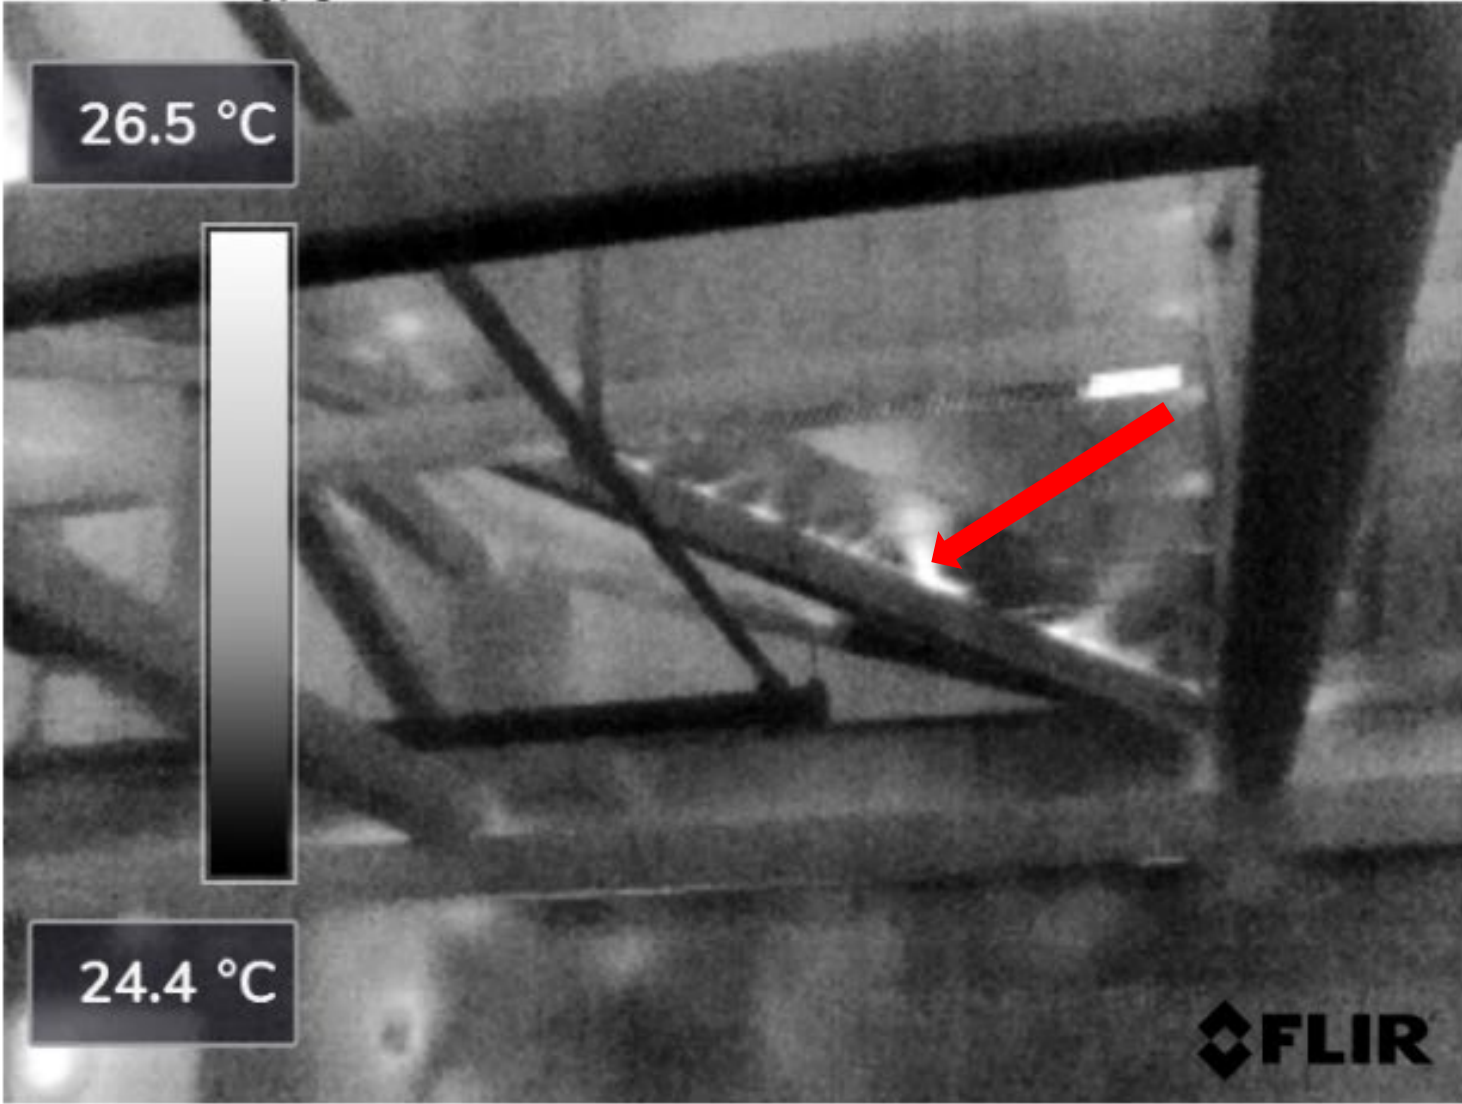
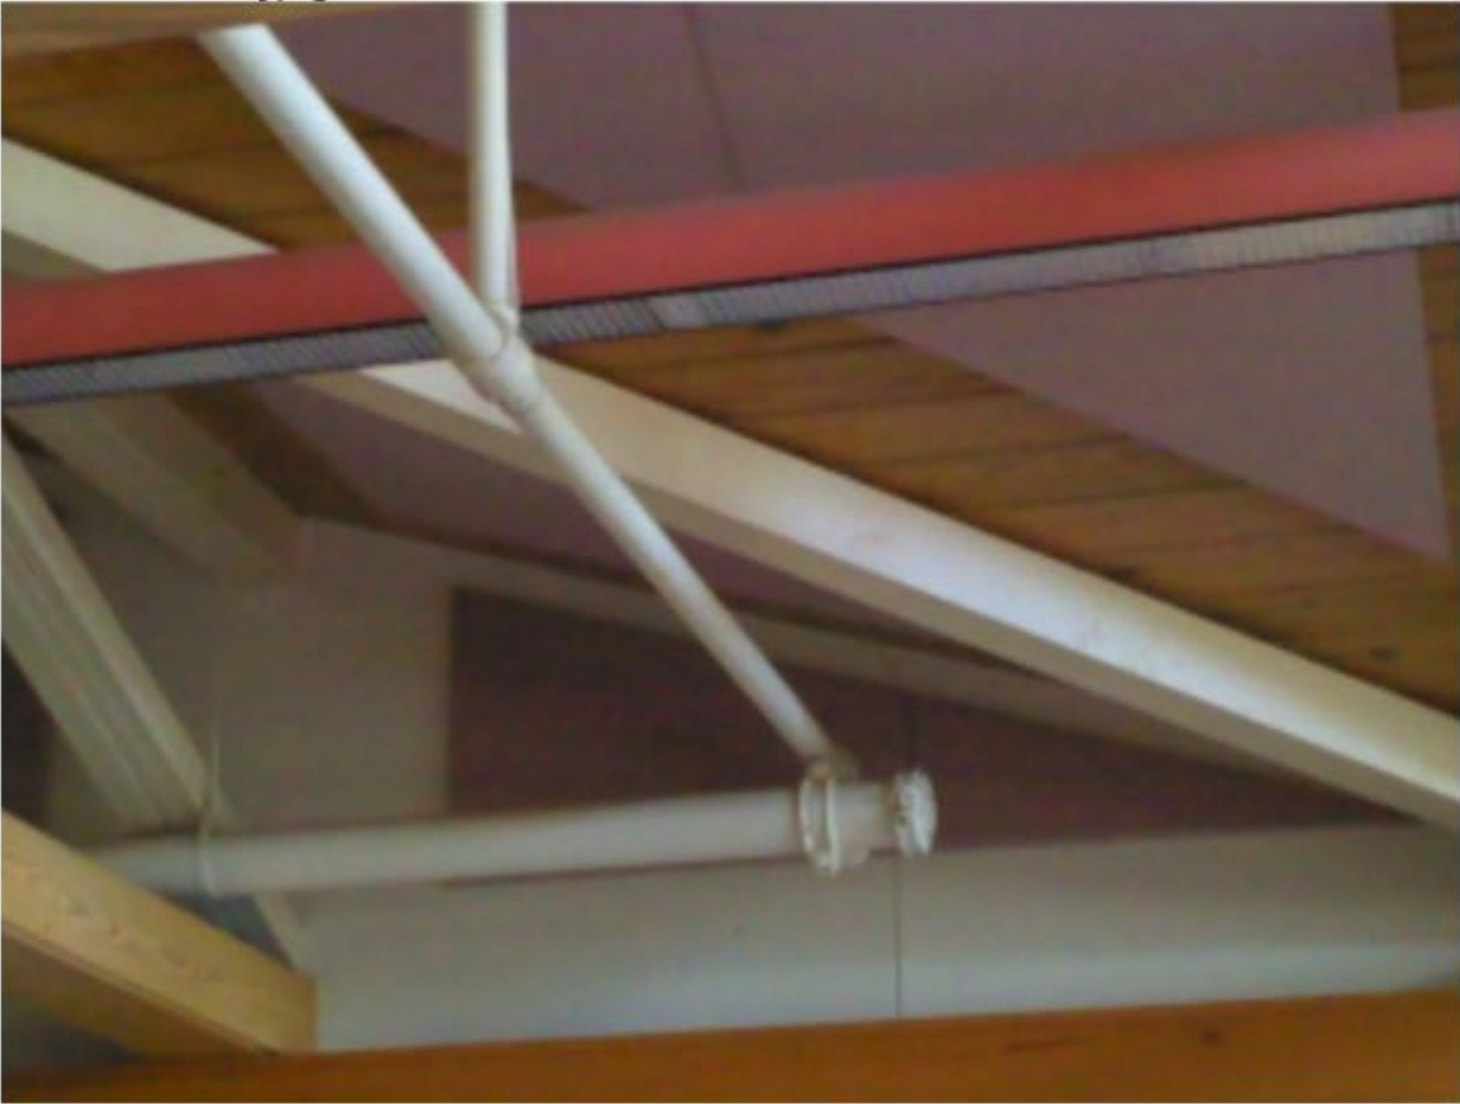
FLIR8713.jpg

LIKELY AIR LEAKAGE AT ROOF VALLEYS

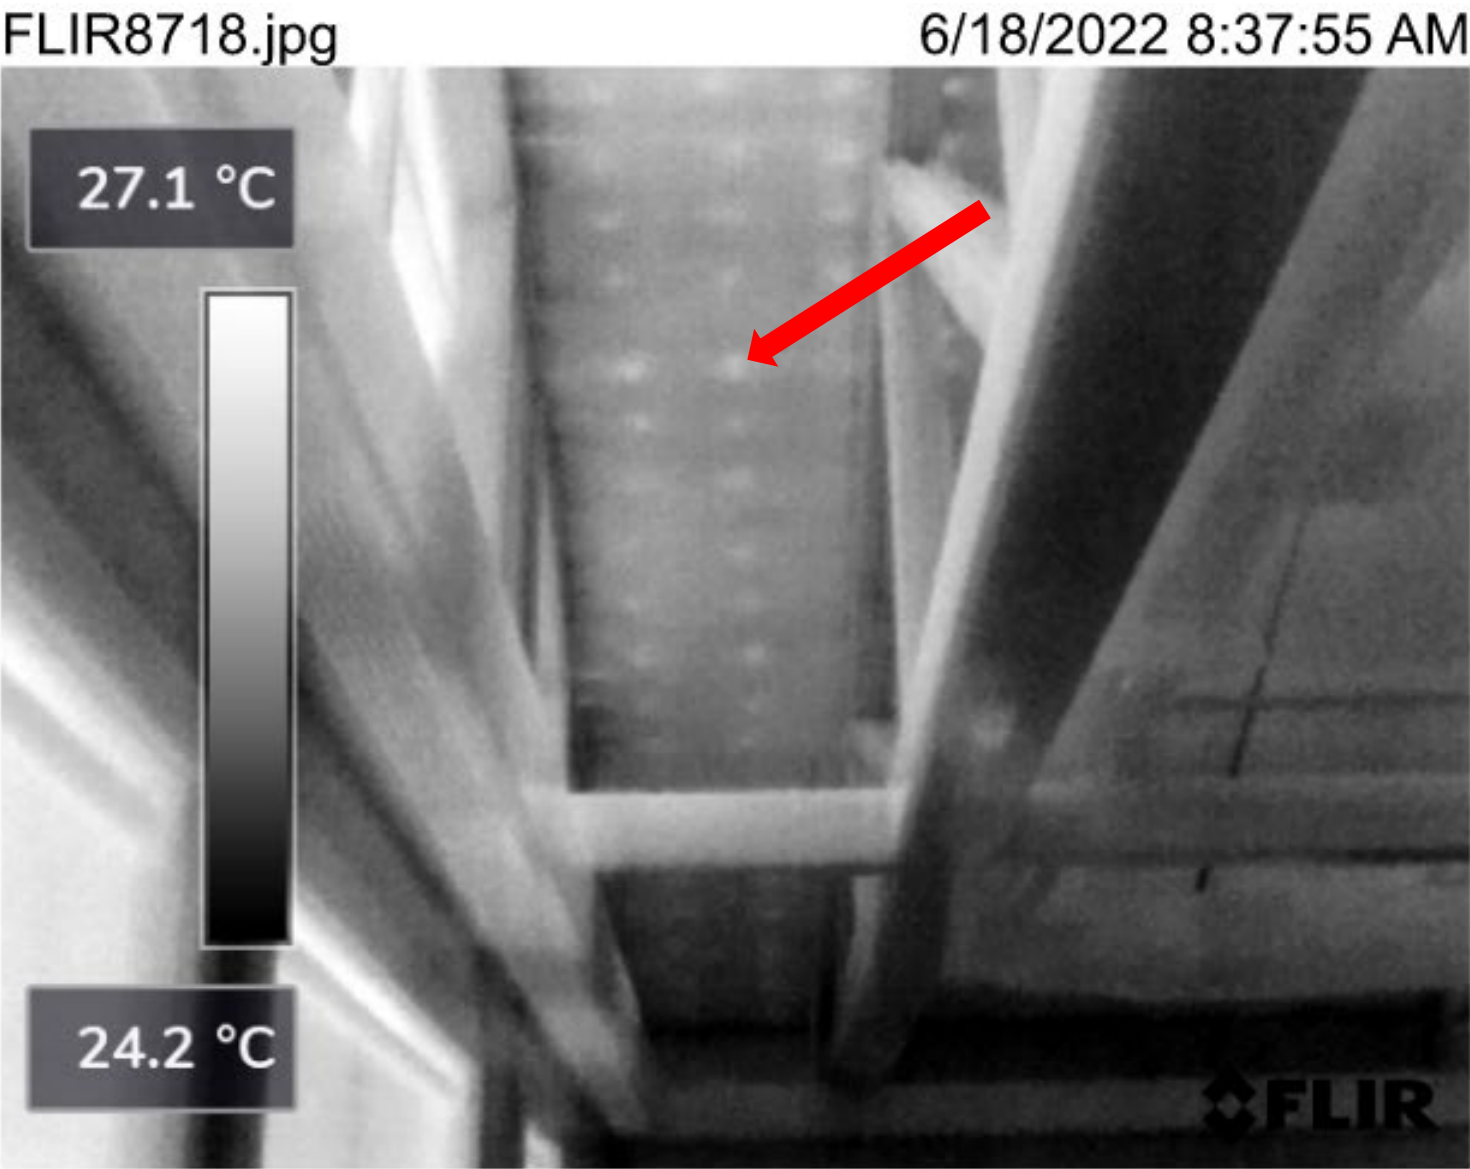
LIKELY AIR LEAKAGE AT ROOFING FASTENERS, VISIBLE IN A REGULAR PATTERN
