ZERO CARBON-READY RETROFIT STUDY

**WEST TISBURY ELEMENTARY SCHOOL
WEST TISBURY, MA**

PREPARED FOR
UP-ISLAND REGIONAL SCHOOL DISTRICT
SEPTEMBER 09, 2022

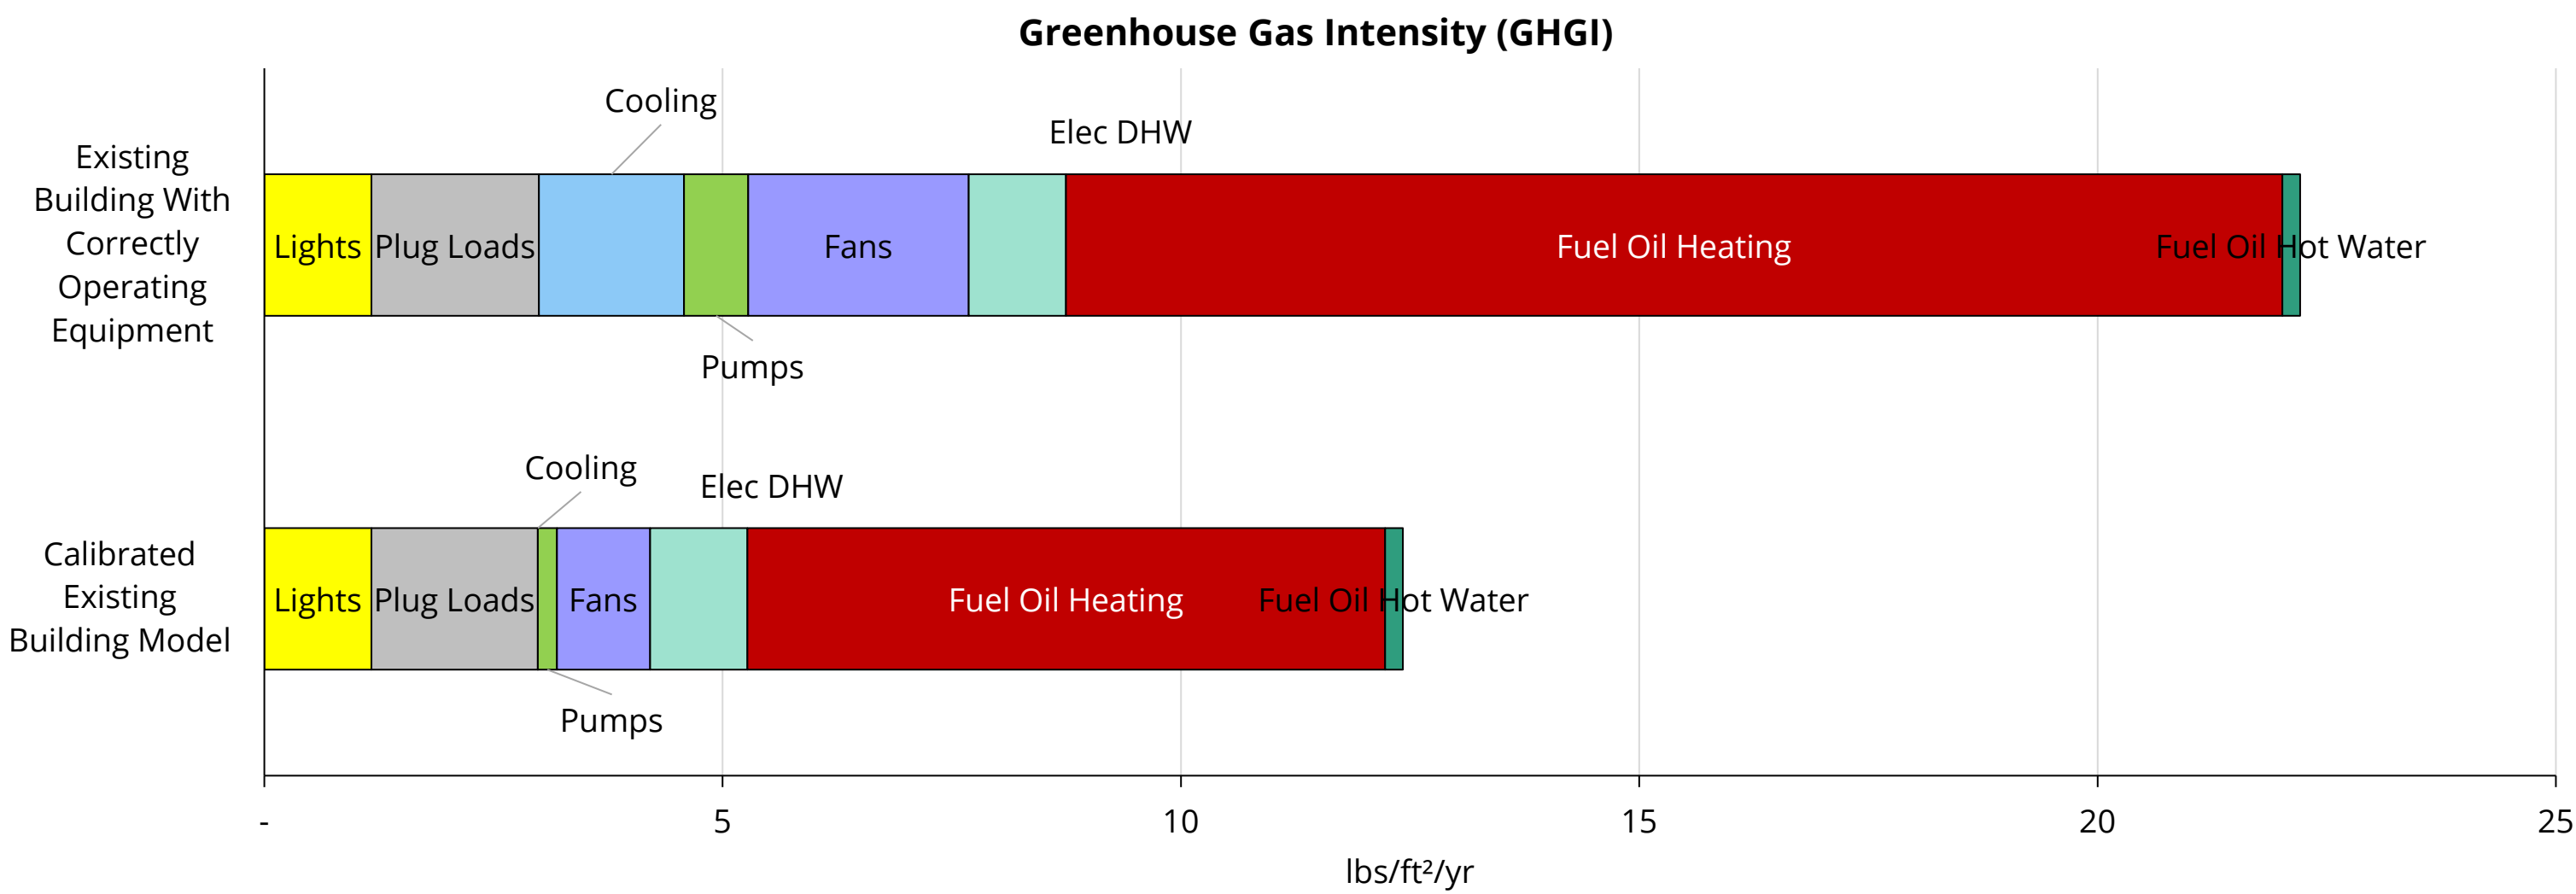
The GHGI graph compares the GHG emissions associated with the **Calibrated Existing Building Model** and the **Existing Building With Correctly Operating Equipment**.

- Fuel oil heating is the largest contributor to GHG emissions, due to a high heating demand and high emissions associated with the on-site combustion of fuel-oil
- The GHG emissions associated with electrical end-uses result from the electrical grid emission factors. Currently, the primary energy source for the electrical grid in the state of Massachusetts is natural gas. The town of West Tisbury, along with the other Up-Island towns of Chilmark and Aquinnah, passed a resolution setting a goal that the town’s energy will come from 100% renewable sources by 2040. This will significantly reduce the greenhouse gas emission factor for the electrical use.
