APPENDIX A

Energy Modeling

Project: West Tisbury Elementary School Air Tightness Measurement and Diagnostics

Dates: 6/17/2022 and 6/18/2022

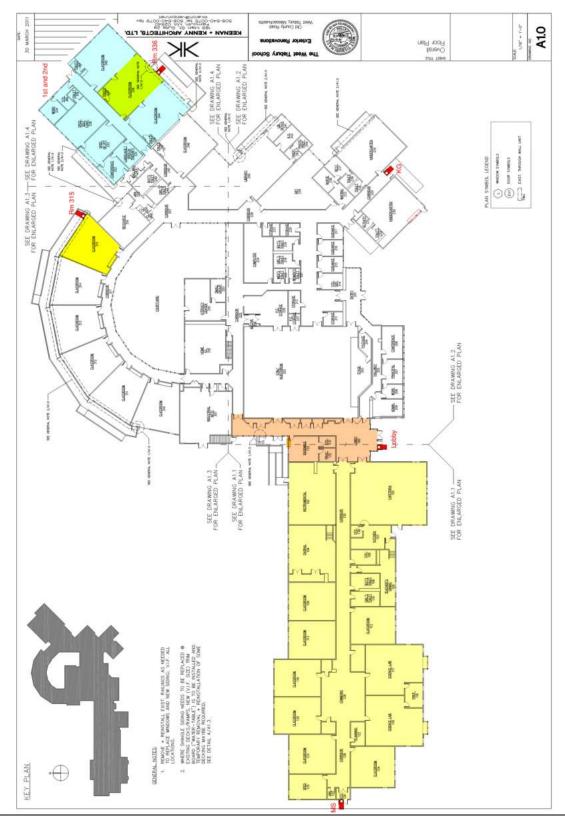
(See test plan on last page)

5 fans were set up at locations distributed throughout the whole school, with one fan held in reserve in case a particular area of the building needed much more pressurization than others. The basement was closed to the interior, but all other interior doors were opened during the whole building test.
