Mill Brook Watershed Study

West Tisbury, Massachusetts

Project No. T329-000
September 30, 2016

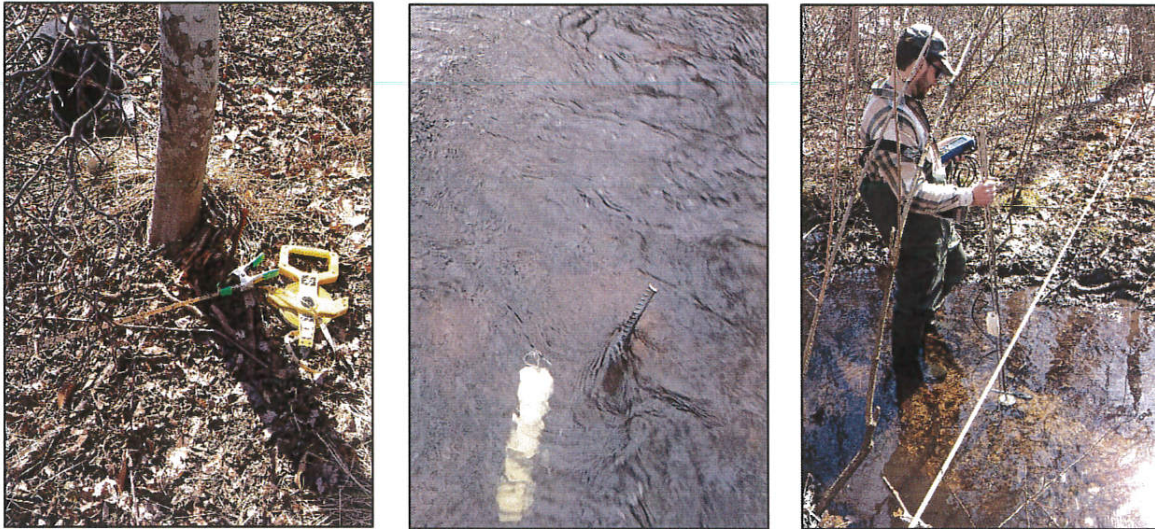
A stream cross section was established at each site. Cross sections were aligned perpendicular to the mean flow vector of the active stream channel and marked with rebar driven into the ground at each end. ESS measured stream discharge at these cross sections three times over the course of the study to develop a relationship (rating curve) between stage (water level) and flow. Discharge measurements were made using a streamlined current-meter method comparable to protocols used by the US Geological Survey (Rantz et al. 1982). A Hach FH950 portable electromagnetic velocity meter mounted on a calibrated rod was used to obtain velocity measurements. Width and depth were measured with a measuring tape and extended ruler, respectively.

Typical stream flow monitoring setup, showing established cross section marked by rebar (left), data logger installed inside protective PVC case and fastened to rebar (center), and discharge measurement with an electromagnetic current meter (right)

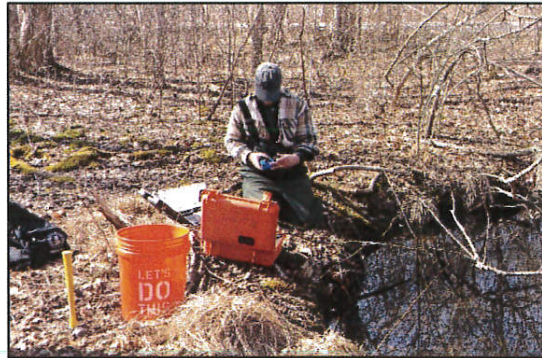
Collection of water quality data at Site 3

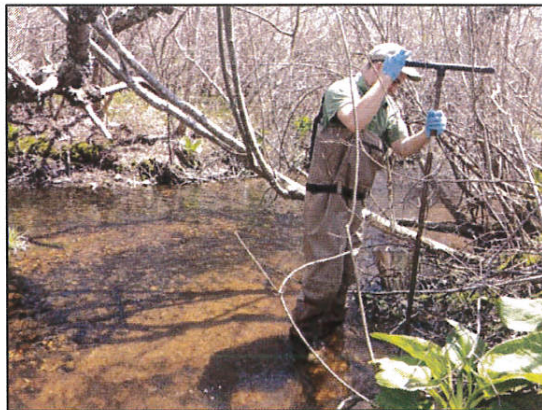
Samples were collected from fine sediments (most likely to retain organic pesticide residues) with a stainless steel bucket auger. Sampling equipment was decontaminated using alconox detergent, isopropyl alcohol and distilled water between locations to avoid cross-contamination of samples. Each sample was submitted to the lab and analyzed for total pesticides.

Collection of sediment sample using soil bucket auger at Site 5

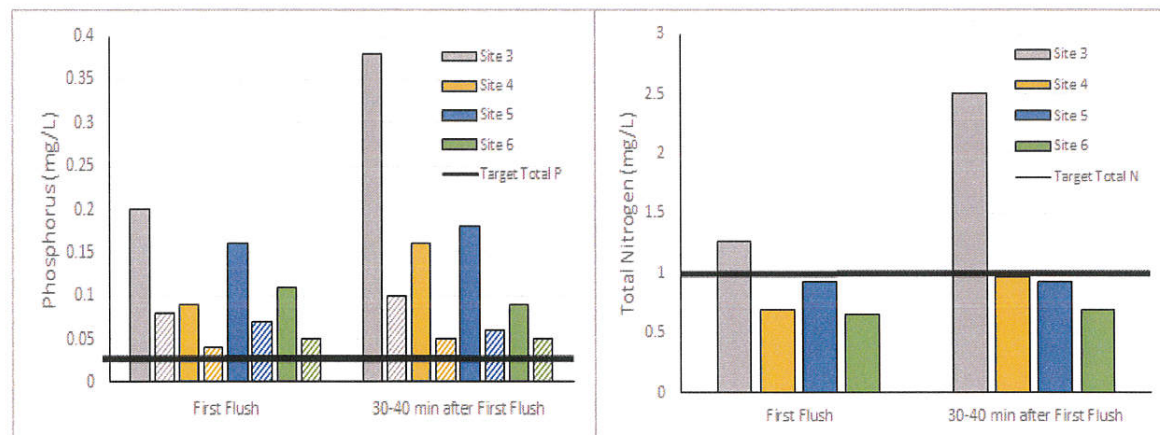
Figure 6. Stormflow Phosphorus and Nitrogen Concentrations

Solid bars indicate *total phosphorus*. Hatched bars indicate *dissolved phosphorus*.

Stormwater quality results are presented in Table 4 and Figure 6. The laboratory report is attached in Appendix B.
