# **Mill Brook Watershed Study Report** **and Recommendations**

**Town of West Tisbury**

**Mill Brook Watershed Management Planning Committee**

**2014-2018**

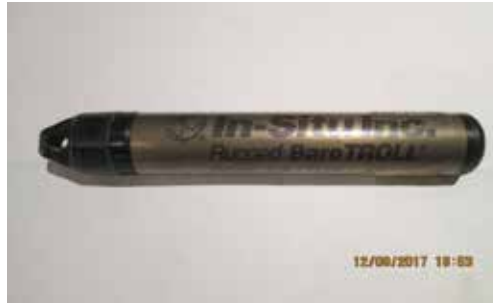
Data logger for continuous measurement of water temperature and water level

A data logger is an instrument that is submerged at specific sites within the stream to continuously record data. Data was collected at each of six different sample sites every 15 minutes between March 2015 and August 2016.

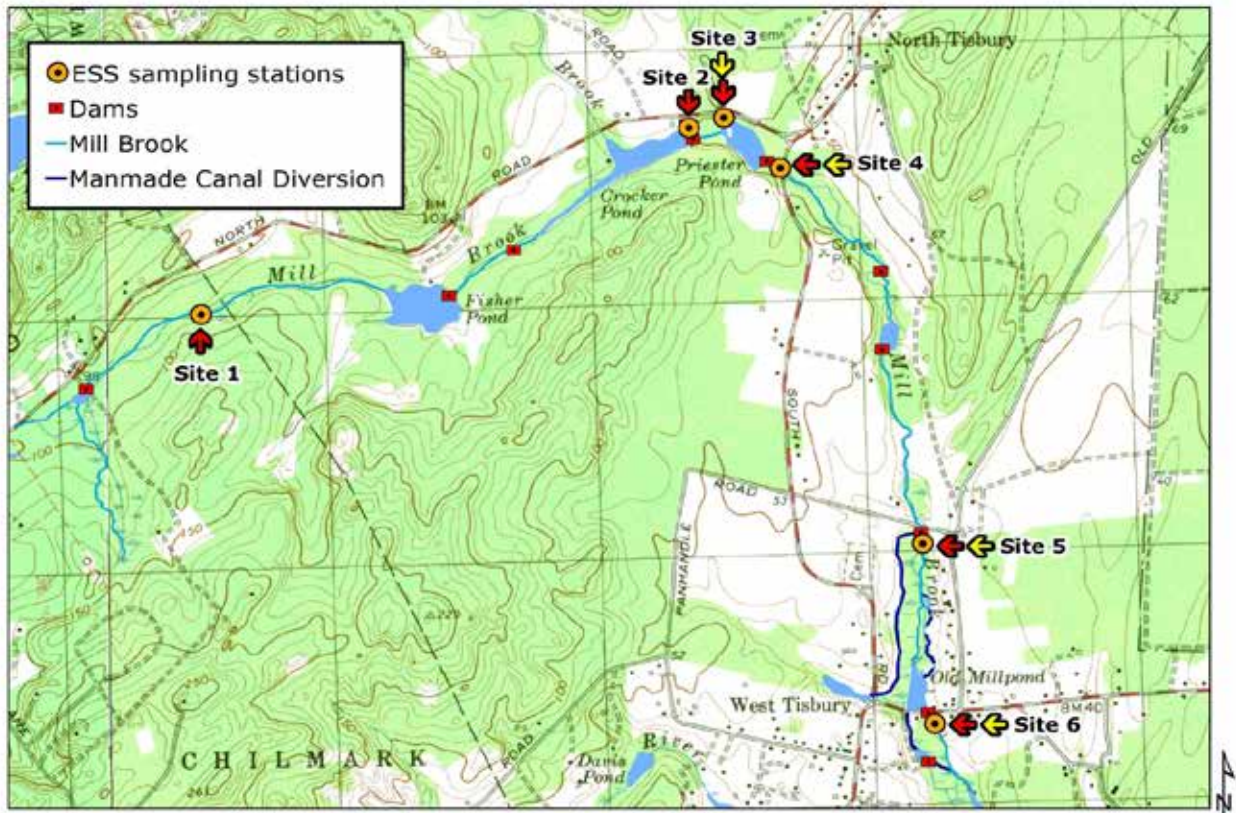
Fig. 9 Red arrows mark the six ESS Group base flow water quality sampling sites and continuous data logger locations, yellow arrows mark the four stormflow water quality sampling sites

ESS Group deployed continuous water temperature and water level data loggers at six locations along Mill Brook (See ESS Sampling Site Map, Fig. 9; Page 11). These loggers were programmed to record data at 15 minute intervals. These six sites reflect conditions found above and below three of the seven impoundments on Mill Brook as well as a site at Waskosim's Rock Reservation near the headwater of the brook, and at Indian Hill Brook.

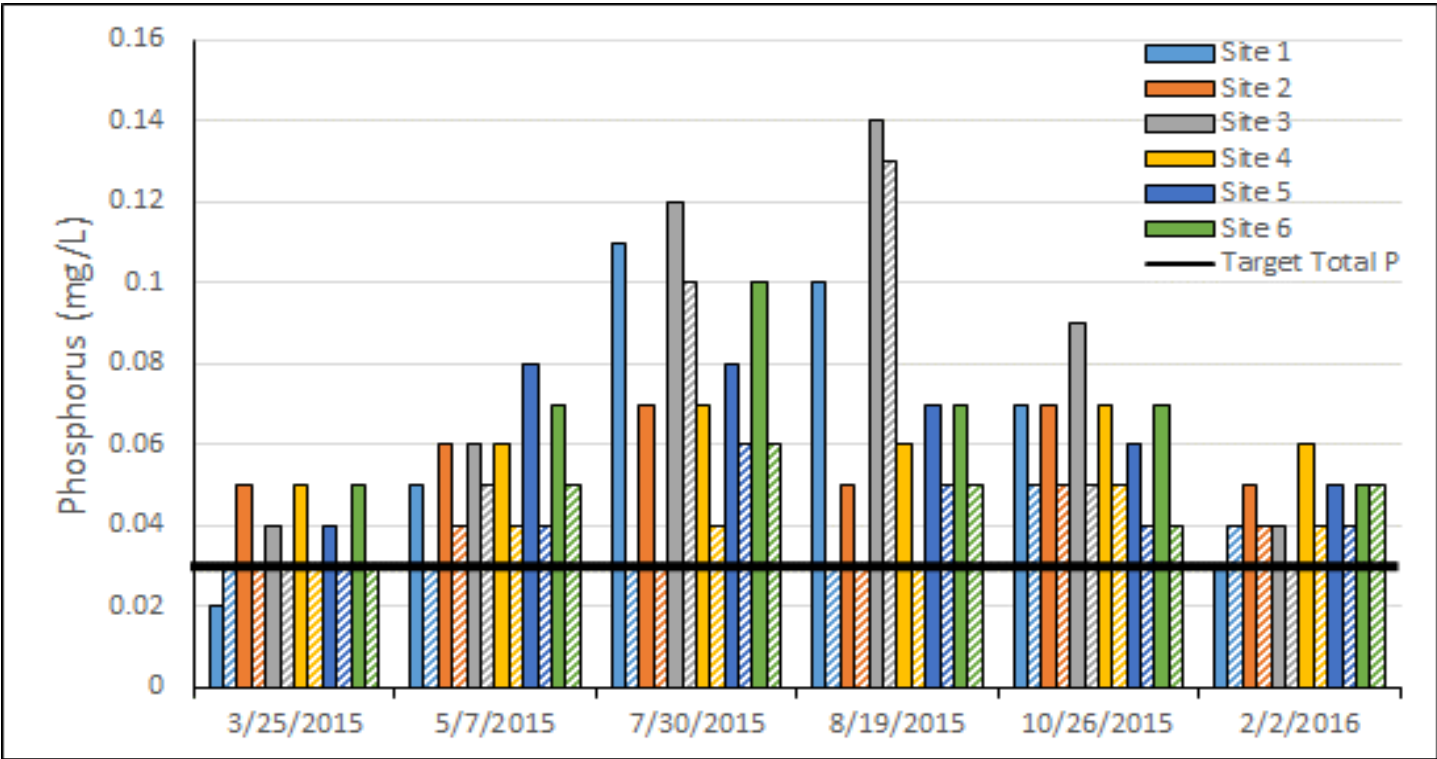
**Baseflow Phosphorous Concentrations.**

**Solid bars indicate total phosphorous. Hatched bars indicate dissolved phosphorous**

Samples from all stations are close to or significantly exceed the guidance level for total phosphorous from near the headwaters of the stream (site 1) to below Mill Pond (site 6) throughout the sampling period.

***The acceptable level is shown as a solid horizontal line.*** It is clear that the concentrations found exceed the acceptable guidance for phosphorus and are below the limit for nitrogen, with the exception of Site 3.

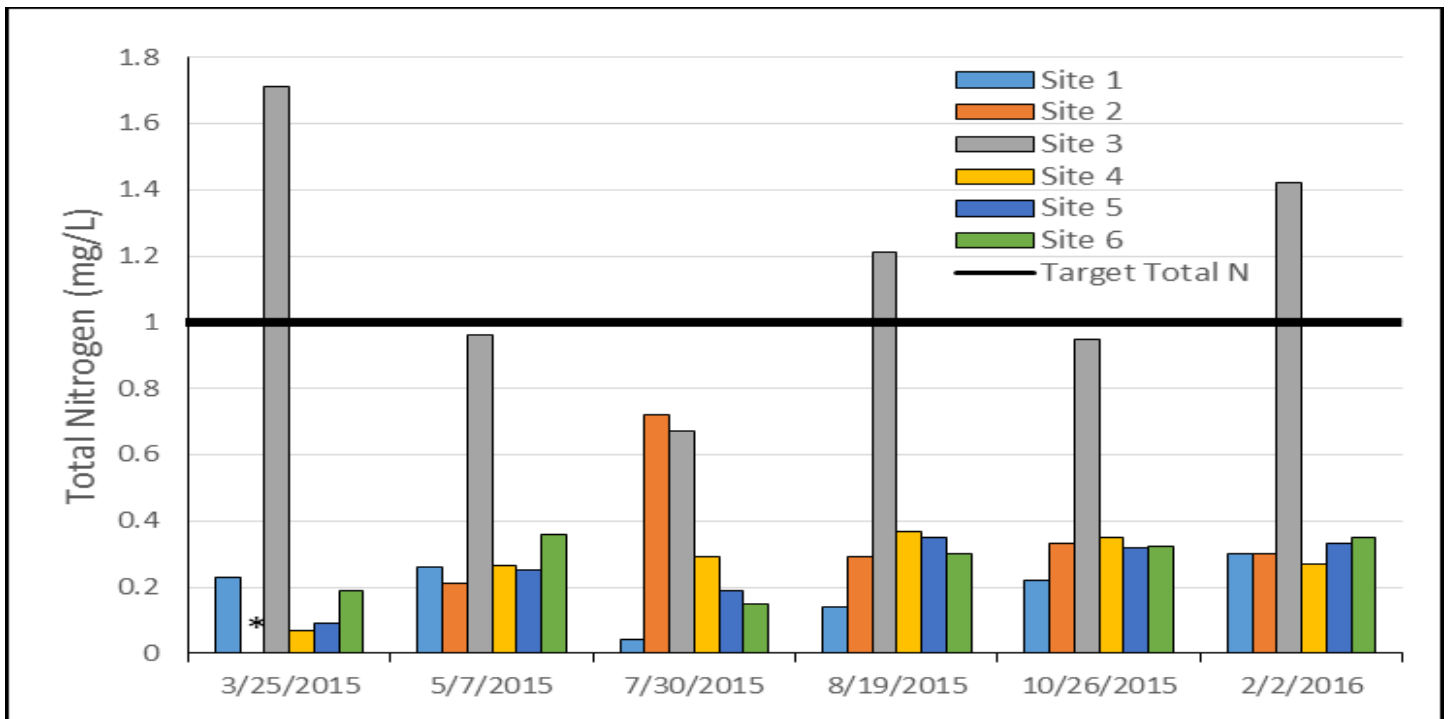
### Baseflow Nitrogen Concentrations

\* The sum of nitrate, nitrite and total Kjeldahl nitrogen (which combined represent Total Nitrogen) were found to be at levels below the laboratory detection limit.

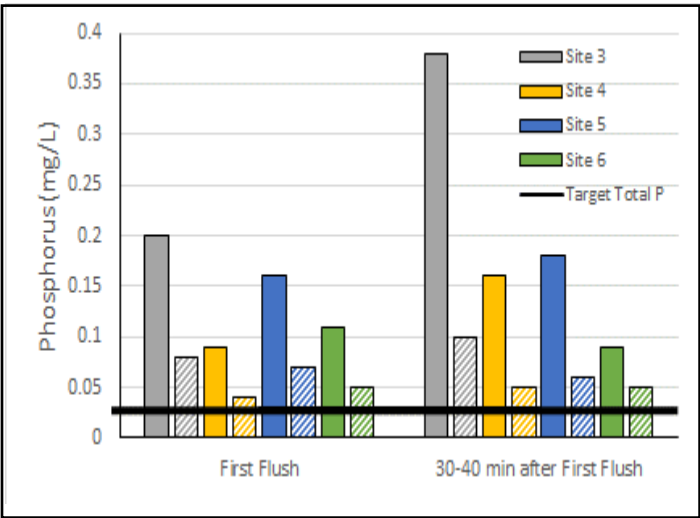
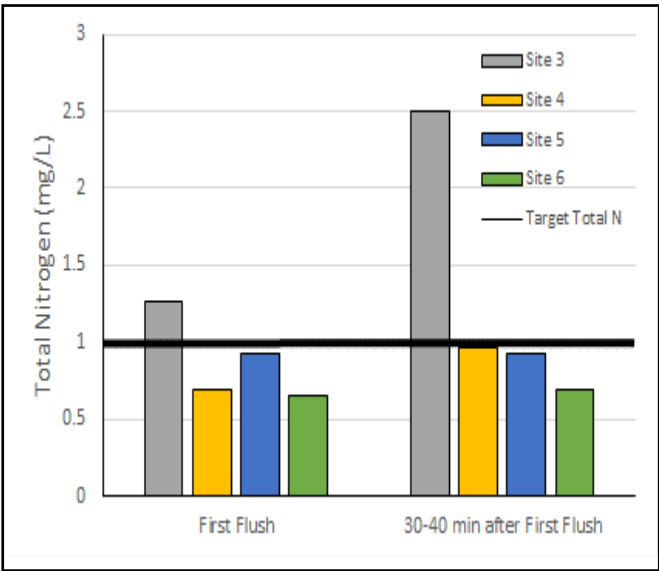
### Stormflow Phosphorus and Nitrogen Concentrations

Solid bars indicate **total phosphorus**. Hatched bars indicate **dissolved phosphorus**.

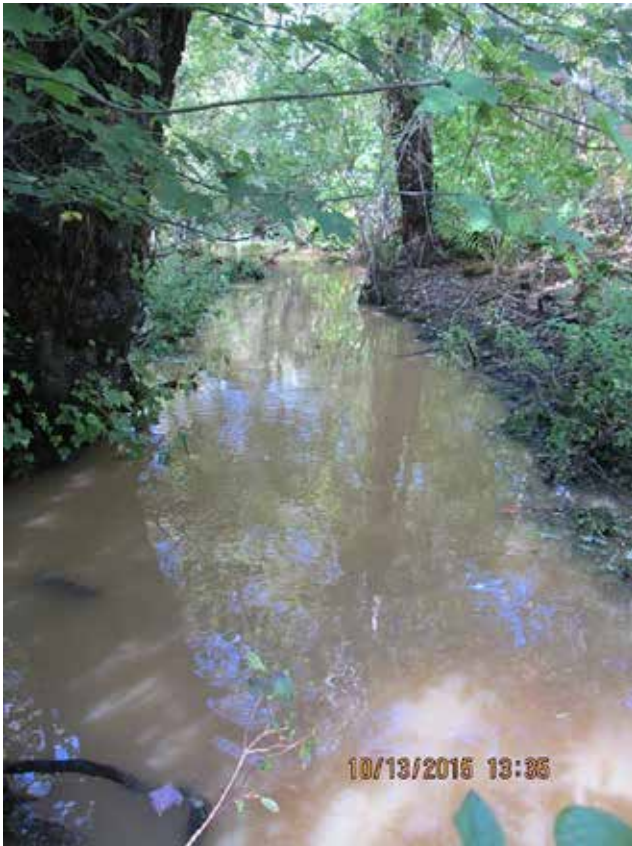
Fig. 12 Condition of the brook prior to restricting livestock access

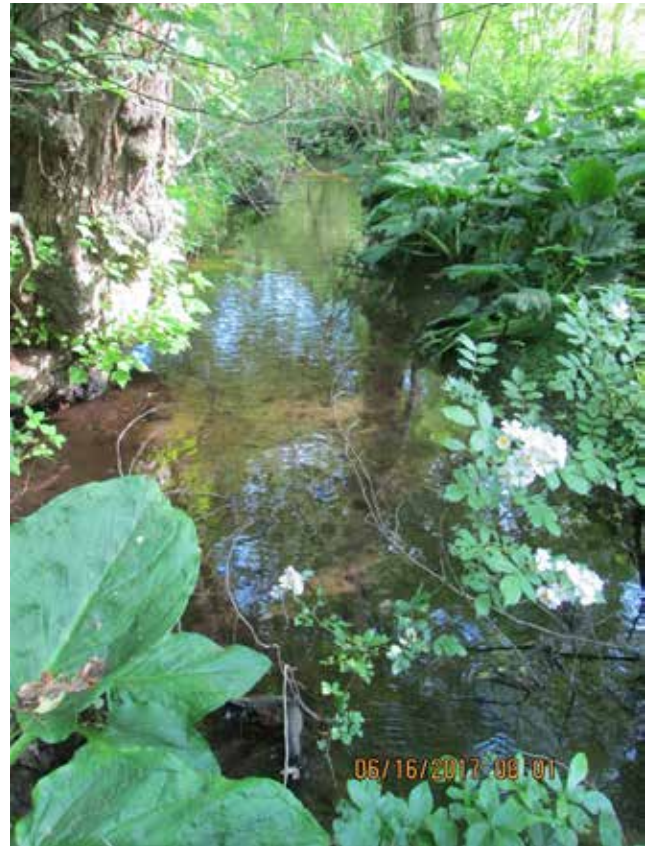
Fig. 13 Condition of the brook today after restricting livestock access

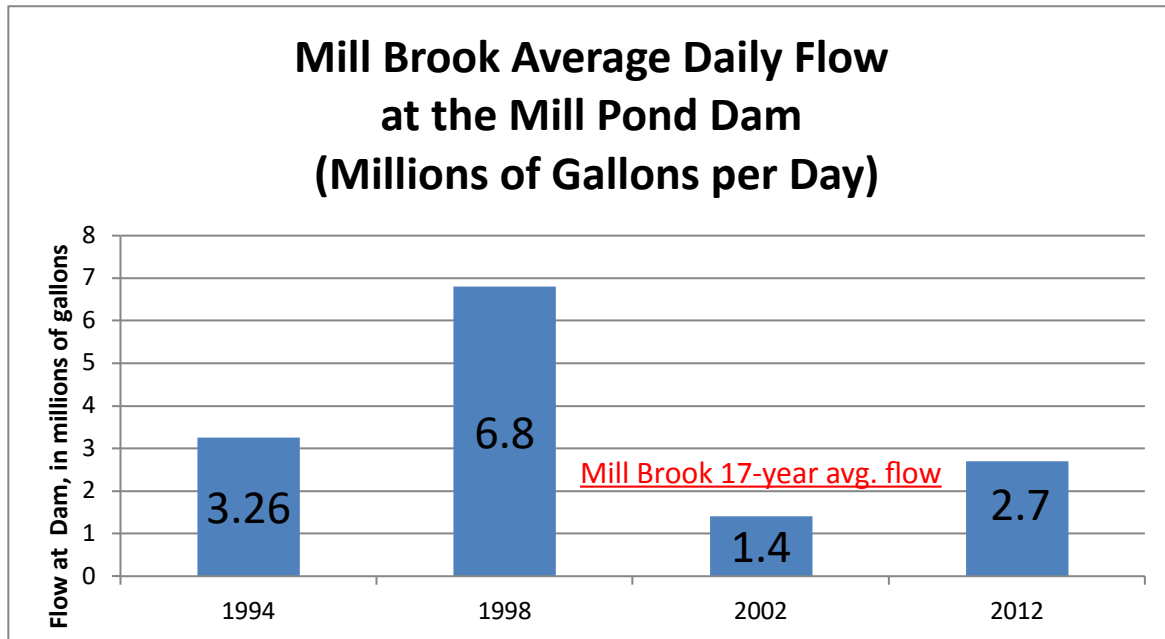
Fig. 14 Source: Kent Healy

The volume of water flowing in the brook along its length informs us as to whether it is receiving groundwater input or losing water to the groundwater by seepage through the stream bed.

**Volume data also allows us to estimate the quantity of nitrogen and phosphorus the stream is carrying to Town Cove in Tisbury Great Pond.** It is clear from the average daily flow data collected by Kent Healy at the Mill Pond discharge that the flow varies widely from year to year. For this study, data was collected at five stations from near the headwater at Roth Woodlands to the Mill Pond outlet.

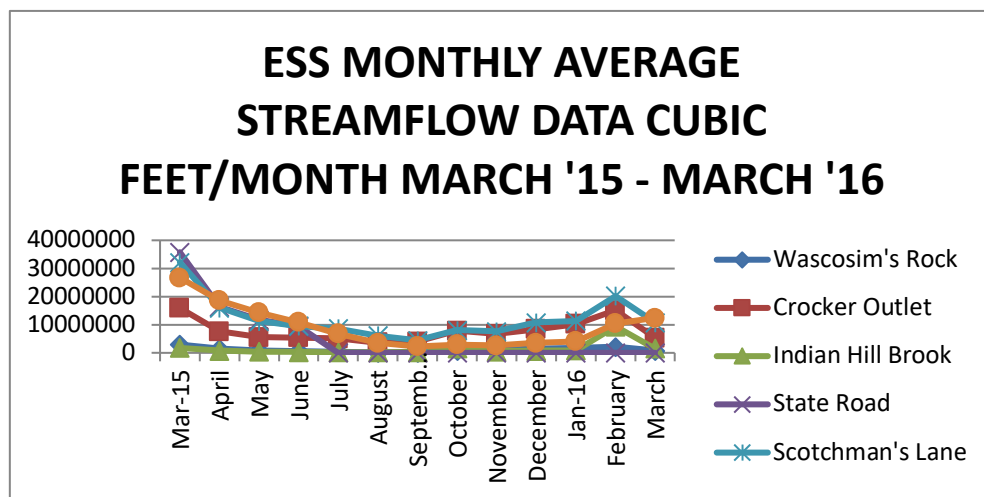
Fig. 15 ESS Monthly Avg. Streamflow March 2015 – March 2016

**Key Finding: This study resulted in a limited amount of data. Improved calibration will be achieved through future additional discharge readings.**

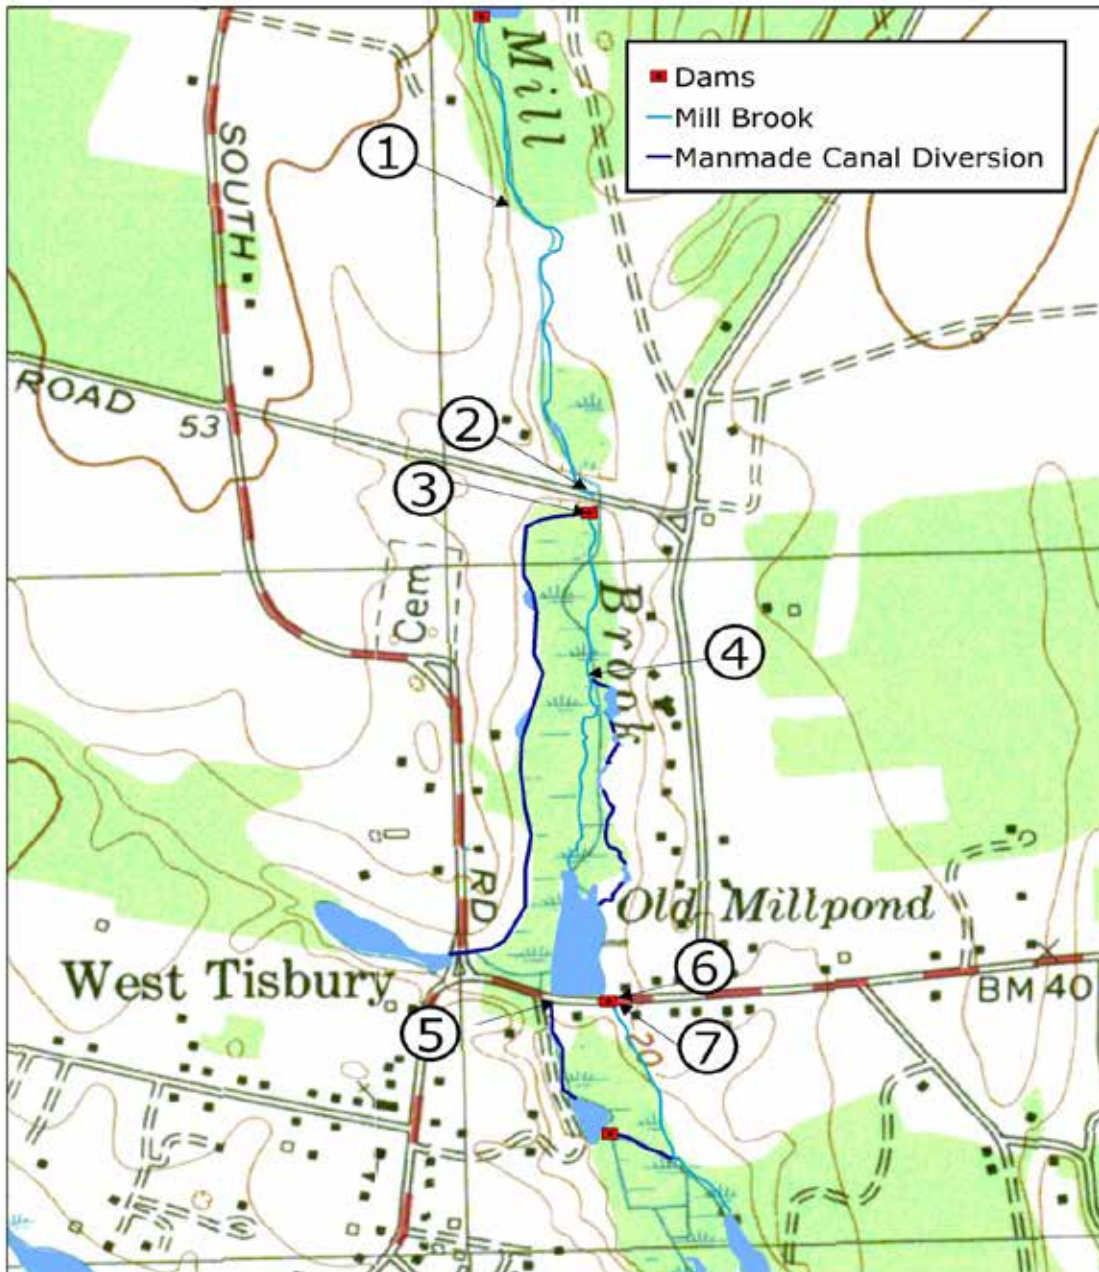
Fig. 16: Known surface water withdrawals and diversions from Mill Brook

The following describe known diversions and water withdrawals from the main flow of Mill Brook. See Fig. 16. Numbered site descriptions follow:

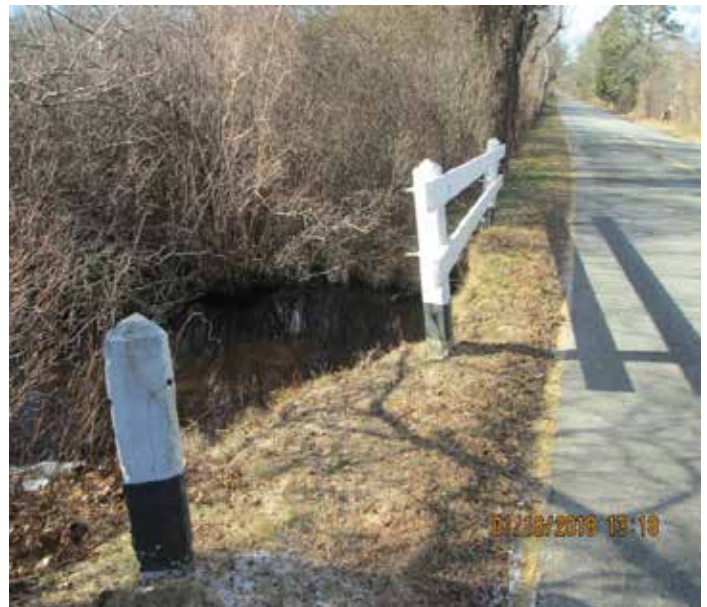
3

### Whiting diversion dam

Whiting diversion dam ~100' south of Scotchman's Bridge Lane directs as much as 20% of the flow away from the main channel of Mill Brook.

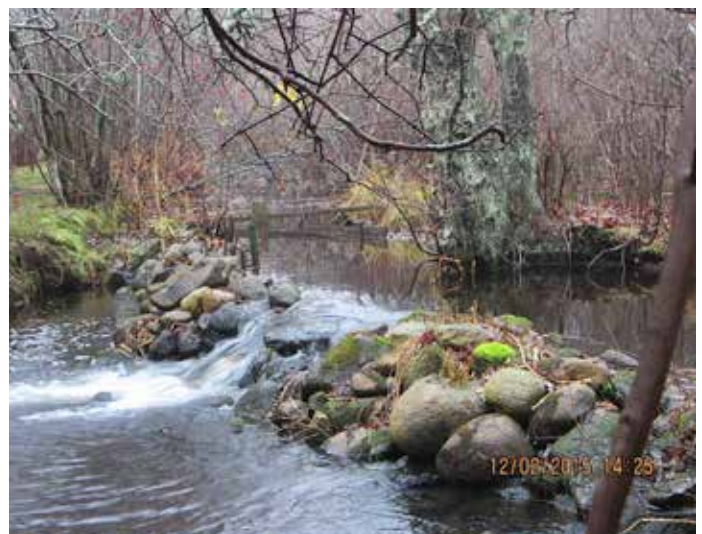
4

Diversions to east side of Mill Brook

Diversions like this one north of Mill Pond also direct flow from the main channel of Mill Brook.

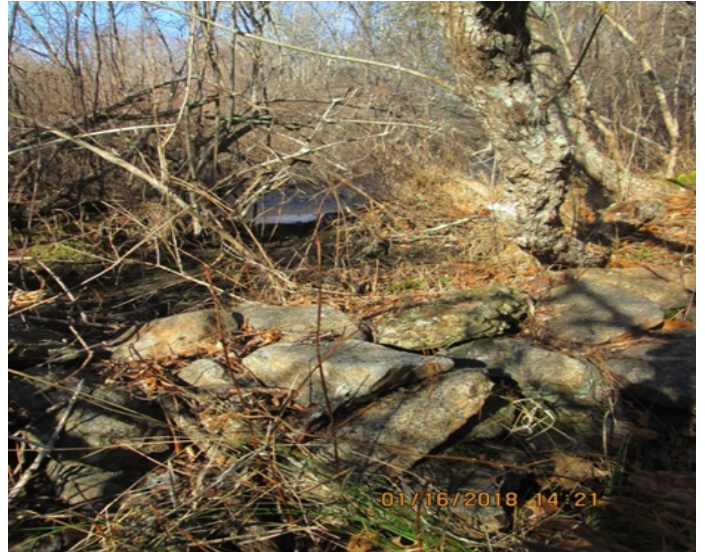
5

Factory Brook diversion

At the southwest corner of Mill Pond, Factory Brook diverts water from Mill Brook via a culvert under Edgartown Road to Maley's Pond – a town designated fire pond.

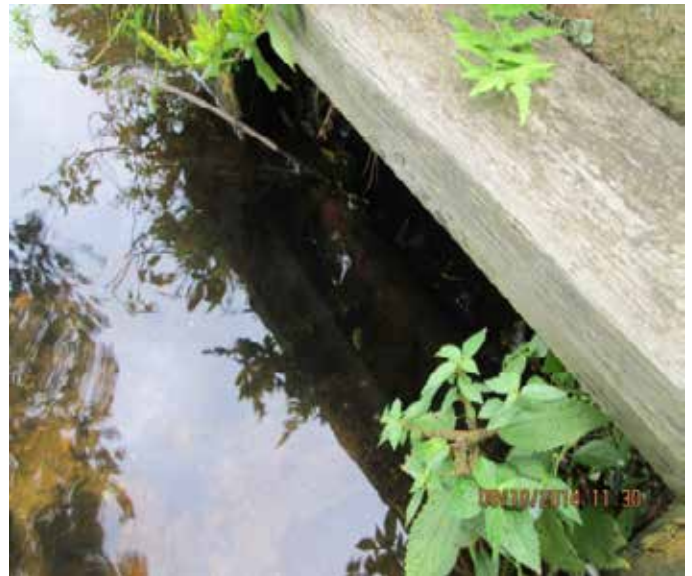
6

Blocked fish Ladder

In order to maintain flow to Maley's Pond during low flow periods, Kent Healy (caretaker of Mill Pond Dam) has blocked flow through the fish ladder at the main spillway.

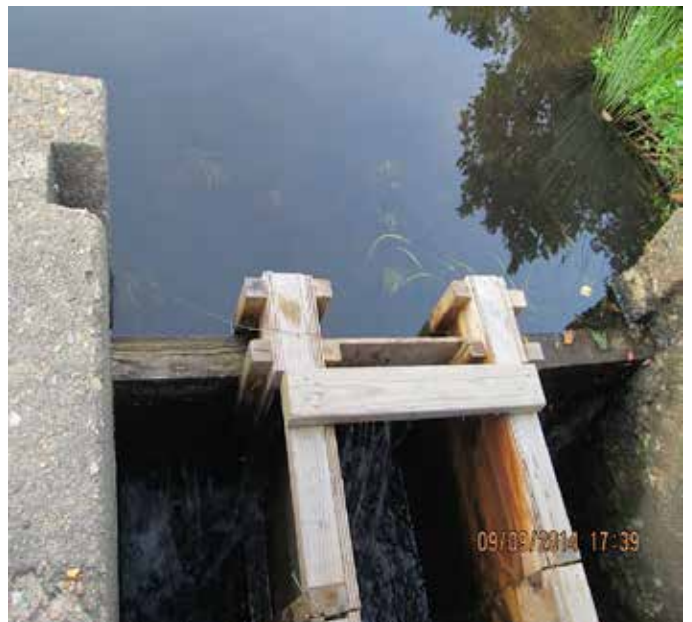
7

No flow over west weir boards at Mill Pond

Dry weir boards during low flow period in late summer at main spillway, Mill Pond.

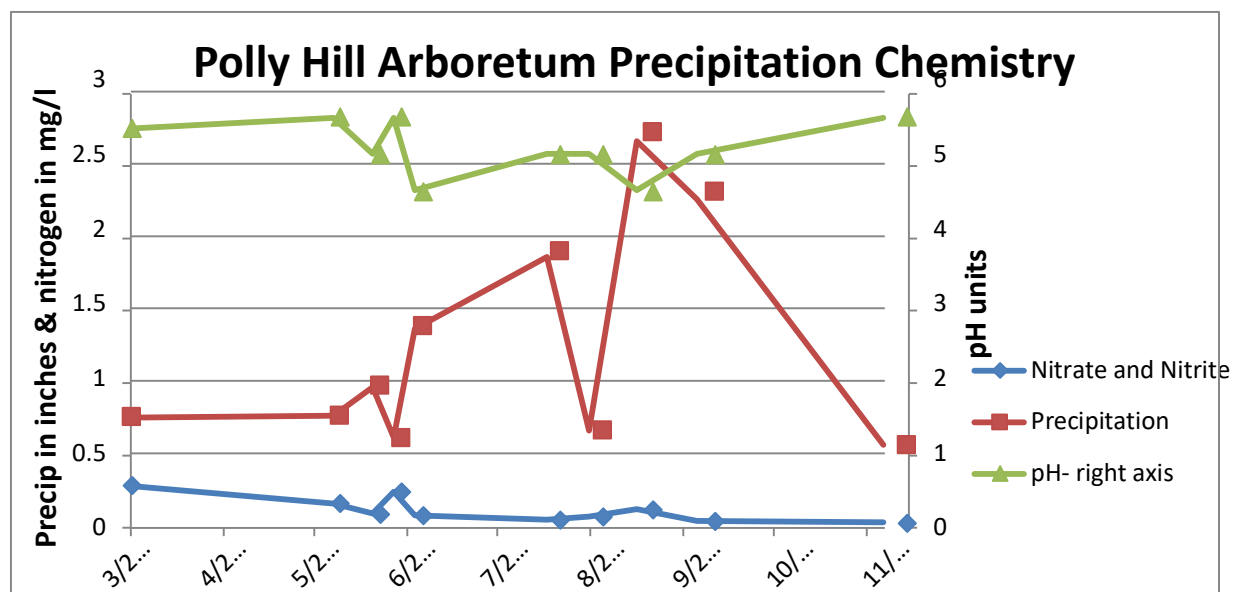
Fig. 17 Polly Hill Rainfall March – November, 2015

Rainfall was recorded at the Polly Hill Arboretum using a Hach wide range pH kit. Samples were sent to Phoenix Lab for analyses for the nitrate content. The acidity as indicated by pH of the stream below the Roth Woodlands sample site are mostly between 6 and 7 (pH 7 is neutral). This is in the desirable range for good habitat. The pH measured in the precipitation was significantly lower (50 to 100 times more acid). ***The fact that the stream pH is in the desirable range despite the acidity of the rainfall indicates that the rainfall is buffered by the upland soil and vegetation that it percolates through on its way to the stream. Without this buffering, this acidity could have an impact on habitat quality.***

**Key Finding: *The nitrate content of the rainfall collected during this study was low compared to Massachusetts Estuaries Project (MEP) nitrogen load calculations for Tisbury Great Pond.***

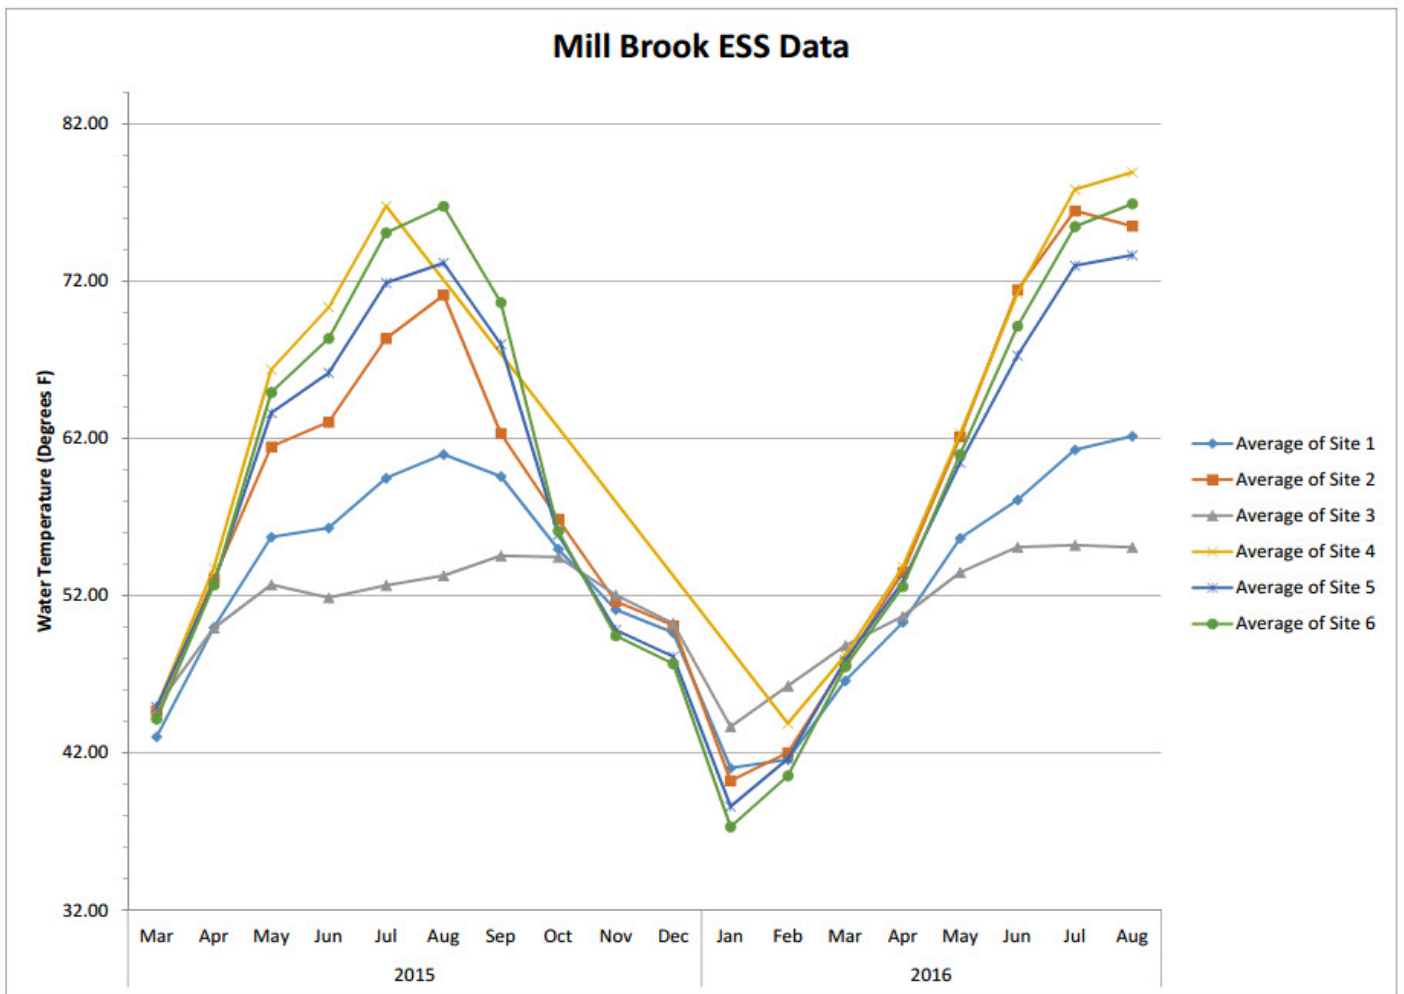
Fig. 18 Mill Brook ESS Data Average Water Temperature illustrates the seasonal fluctuations in average stream temperatures for this study period

Figure 18 shows average water temperatures for the six sites from March, 2015 through August, 2016. This graph illustrates the seasonal changes in water temperature recorded at these six sites; warmer in the summer, cooler in the fall/winter.

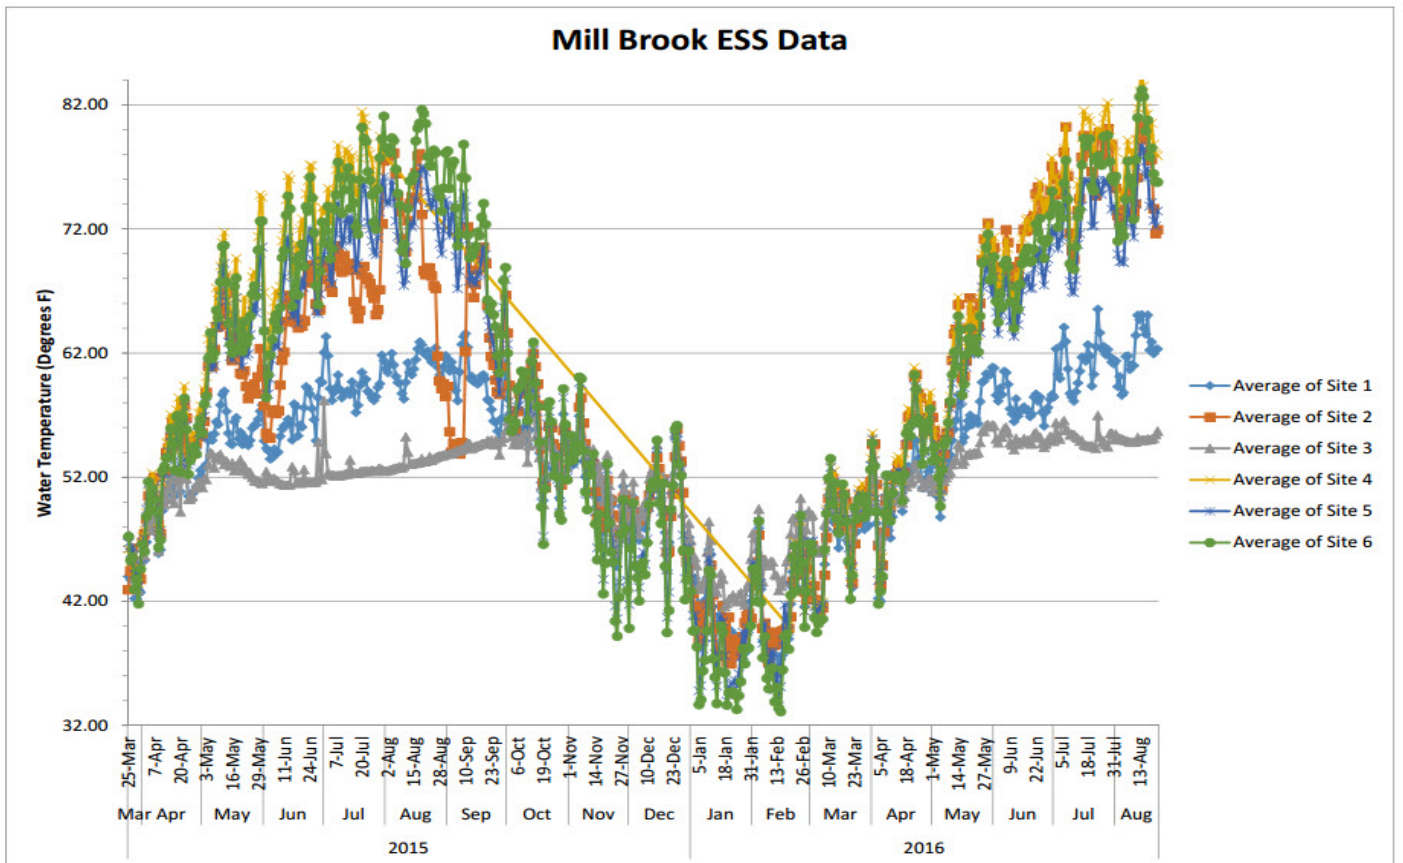
Fig. 19 Mill Brook ESS Data Daily Fluctuations

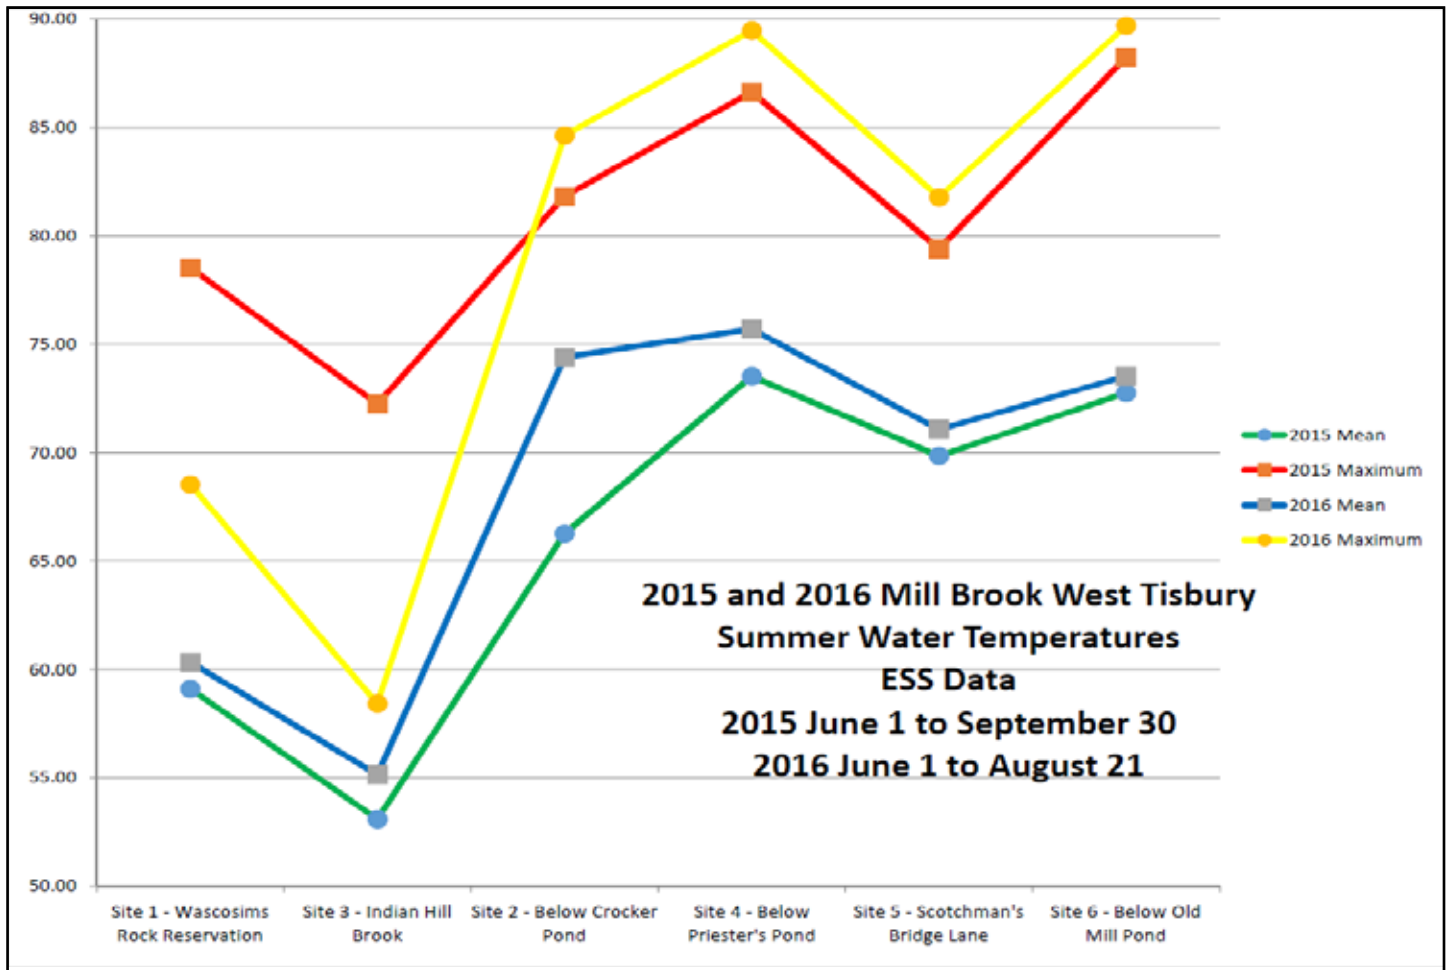
Fig. 20 ESS Group Maximum and Average Water Temperature March 2015 through August 2016 within the Mill Brook Stream System

Figure 20 represents maximum and average water temperatures recorded at these six sites in both 2015 and 2016. Maximum water temperatures of nearly 90 degrees were recorded below Priester and Mill Ponds.

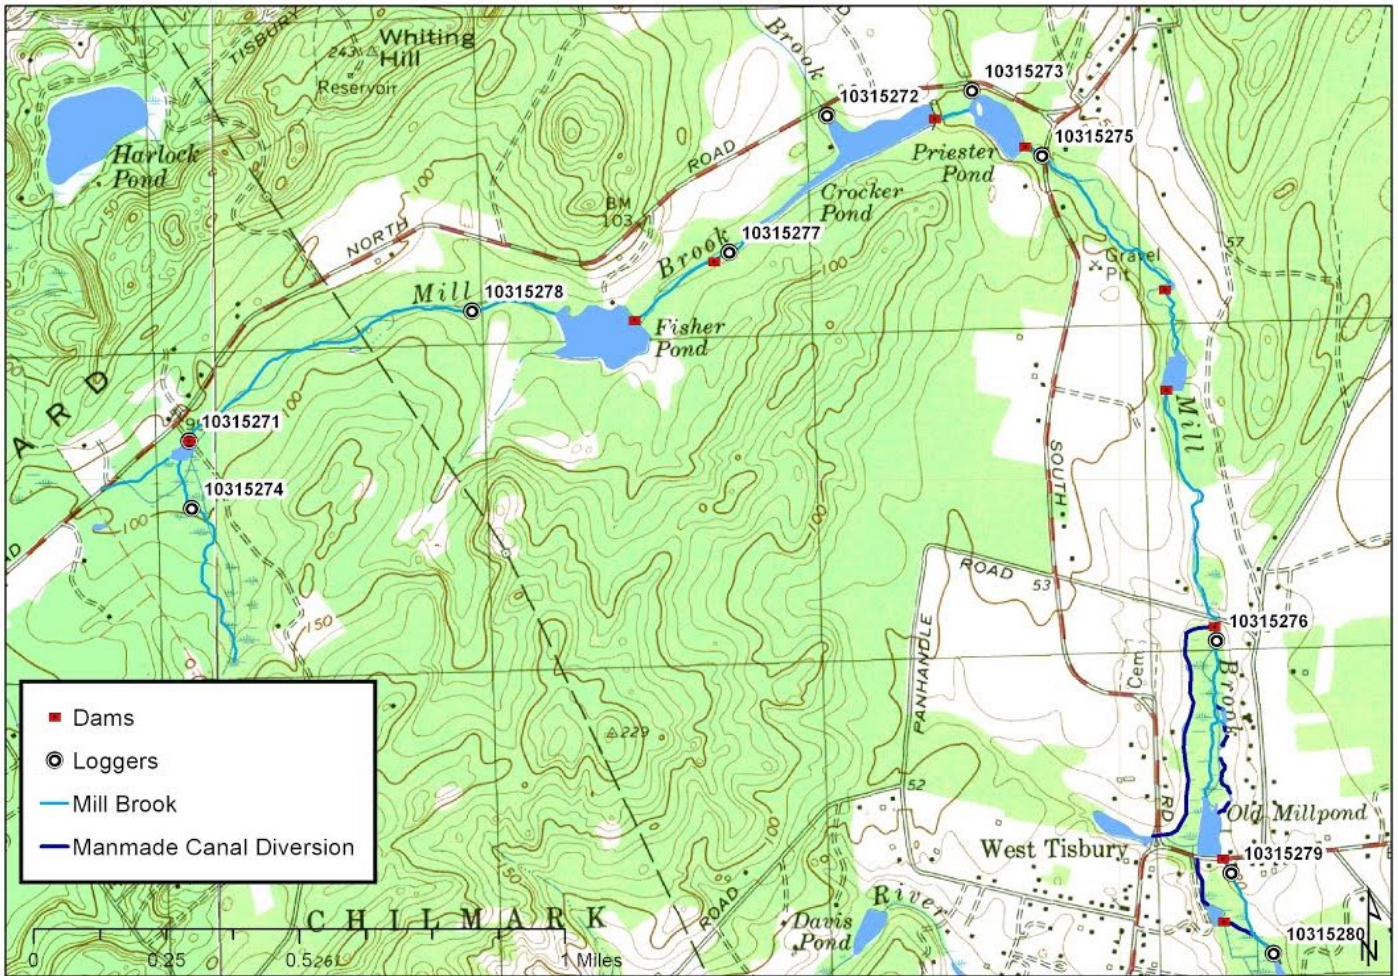
Fig. 21 Sea Run Brook Trout Coalition Data Logger Locations

In addition to the data gathered by ESS Group, the Sea Run Brook Trout Coalition (SRBTC), a non-profit organization dedicated to the preservation and restoration of native brook trout habitat, has (through a grant from the local Edey Foundation) installed and monitored continuous water temperature loggers at ten locations along the four mile length of Mill Brook. These data loggers were installed in May, 2013, and are still in place and recording at intervals of 15 minutes, 24/7 (Fig. 21).

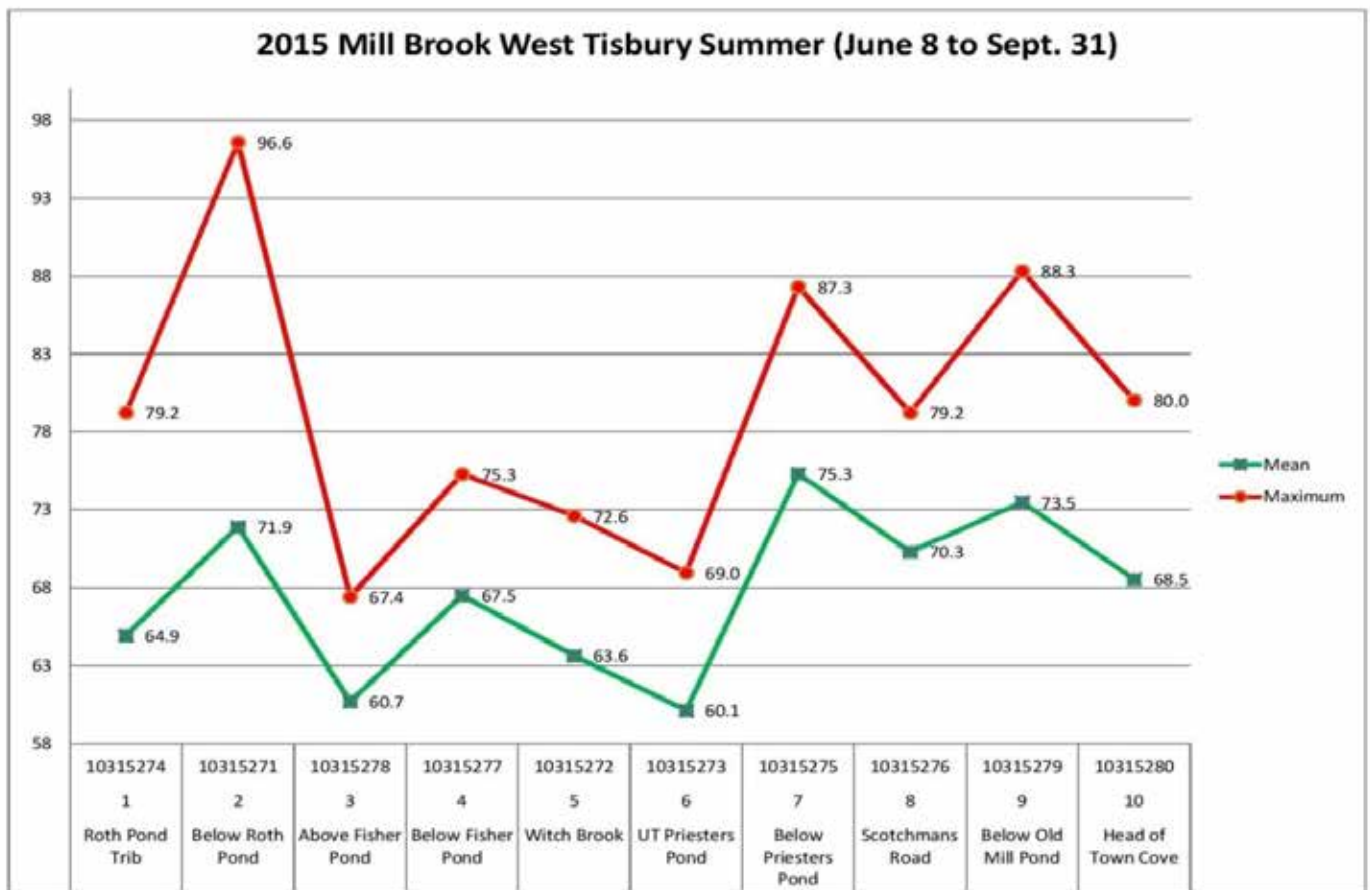
Fig. 22 Sea Run Brook Trout Coalition Maximum and Average Water Temperature June to September 2015 within the Mill Brook Stream System

Brook trout cannot long survive water temperatures above 70 degrees and water temperatures above 78.8 degrees impair river herring egg incubation and juvenile river herring habitat; River herring (*Alosa pseudoharengus*) are seasonally present and spawning in Mill Brook below the dam at Mill Pond, as are numbers of American eel (*Anguilla rostrata*). Warm water temperatures persist far downstream of the impoundments. Mill Brook water temperatures have been recorded as high as 82 degrees where it flows into Town Cove of Tisbury Great Pond (Fig. 22 ; # 10 “Head of Town Cove”).

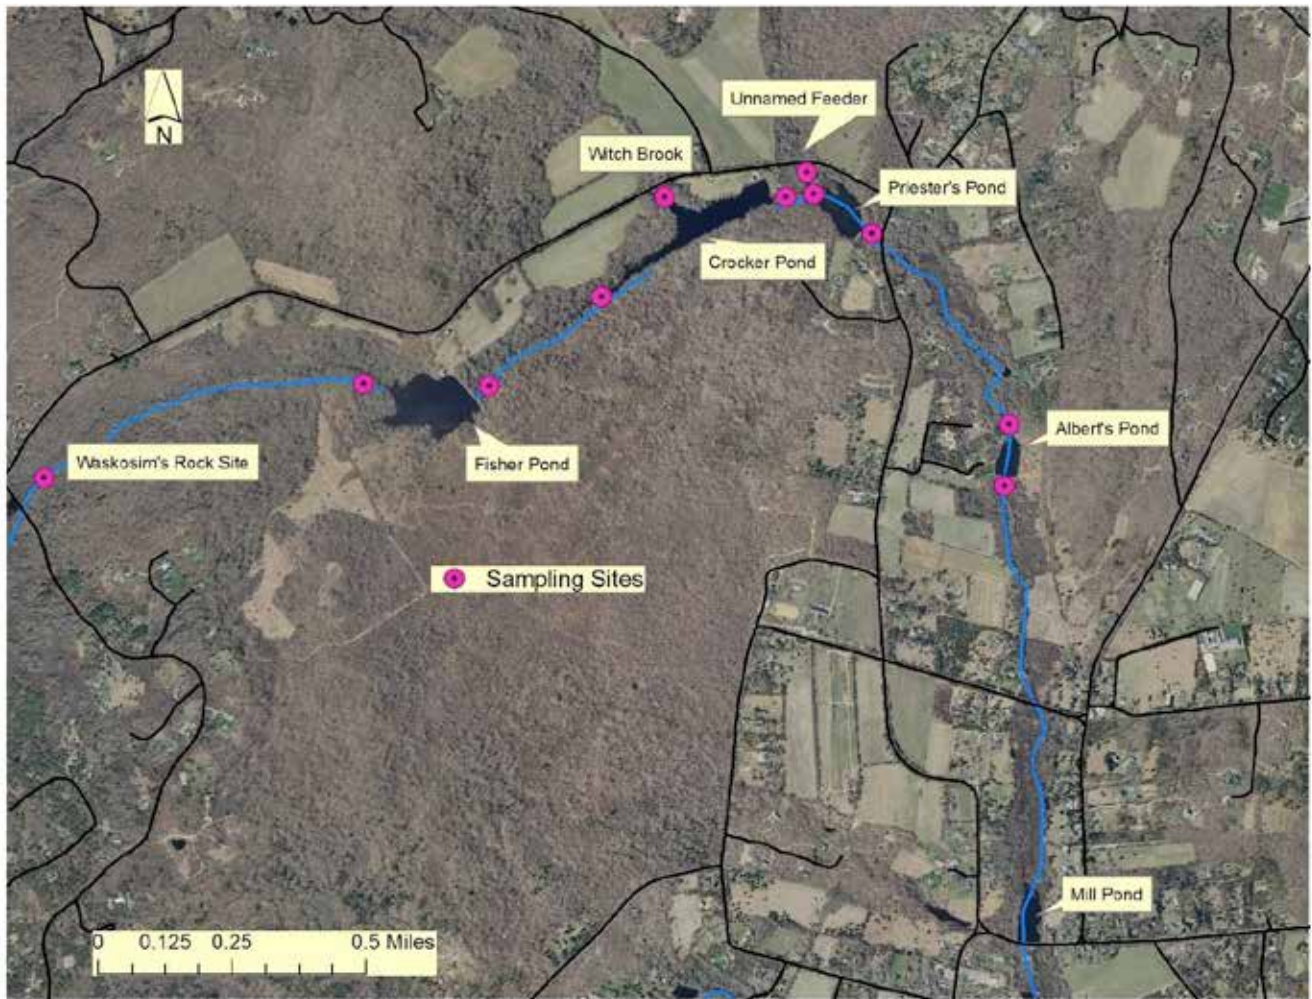
Fig. 25 BiodiversityWorks Sampling Sites

- 11 sampling sites (Fig. 25 next page):
  - Above and below four impoundments excluding the Mill Pond
  - Waskosim's Rock Reservation
  - Witch Brook after passing under North Road above Crocker Pond
  - Indian Hill Brook after passing under North Road above Priester Pond
- Field work was conducted in two parts: June 3 – 25, 2015; August 6 – 27, 2015
- Data collected at each site
  - Physical characteristics using the Stream Habitat Walk form from the EPA.
  - Basic water quality measures (pH, temperature, dissolved oxygen and conductivity) measured with a YSI 60 pH meter and a YSI 85 multimeter
  - Plant list
  - Sample of aquatic organisms

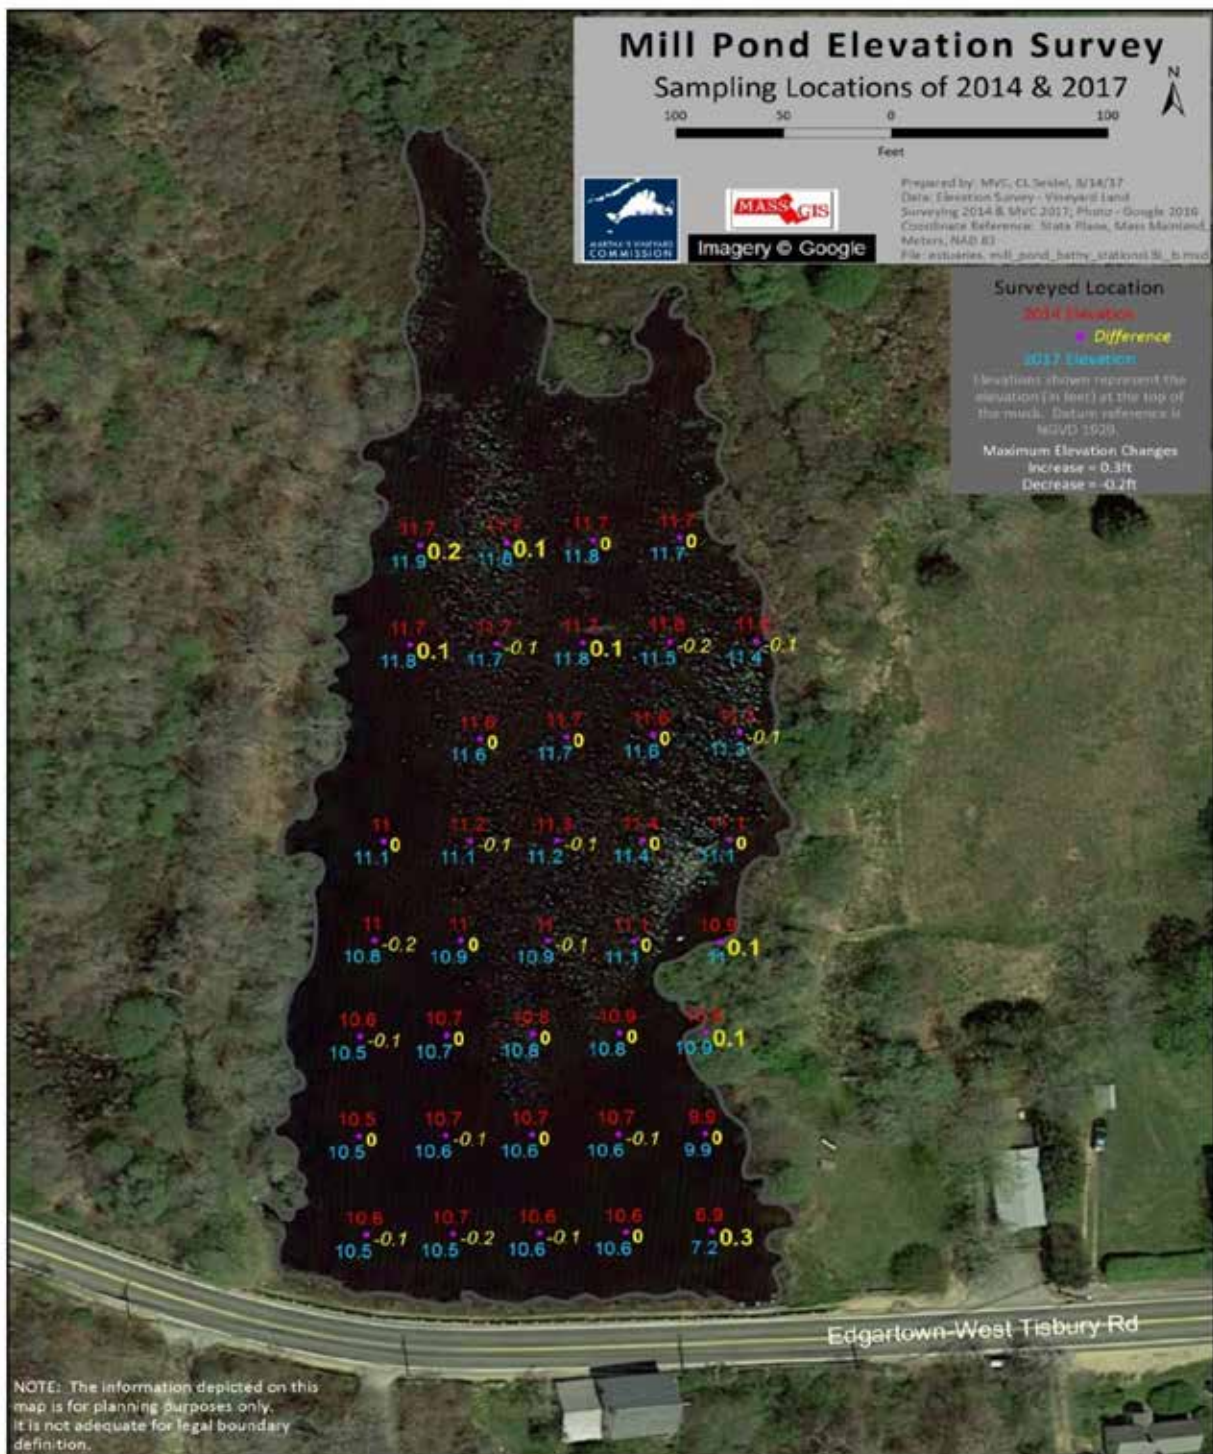
Fig. 28 Mill Pond Elevation Survey – Data source Kent Healy, Prepared by Seidel MVC

**Key Finding:** *As illustrated in Figure 28 bathymetry data gathered by Kent Healy and Bill Austin annually from April 2014 until May 2017 indicates no measurable change in water depths at Mill Pond.*
