# **Mill Brook Watershed Study Report** **and Recommendations**

**Town of West Tisbury**

**Mill Brook Watershed Management Planning Committee**

**2014-2018**

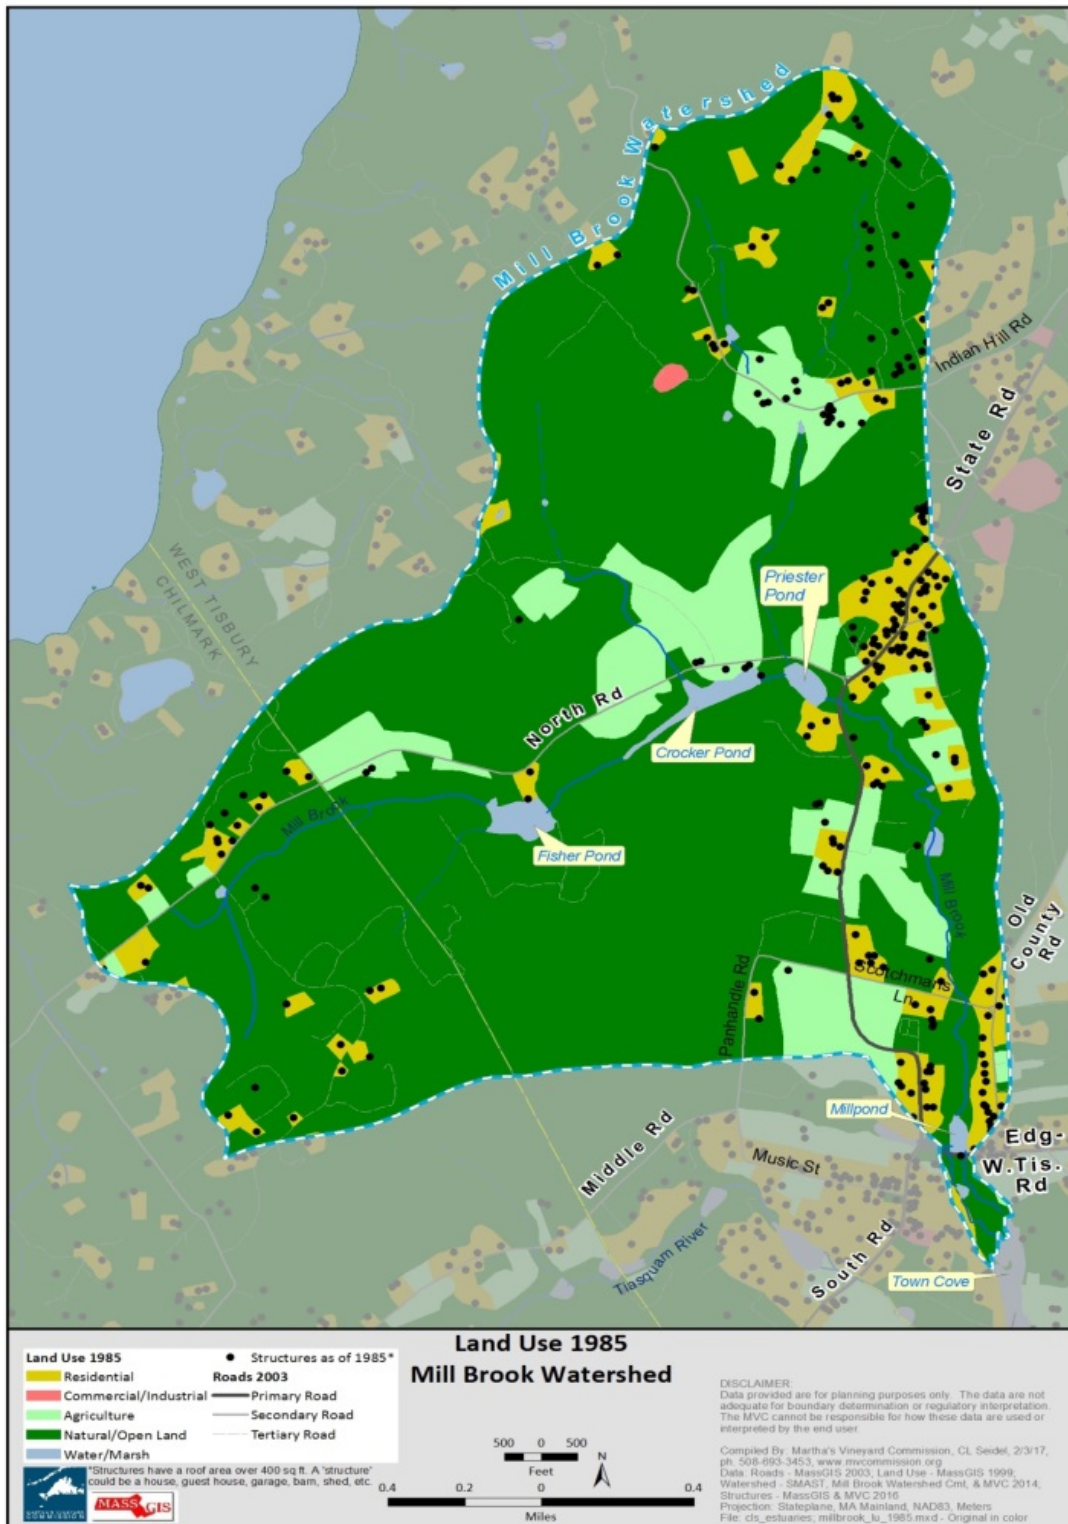
Fig. 29 Mill Brook Watershed Land Use 1985 - MVC

The **three charts** (fig. 29, 30, 31) demonstrate the development density within the watershed in 1985, 2005 and the projected impact if all buildable land in the watershed were developed.

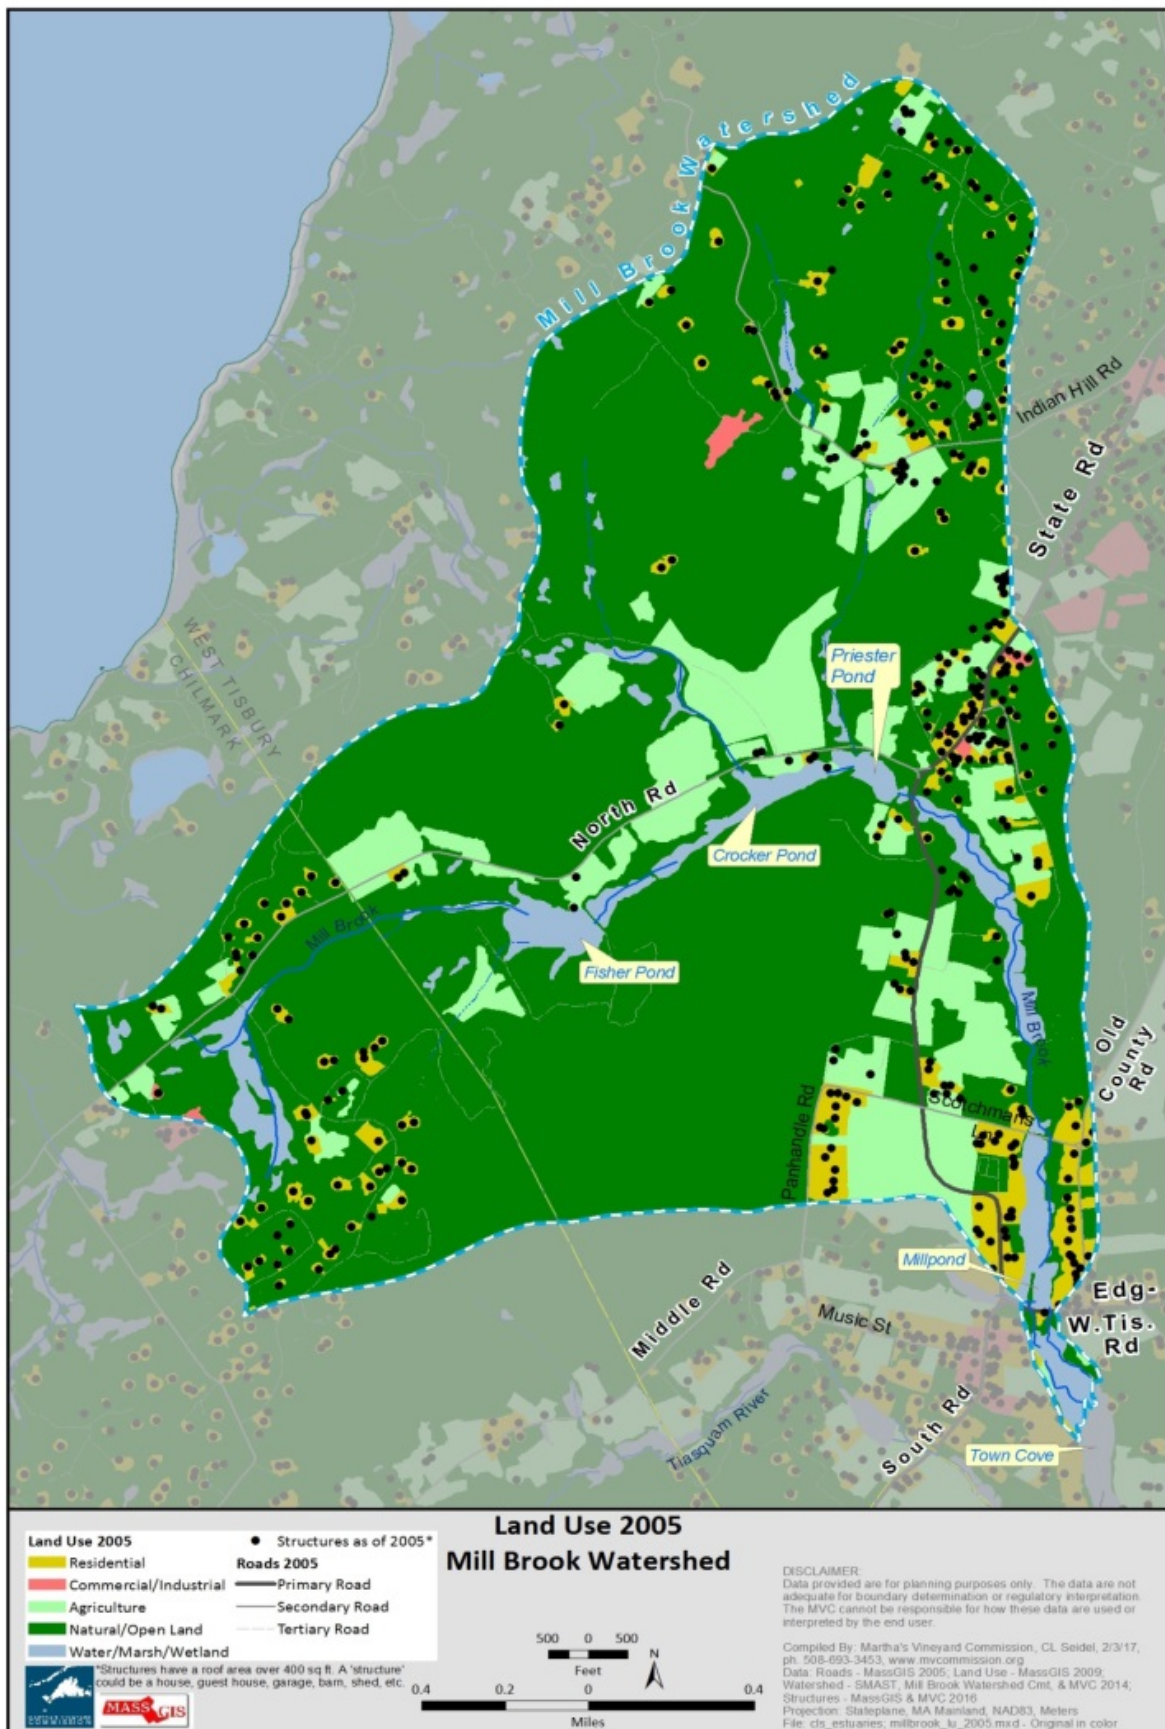
Fig. 30 Mill Brook Watershed Land Use 2005 - MVC

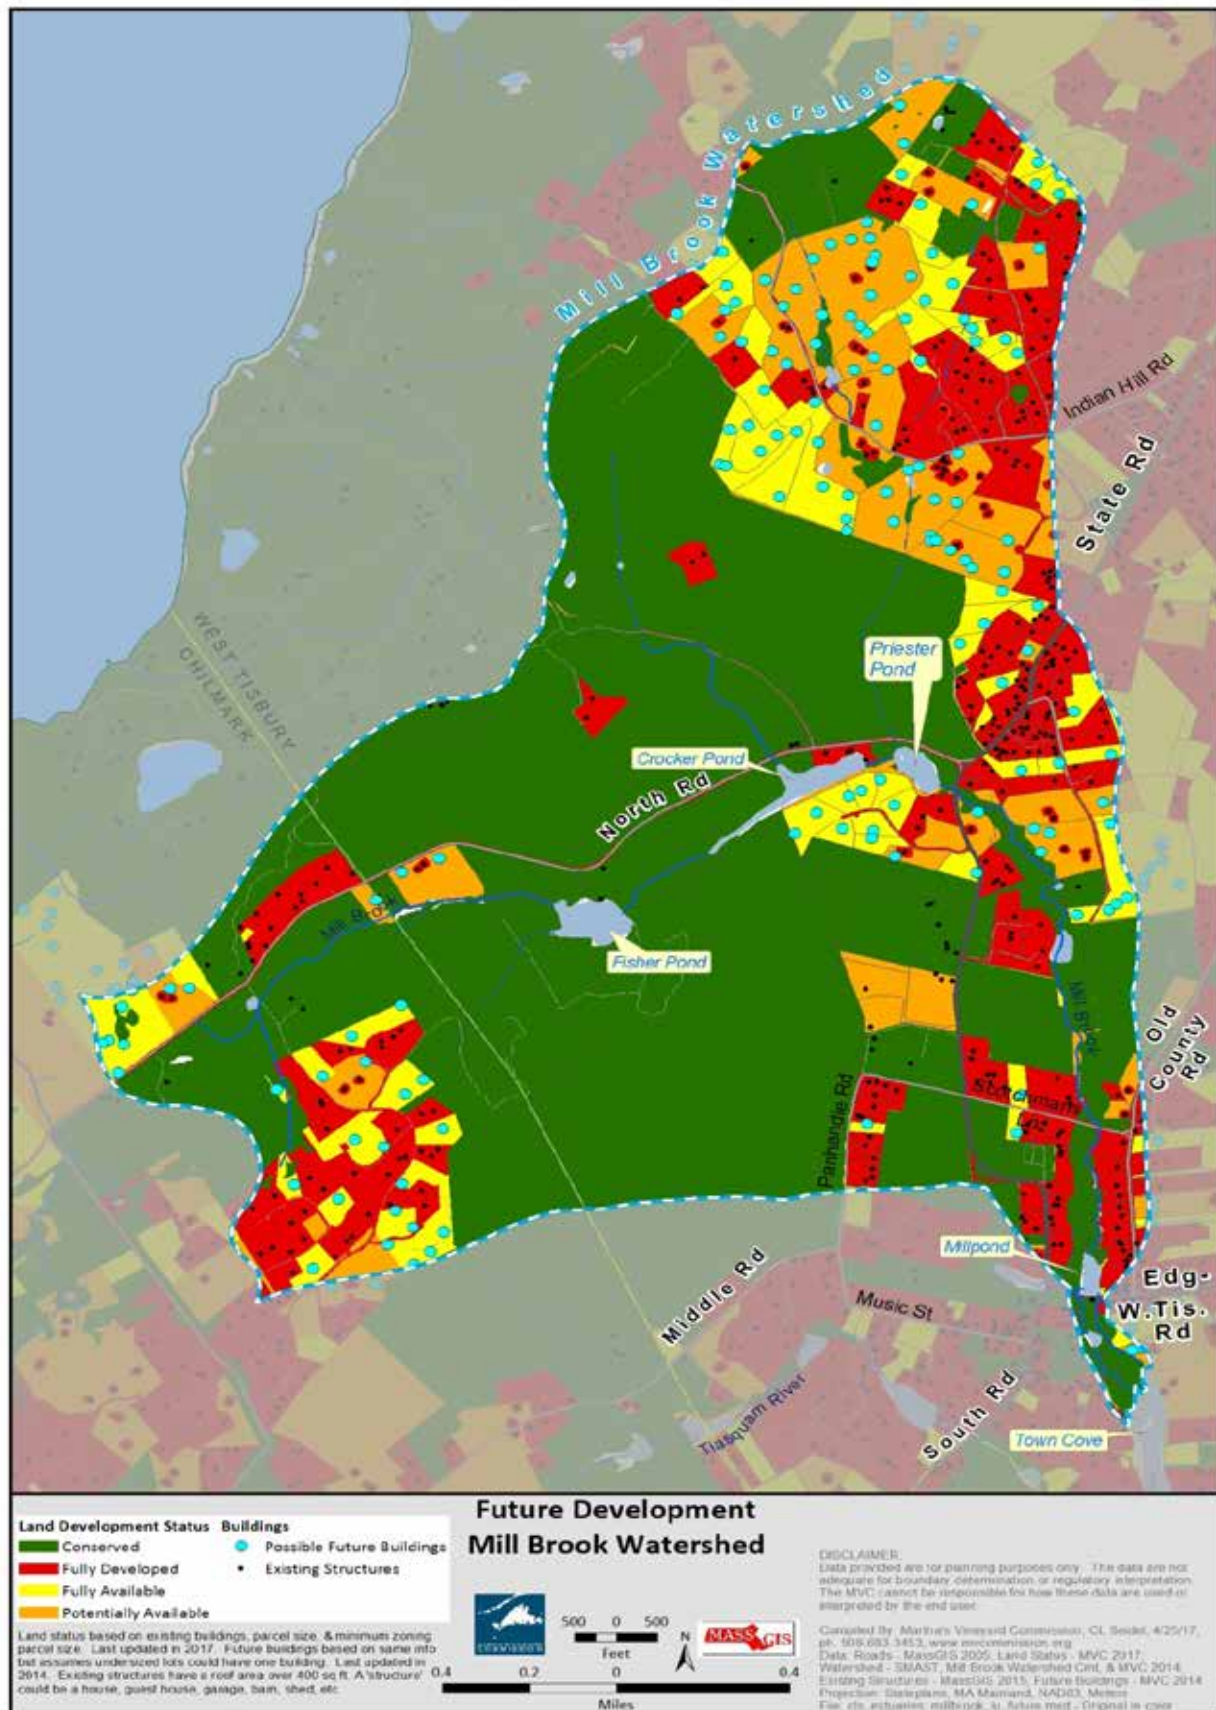
Fig. 31 Projected Mill Brook Watershed Development of all Buildable Land – MVC
