## **SURVEY REPORT**

### **MILL POND BASELINE ASSESSMENT AND MANAGEMENT PLAN – WEST TISBURY, MA**

**December 2006**

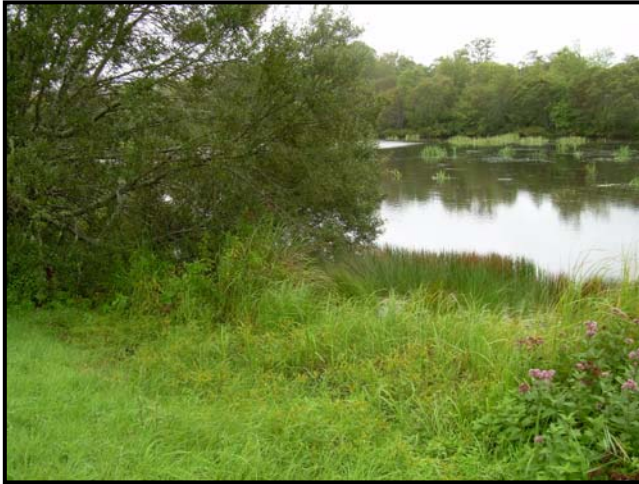
As a result of the extremely shallow water depths (<0.5 ft.) in the northern portion of the pond the density of the submersed growth was lower in that region than elsewhere, with

an average areal coverage estimated in the range of 40%-50%. Although the shallow water depths in this region of the pond limited submersed plant densities, they facilitated widespread colonization by wetland/emergent growth, dominated by bur-reed and water willow.

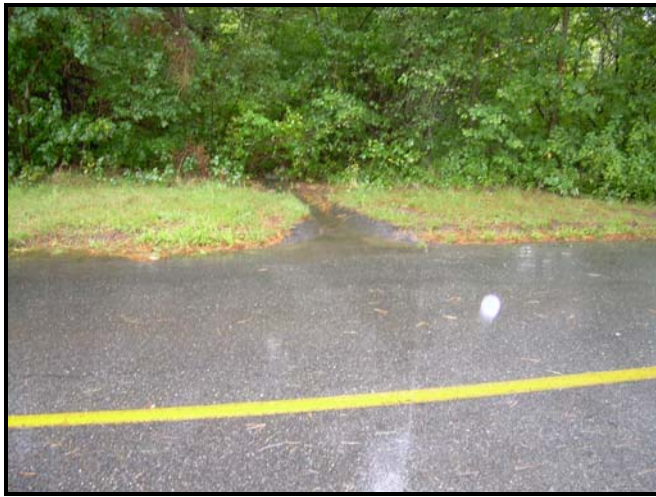
It does appear that Mill Brook receives direct stormwater run-off from Panhandle Road. At the time of the survey transport of small particulate matter and other debris was

evident where stormwater run-off from Panhandle Road is channeled directly into Mill Brook. The introduction of these and possible other pollutants (i.e. petroleum based substances) may have a contributing effect on the nutrient loading and sedimentation of the pond.

Prior to the implementation of any focused watershed management techniques, we recommend performing a more detailed investigation, inclusive of field confirmation of the watershed

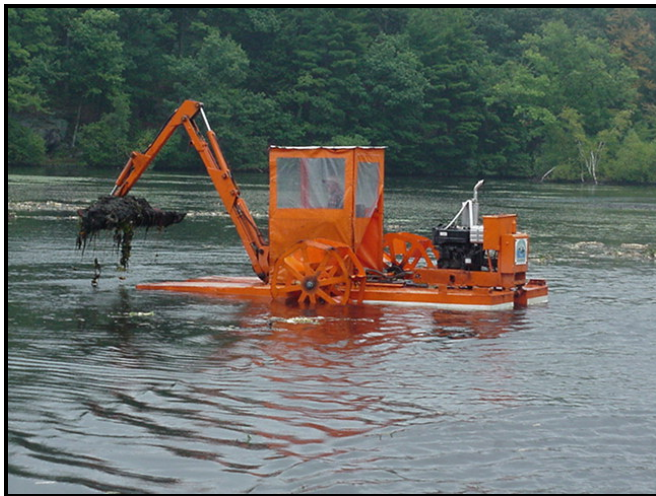
**Mechanical Hydro-Raking** - The mechanical Hydro-Rake can best be described as a "floating backhoe" with a York Rake attachment. The barge is paddle wheel driven to

facilitate operation in shallow water (<2 feet) and it can effectively work to depths of about 10-12 feet. The Hydro-Rake is most effective at removing plants with well defined root systems, such as emergent species. It works from the water, thereby avoiding damage to sensitive shoreline habitat and property. This machine "rakes" the upper sediment layer collecting plants and their attached root systems.

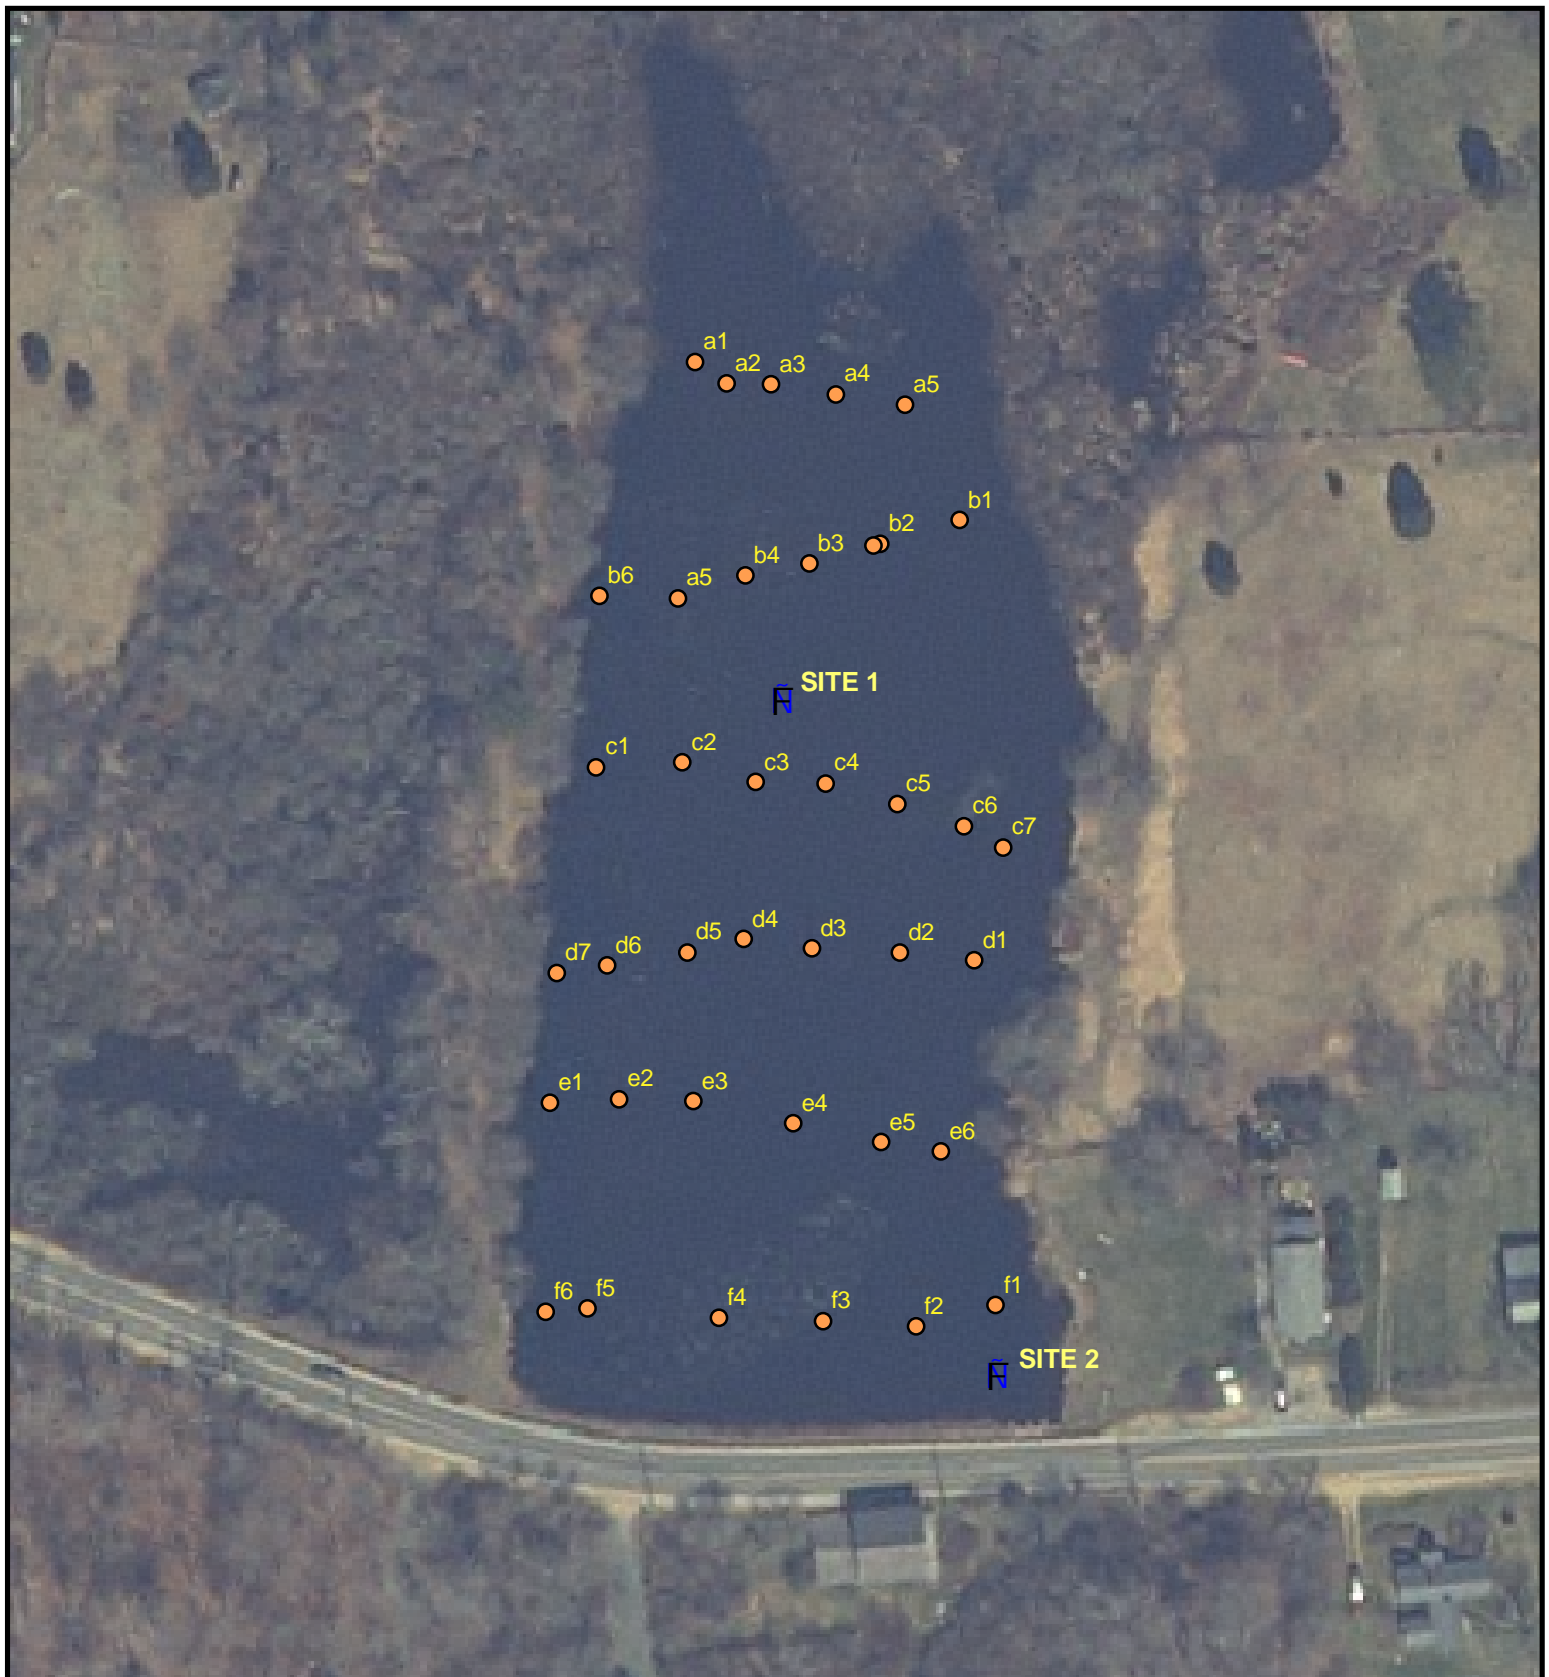
Data Point and Sample  
Collection Site Map

Two water sampling stations were established, one located at the inlet end of the pond and the other was located directly adjacent to the pond's primary outlet structure (see Figure 2). A single surface grab (1.0 –2.0 ft. below the surface) sample was collected from each sample site on the day of the field data collection (9/15/06). The water

A single round of two surface grab water samples were collected during the field survey. One sample was taken from the inlet end of the pond (Site 1) and the other from the outlet end (Site 2). The samples were analyzed by a certified independent laboratory for a suite of common baseline water quality parameters.
