RE: 101 Capawock Rd. (Pcl. 1-15), West Tisbury, MA

At your request, we visited the above-referenced property to re-flag an approximately 1,400 sq.ft. isolated depression, which was previously flagged in July of 2015. Those flags were surveyed and are portrayed on your Site Plan dated December 1, 2021. During our recent visit we observed the vegetative community, the local hydrology, and the soil conditions within this area.

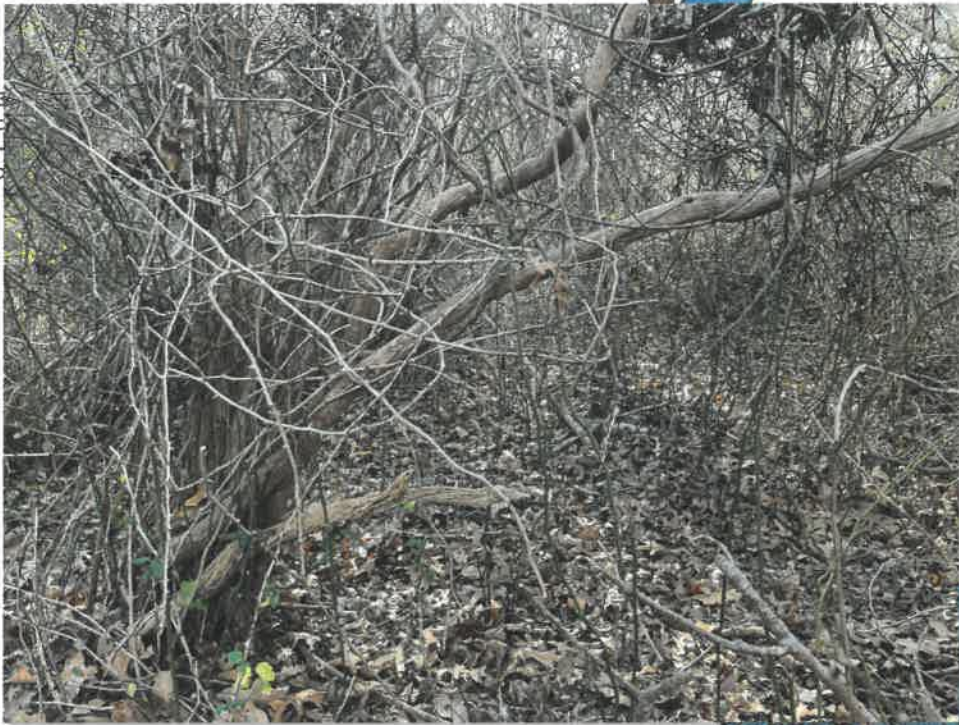
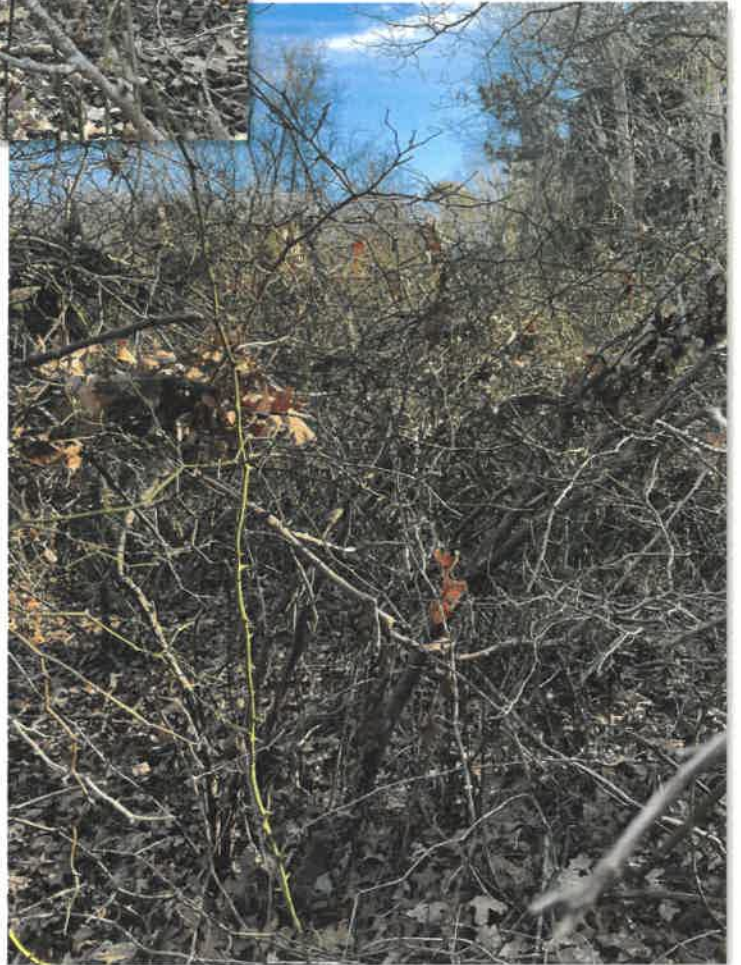
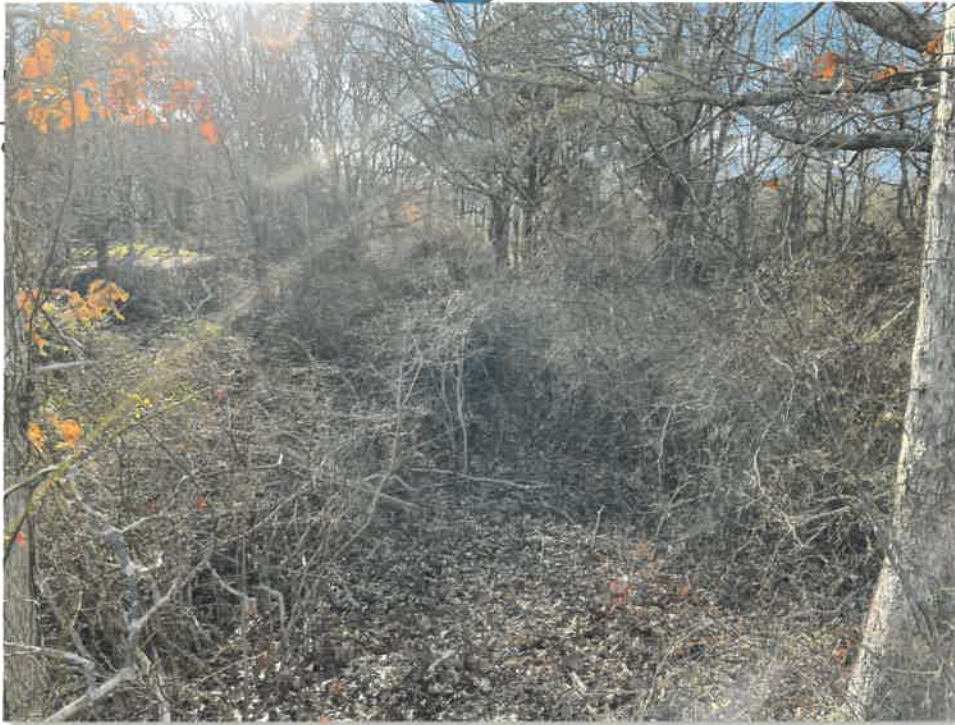
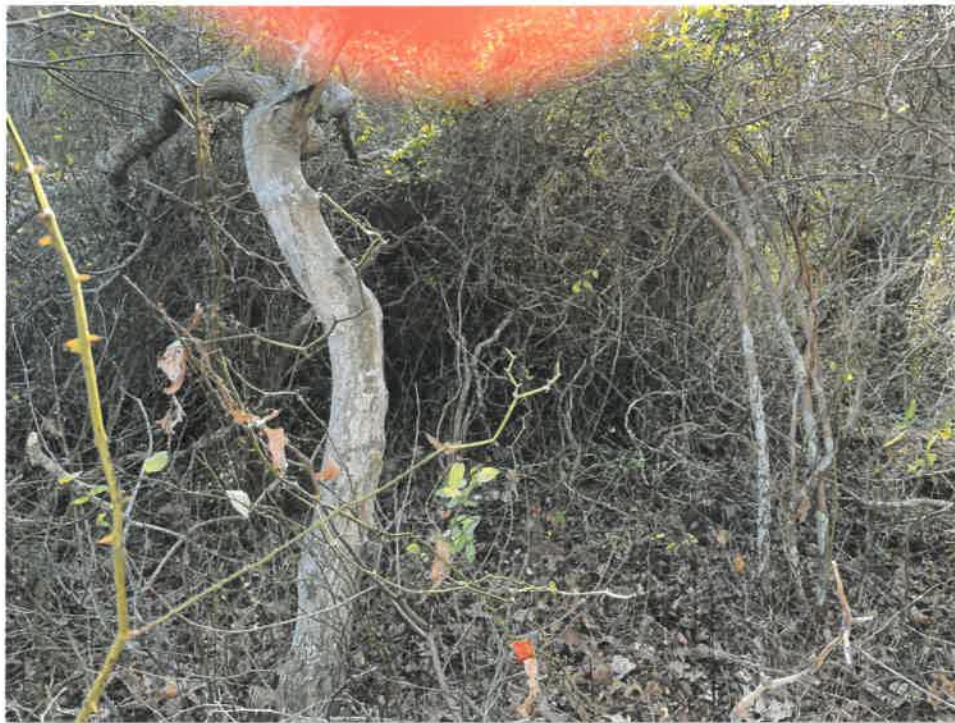
The subject area is topographic depression located on the Martha's Vineyard moraine deposit, typical of the north shore of Martha's Vineyard. It is a dense, thorny thicket of vines intertwined among primarily highbush blueberry shrubs (see attached photos). Species observed both within the depression and along the perimeter include several plants categorized as "invasive" by the Massachusetts Invasive Plant Advisory Group. These include: greenbriar (*Smilax rotundifolia*), Japanese honeysuckle (*Lonicera japonica*) and Asian bittersweet (*Celastrus orbiculatus*). Other species observed include: highbush blueberry (*Vaccinium corymbosum*), winged sumac (*Rhus copallinum*), raspberry, black cherry (*Prunus serotina*), white oak (*Quercus alba*), post oak (*Quercus stelatta*) and pin oak (*Quercus palustris*).

The depression has a small, local contributing drainage area, restricted to the property, and estimated to be less than 3 acres in area. The drainage area is mostly wooded, with a mowed meadow, a pervious driveway, and a small residential lawn. No ponding of water or evidence of recent ponding, including water-stained leaves or drift lines, were observed. The soil test holes in the lowest point in the depression showed soils that were marginally hydric in nature, but without thick organic accumulation or other diagnostic features that would indicate frequent ponding or long-term saturation at or above the soil surface.

nonetheless is an interesting landscape feature that provides some habitat for local wildlife. The activities proposed on the Site Plan do not appear to pose an adverse impact on this depression.
