## PEER REVIEW

**TO:** Town of West Tisbury Conservation Commission  
**FROM:** Stan Humphries @ ECR *SMH*  
**DATE:** August 7, 2023  
**LOCUS:** 245, 257 and 271 John Cottle Rd., West Tisbury

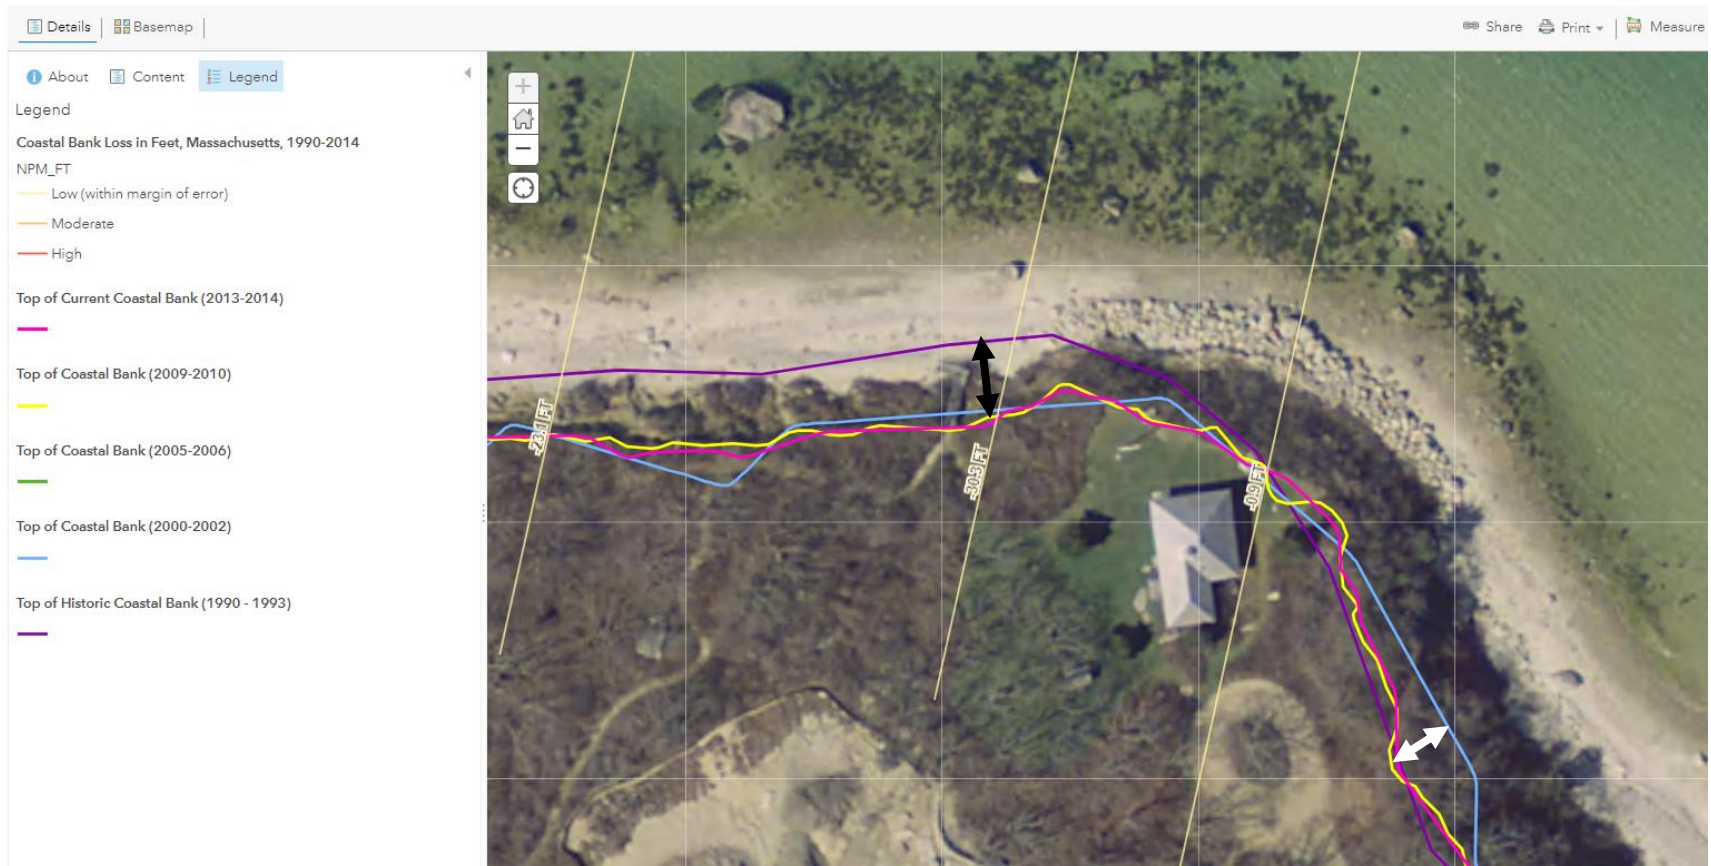
**Figure 1.** The most critical section of coastal bank erosion and retreat (↔) is located north and west of the cottage, landward of the historic position of the top of bank. The less critical section is located east and south of the cottage, seaward of the historic position of the top of bank, as shown by the white arrow.

The glacial deposit on the site clearly characterizes a Coastal Bank as defined in the state wetland regulations and as MCZM has mapped the top of this bank for the site (Figure 1). As shown on the figure, a distinction between the critical nature of the erosion can be made on the west side of the cottage versus the east side. This observation is one factor used in recommending downsizing of the project, as discussed below. As confirmed during the ECR site evaluation, a coastal dune exists where the construction begins approximately 700 feet east of the revetment.

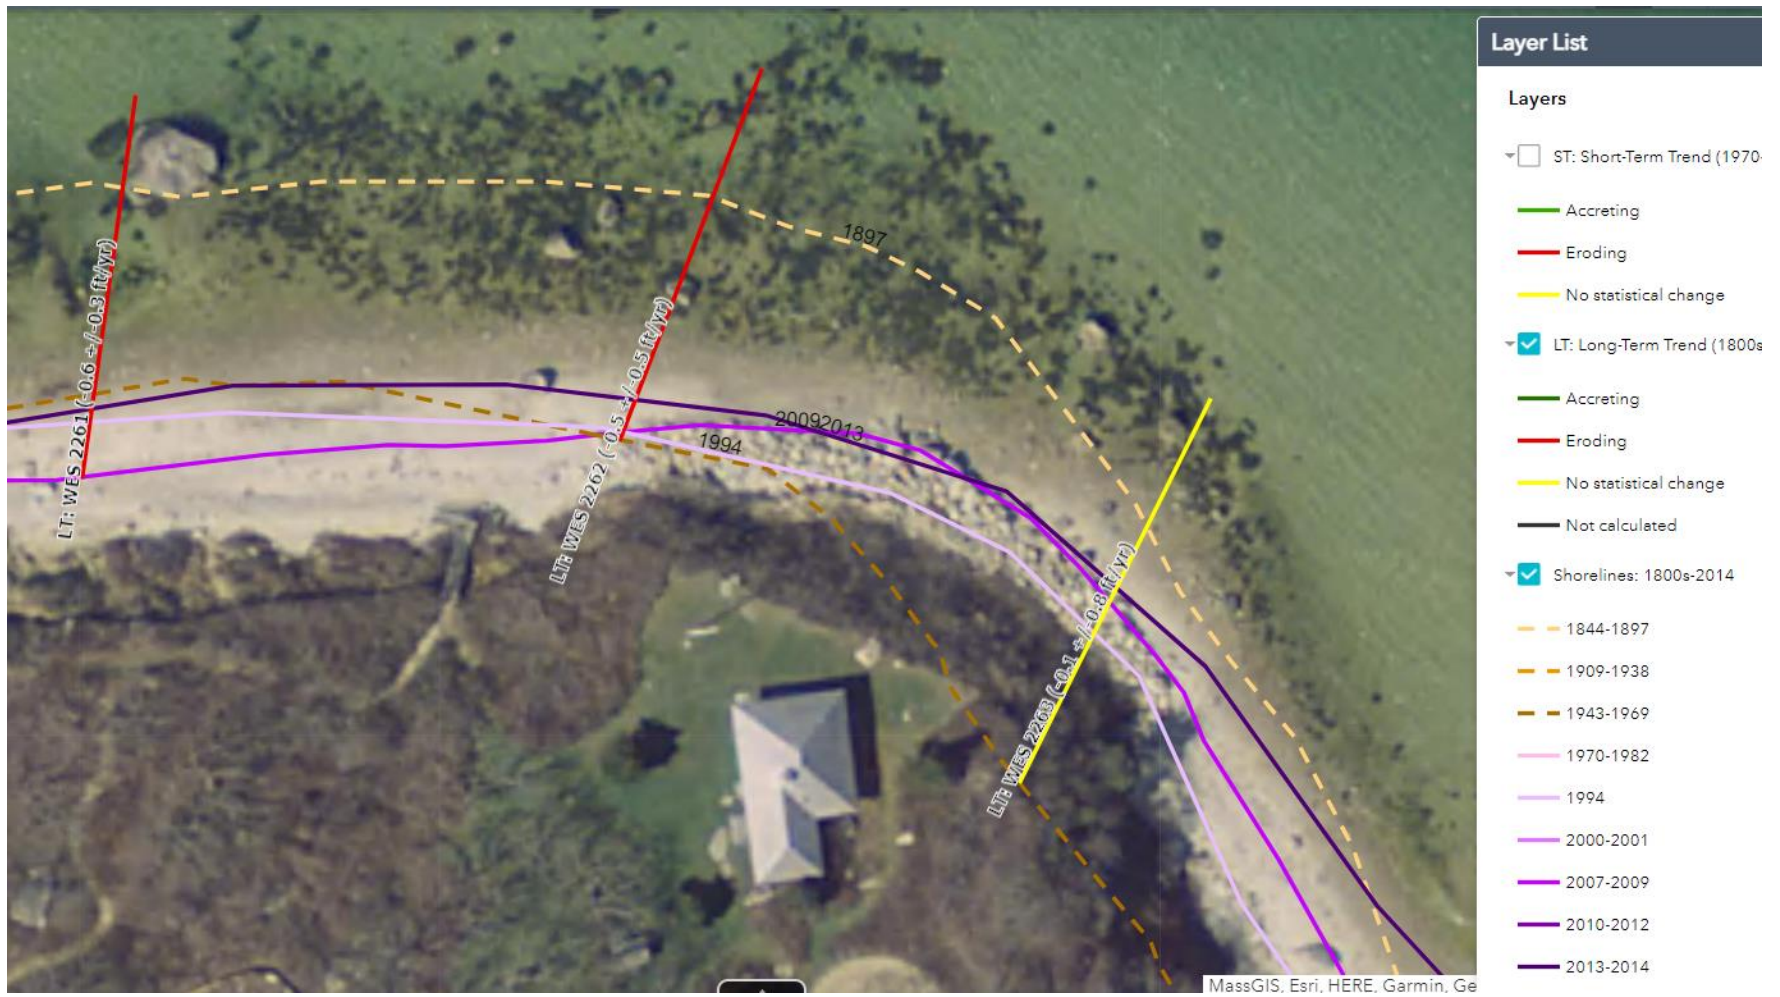
**Figure 2.** Updated shoreline change mapping by MCZM.

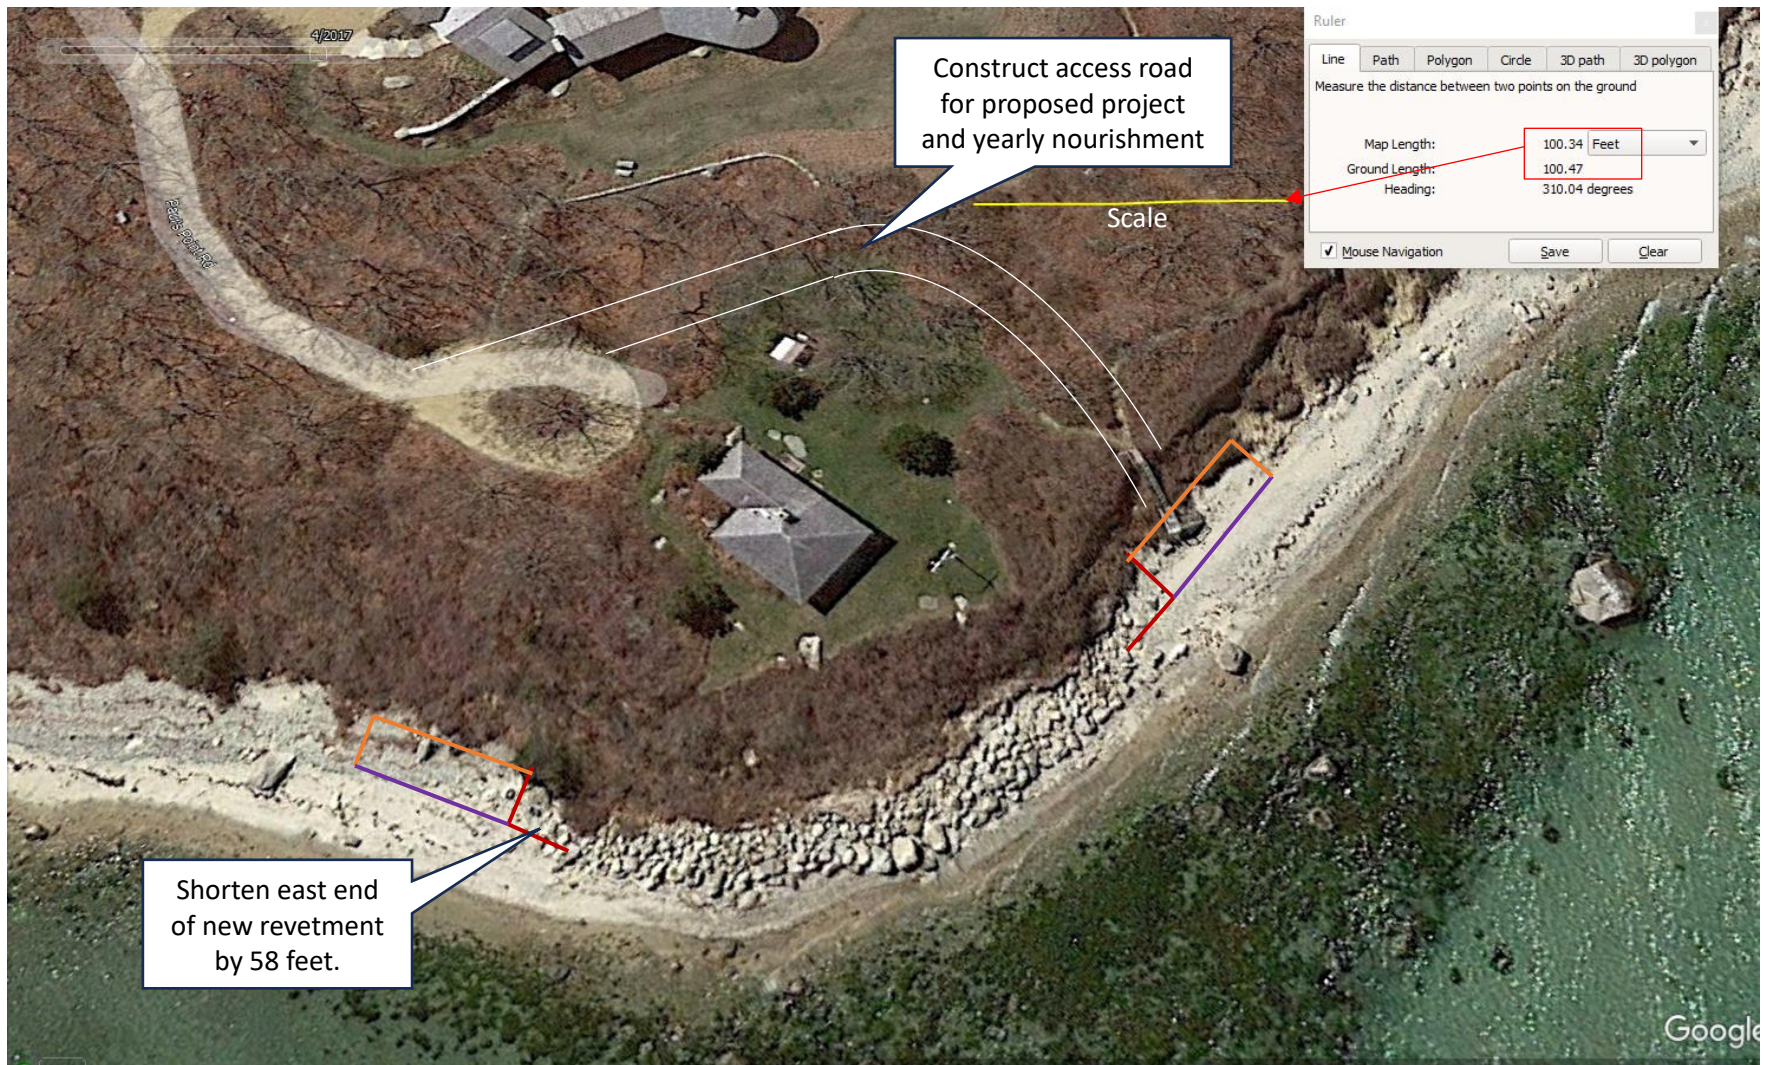
**Figure 3. Recommended Alternative Analysis 6** to minimize project impacts. The different colors correspond to those used on the Sourati Plan for the different measures being proposed.

The Applicant has evaluated five (5) alternatives which address (b) of this section, but it is (a) of this section that requires more attention so as to minimize adverse effects. We recommend that a sixth alternative be evaluated as summarized in Figure 3 which would maintain the length and location of the protective measures on the west side, shorten and shift the measures westward on the east side, include tapering of the ends, and consider relocating the construction access within much closer proximity to the project. The current access proposal will have an adverse effect on the coastal dune and beach, initially, and presumed to have negative impacts in the future if it is used for annual nourishment.

The approximate 16' buffer from cottage to the top of the bank is likely close enough to be considered imminent danger and the proposed revetment reconstruction with other gabion/coir measures, to a large degree, may be permissible. However, in consideration of the difference in eroded conditions of the bank, the length of the revetment, and the proposed short- and long-term impacts to the coastal dune from construction access, there is another alternative (6) which would minimize adverse effects of this shoreline protection project.
