RE: 76 Christiantown Rd. (Pcl. 12-33) West Tisbury, MA

At your request, we visited the above-referenced property on December 17, 2021 to examine a $\pm 1,800$ sq.ft. isolated depression, which was previously flagged on November 11, 2021. Those flags were surveyed and are portrayed on your Site Plan dated December 15, 2021. During our recent visit we observed the vegetative community, the local hydrology, and the soil conditions within this depression.

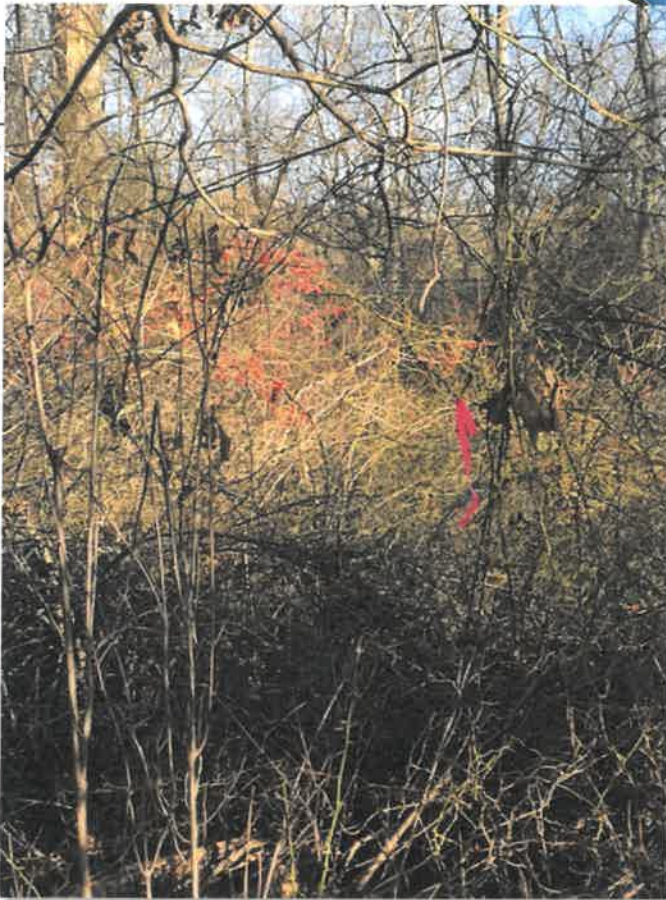
The subject area is an isolated topographic depression located on the Martha's Vineyard moraine deposit, typical of the north shore of the island. It is a dense, thorny thicket of vines intertwined with shrubs (see attached photos). Species observed both within the depression and along the perimeter include: greenbriar (*Smilax rotundifolia*), wild grape (*Vitis labrusca*), arrowwood viburnum (*Viburnum dentatum*), winterberry (*Ilex verticillata*), red maple (*Acer rubrum*), American beech (*Fagus grandifolia*), and mixed oak species (*Quercus* sp.).

Isolated depression facing north

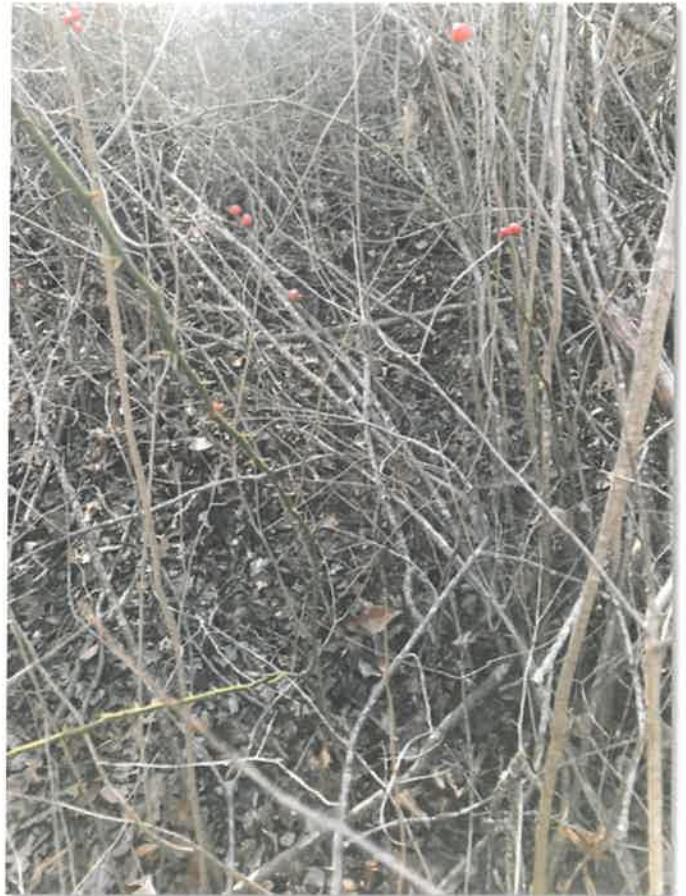
This isolated depression has no inlet or outlet, and a small, mostly wooded, local contributing drainage area estimated at <0.5 acres. While the depression was not ponded on the date of our visit, we observed stained leaves in the lowest portion of the depression, which indicates periodic saturation at, or slightly above, the surface. This ponding appears to be less than 6" in depth and occupies an area of approximately 400 sq. ft. The soil test holes in the lowest point in the depression showed soils that were hydric in nature, with a 6" dark organic O-horizon and a Bg-horizon that was gleyed and strongly mottled.

Water-stained leaves at lowest elevation of depression

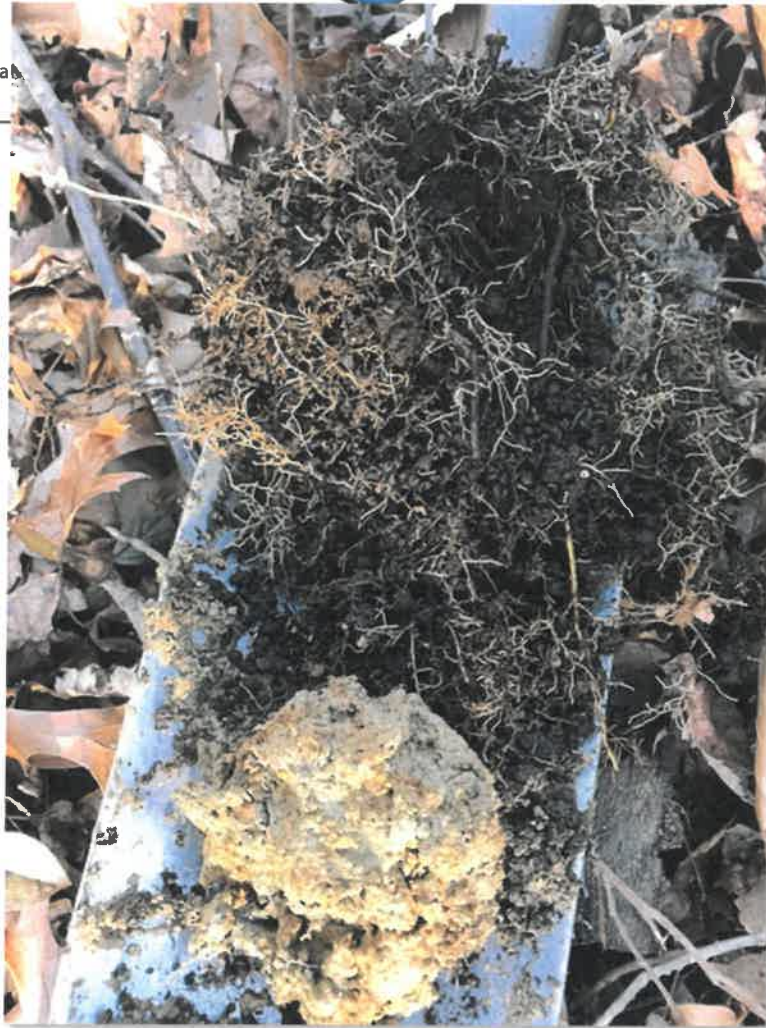
Soil Sample O and Bg horizons
