*Conservation Commission Site Plan
 in
 West Tisbury, Massachusetts
 Assessor Parcels 1-56 & 3-19
 prepared for
Makonikey Roads & Beach Trust
 Scale 1"=20' January 17, 2022
 Revision Date February 16, 2022*

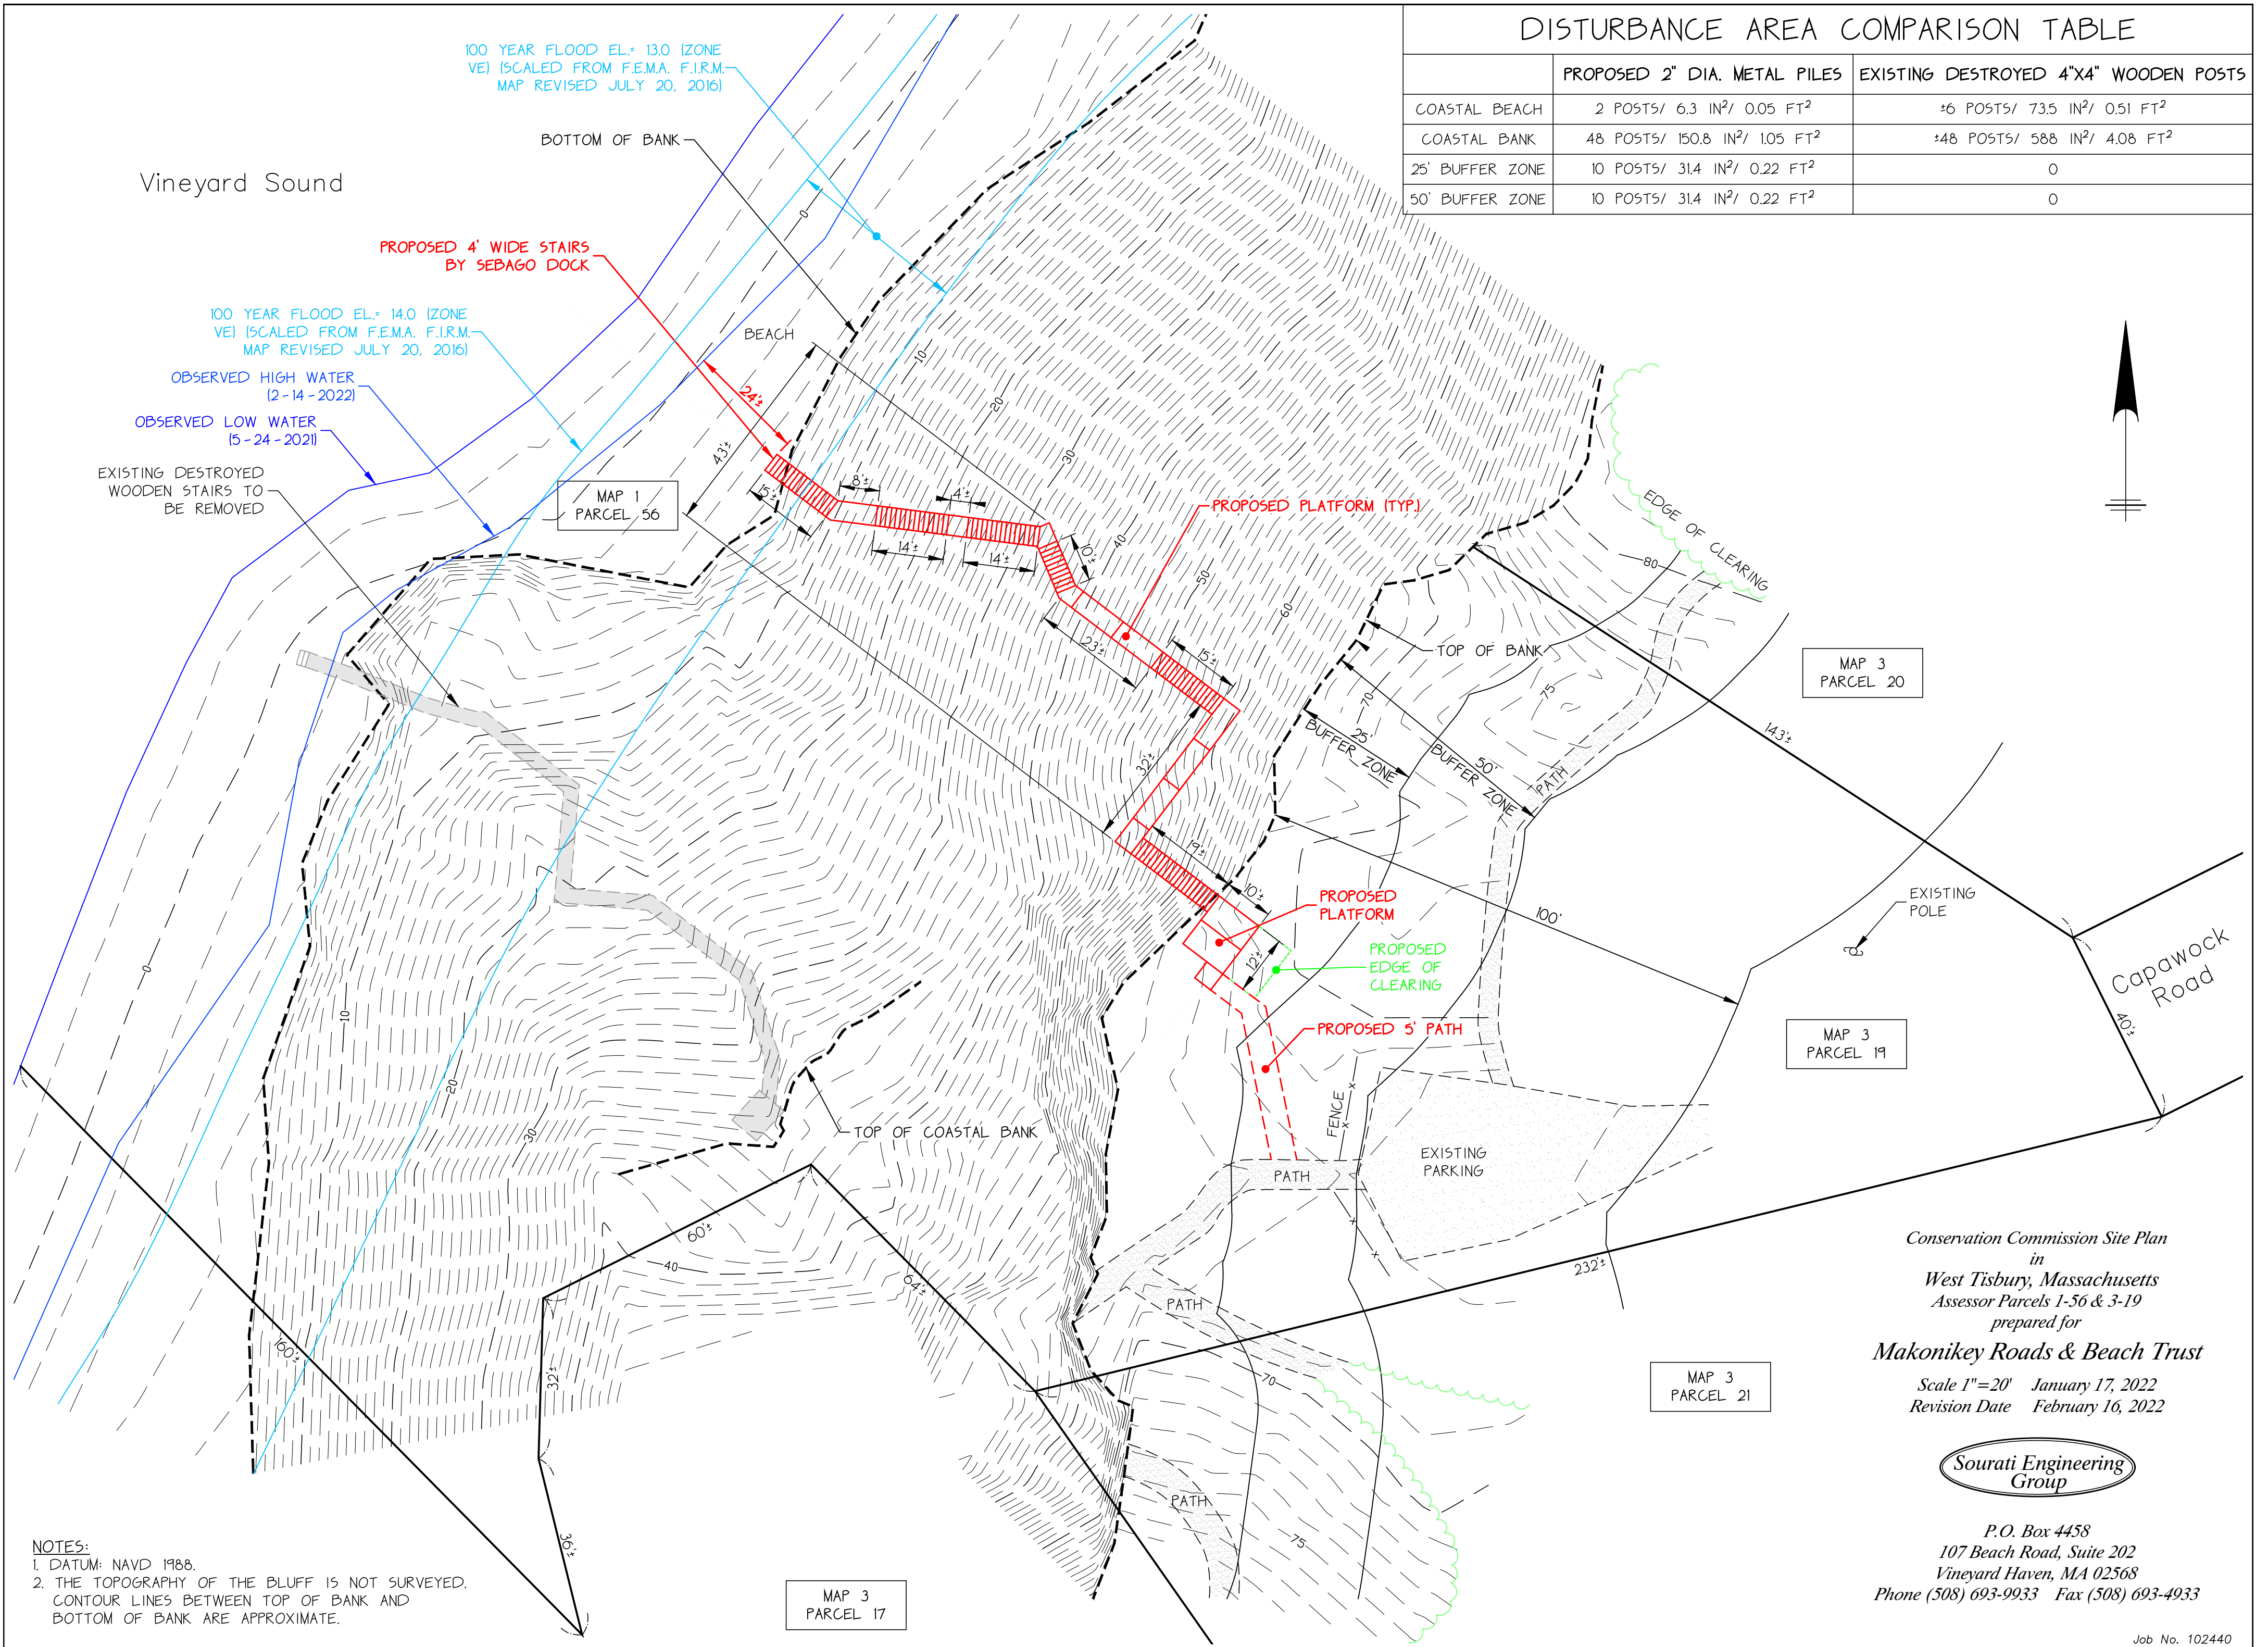
PROPOSED 2" DIA. METAL PILES	EXISTING DESTROYED 4"x4" WOODEN POSTS
COASTAL BEACH	2 POSTS/ 6.3 IN ² / 0.05 FT ²	±6 POSTS/ 73.5 IN ² / 0.51 FT ²
COASTAL BANK	48 POSTS/ 150.8 IN ² / 1.05 FT ²	±48 POSTS/ 588 IN ² / 4.08 FT ²
25' BUFFER ZONE	10 POSTS/ 31.4 IN ² / 0.22 FT ²	0
50' BUFFER ZONE	10 POSTS/ 31.4 IN ² / 0.22 FT ²	0

NOTES:
 1. DATUM: NAVD 1988.
 2. THE TOPOGRAPHY OF THE BLUFF IS NOT SURVEYED. CONTOUR LINES BETWEEN TOP OF BANK AND BOTTOM OF BANK ARE APPROXIMATE.
