SIMON SINGEL
Industrial Designer
50 Pepperbush Way West Tisbury, 02575

Date:
08-11-2021

Title:
Framing Equipment storage

Ross Singel Residence
50 Pepperbush Way
West Tisbury,
MA 02575

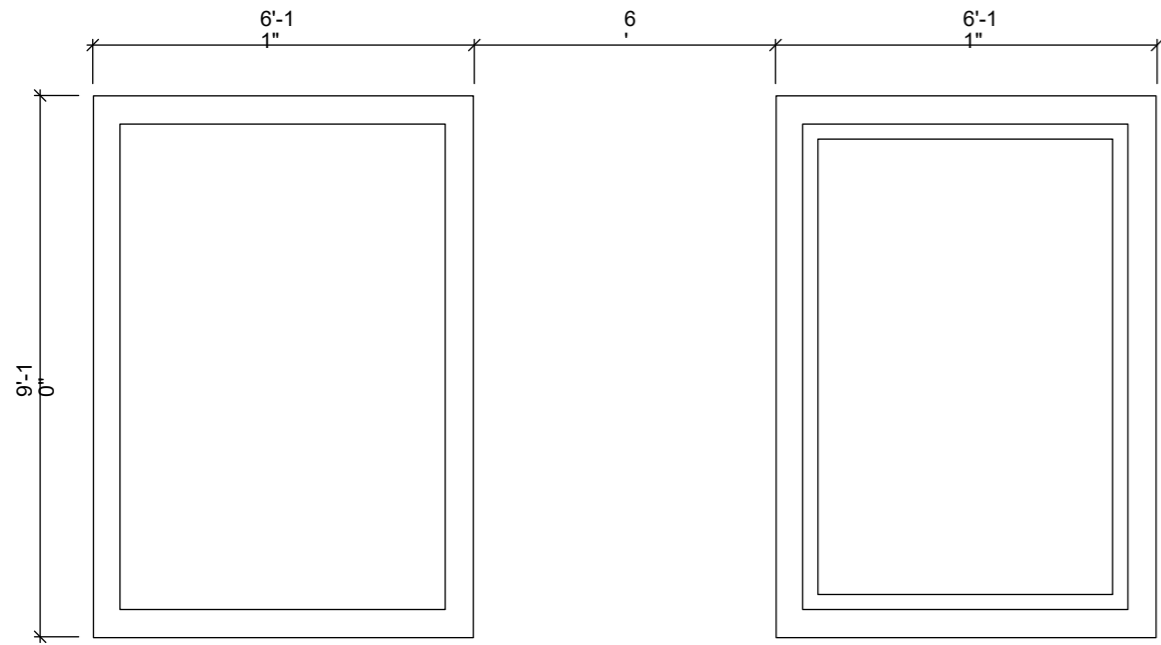
A Foundation (top view)

A1 5" high concrete wall raiser will allow .75" decking material to rest on top.

3" 1/2 thick foundation wall raiser.

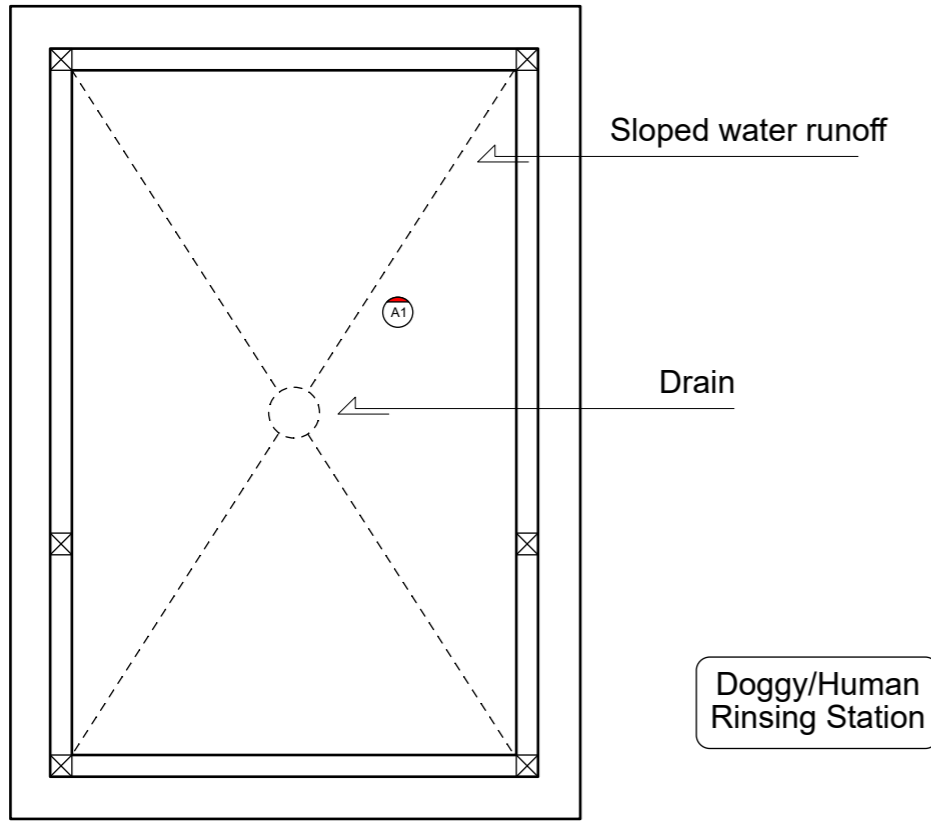
A Foundation rinsing station(top view)

- A1** Concrete pad pitched to help water runoff towards center or back (tbd)
- A2** water drains outside the back of the structure towards the lawn slope
- A3** 5.5" depth to allow 2x6 pt lumber install.
2x6 lumber will hold decking material in place
- A4** 4x4 Cedar post are poured in concrete.

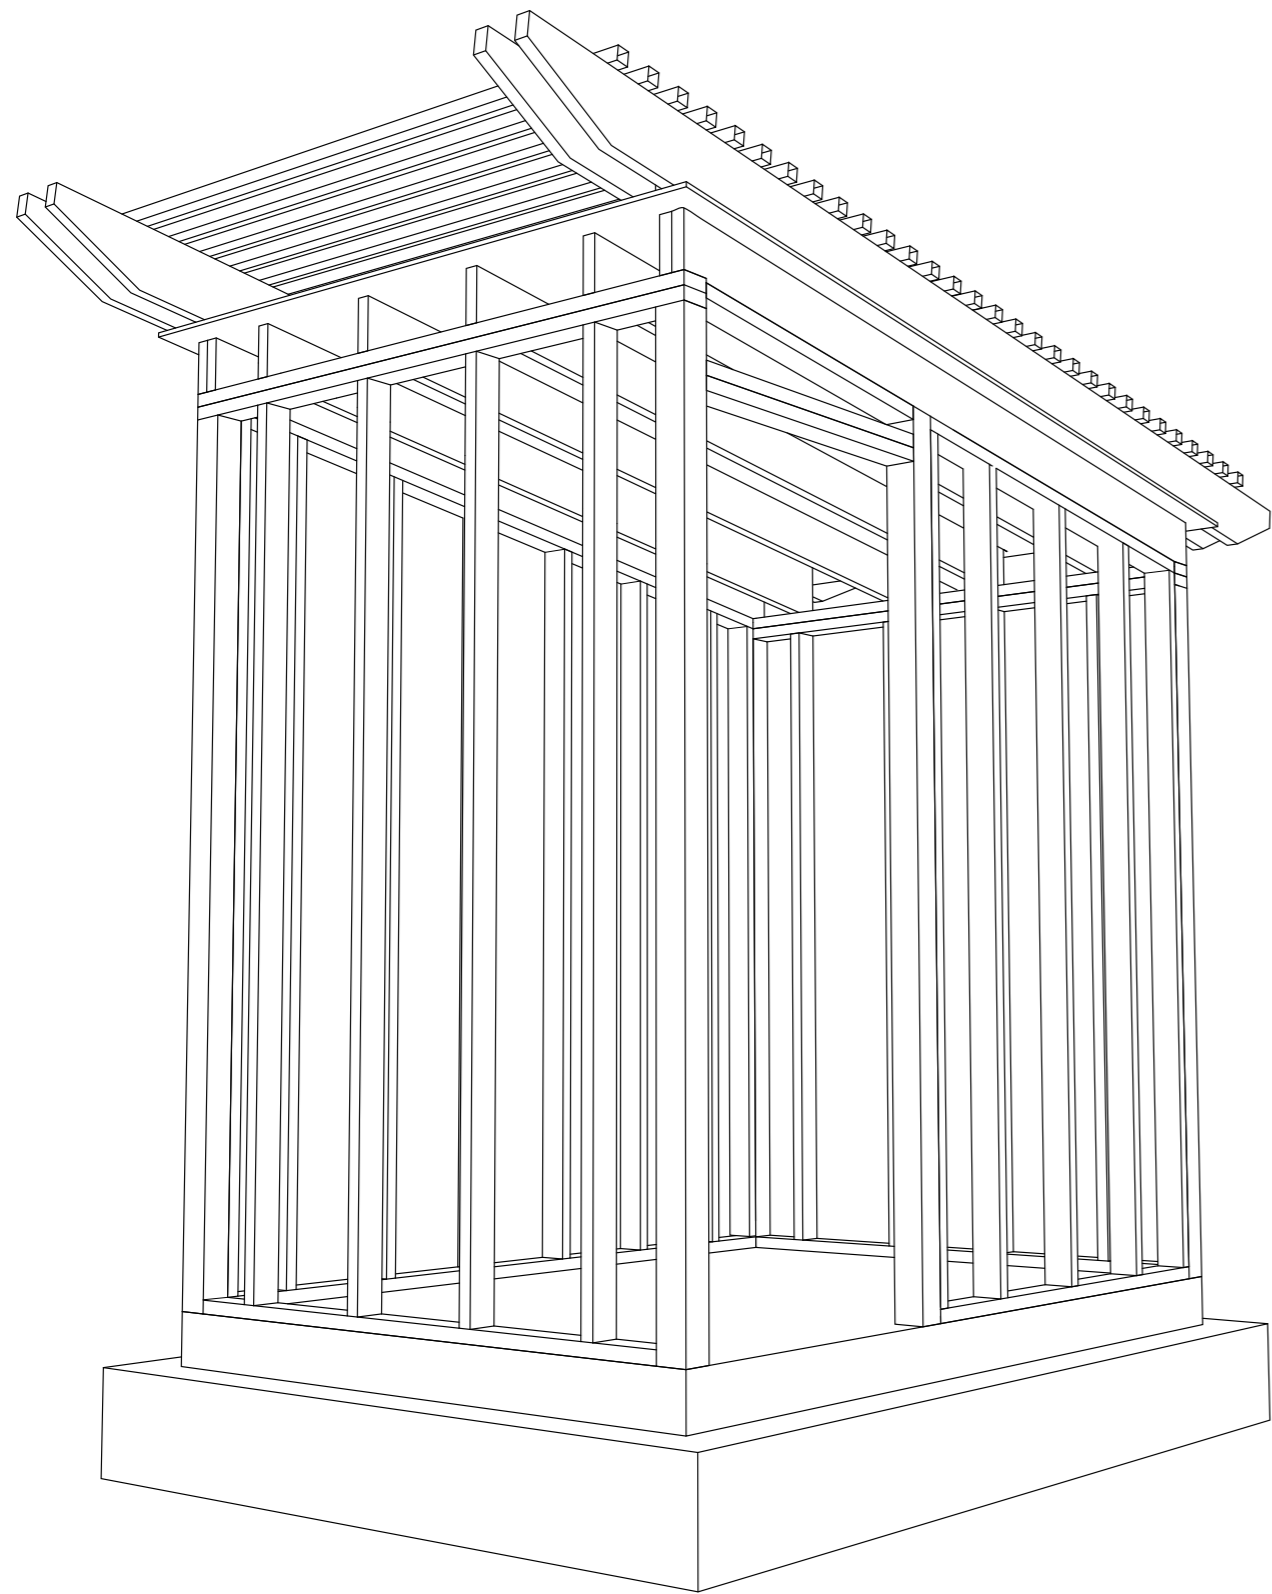
A Framing enclosure for equipment shed

decorative roof element

2x6 rafter roof

2x4 traditional framing

concrete pad

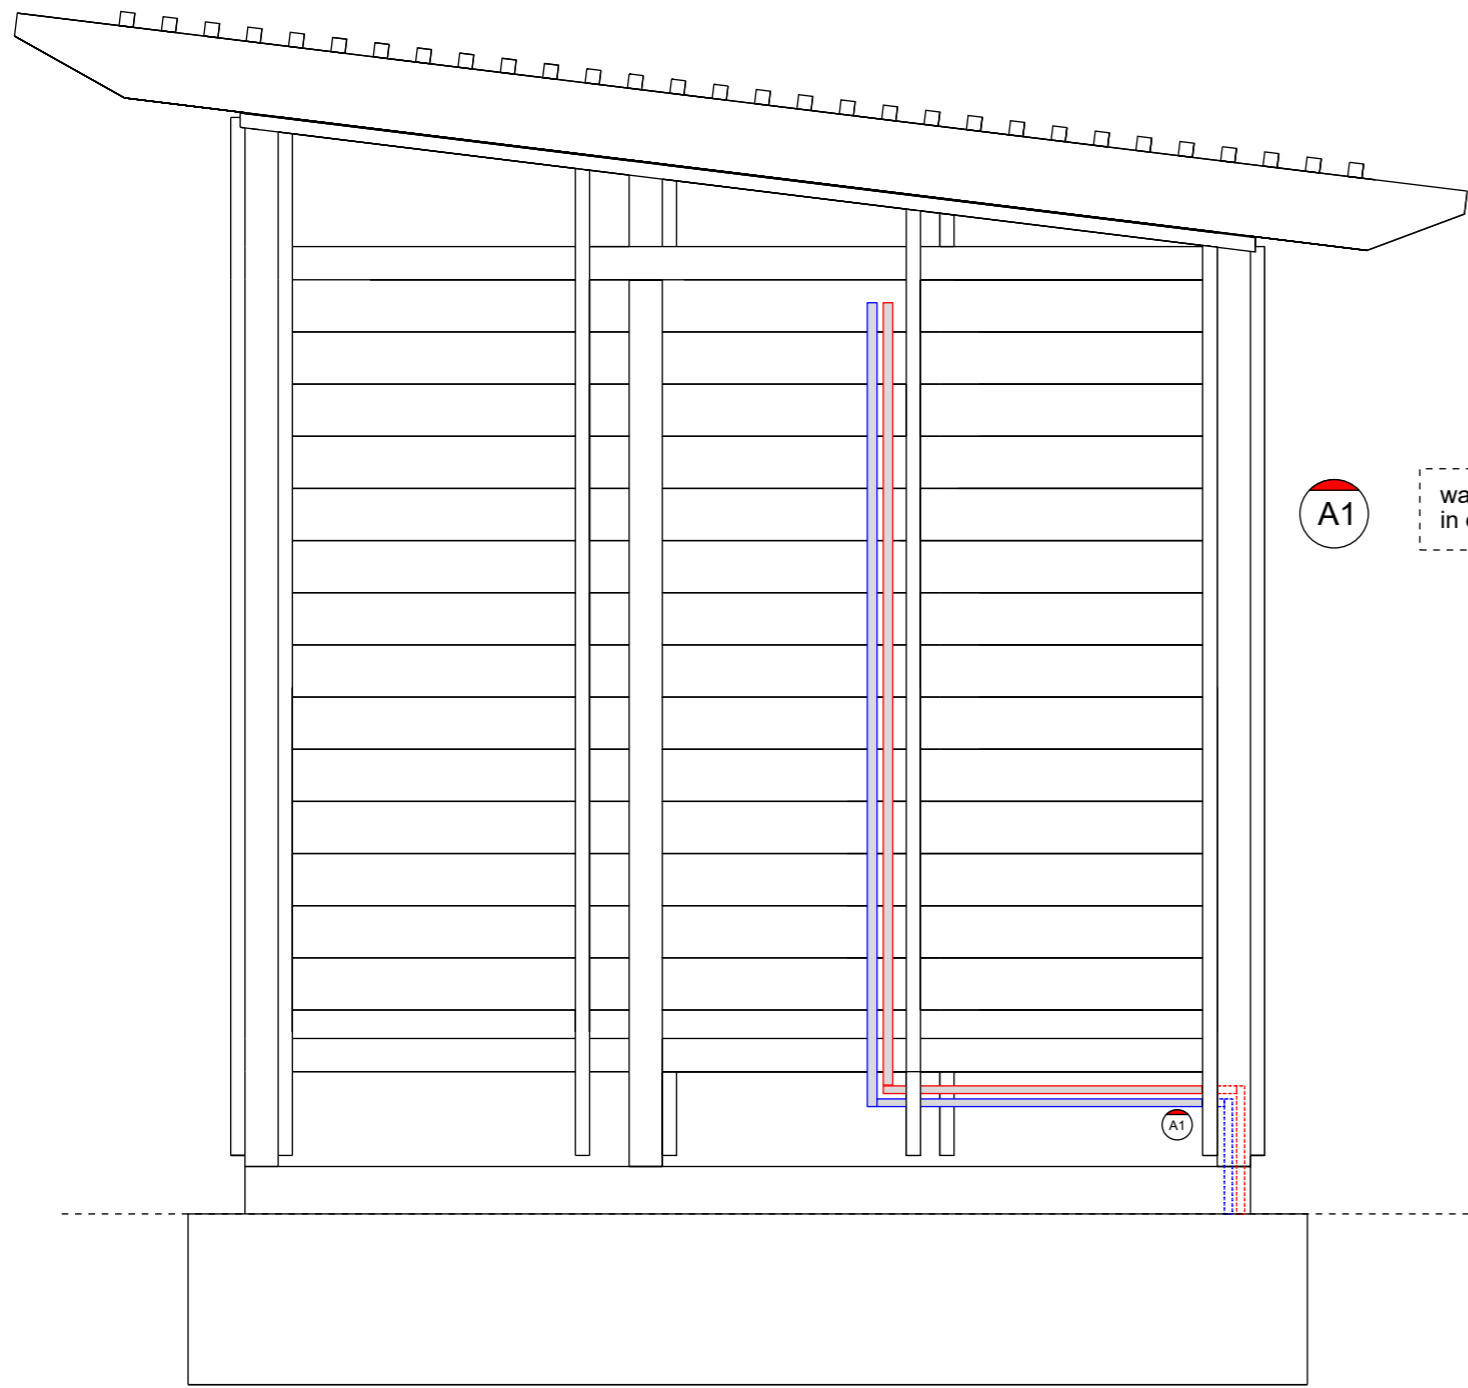
A Rinsing station plumbing detail (no rain screen view)

A1

water supply attached to tankless water heater in equipment storage.

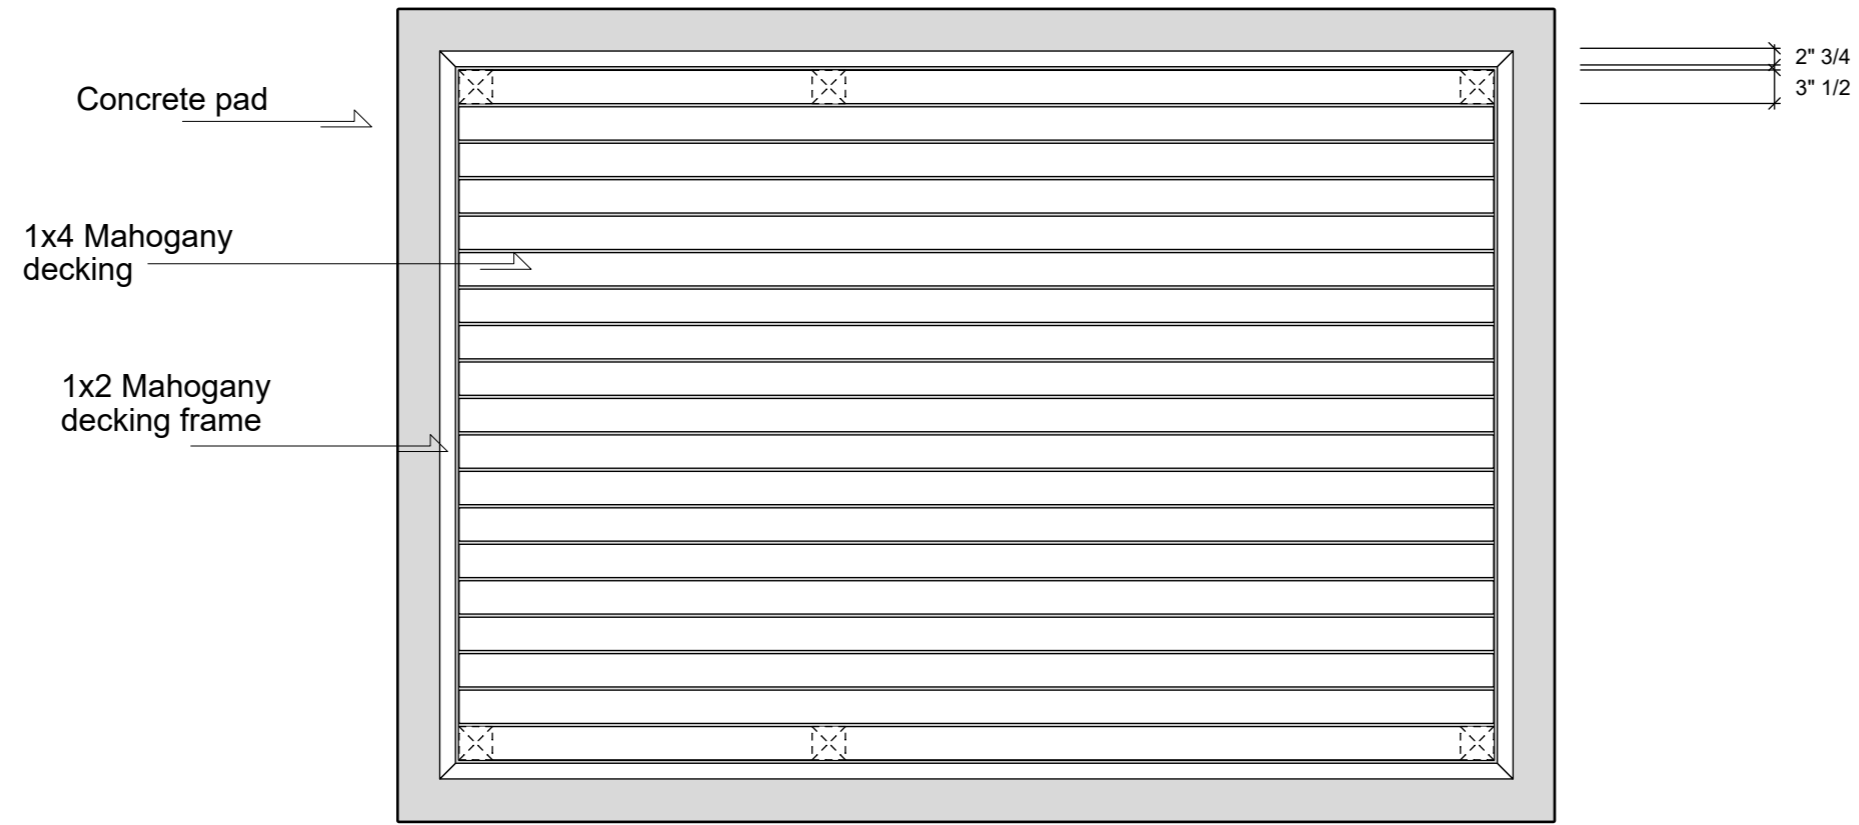
A Deck construction detail (front view)

- A1** Pressure treated wood rated for ground contact 2x6
- A2** Simpson strong tie LUS26 galvanized steel hanger
- A3** Simpson strong tie structural screws (4) SD9212 / (4) SD9112
