Aquatic Habitat Connectivity Survey

Mill Brook

West Tisbury and Chilmark, Massachusetts

August 2012

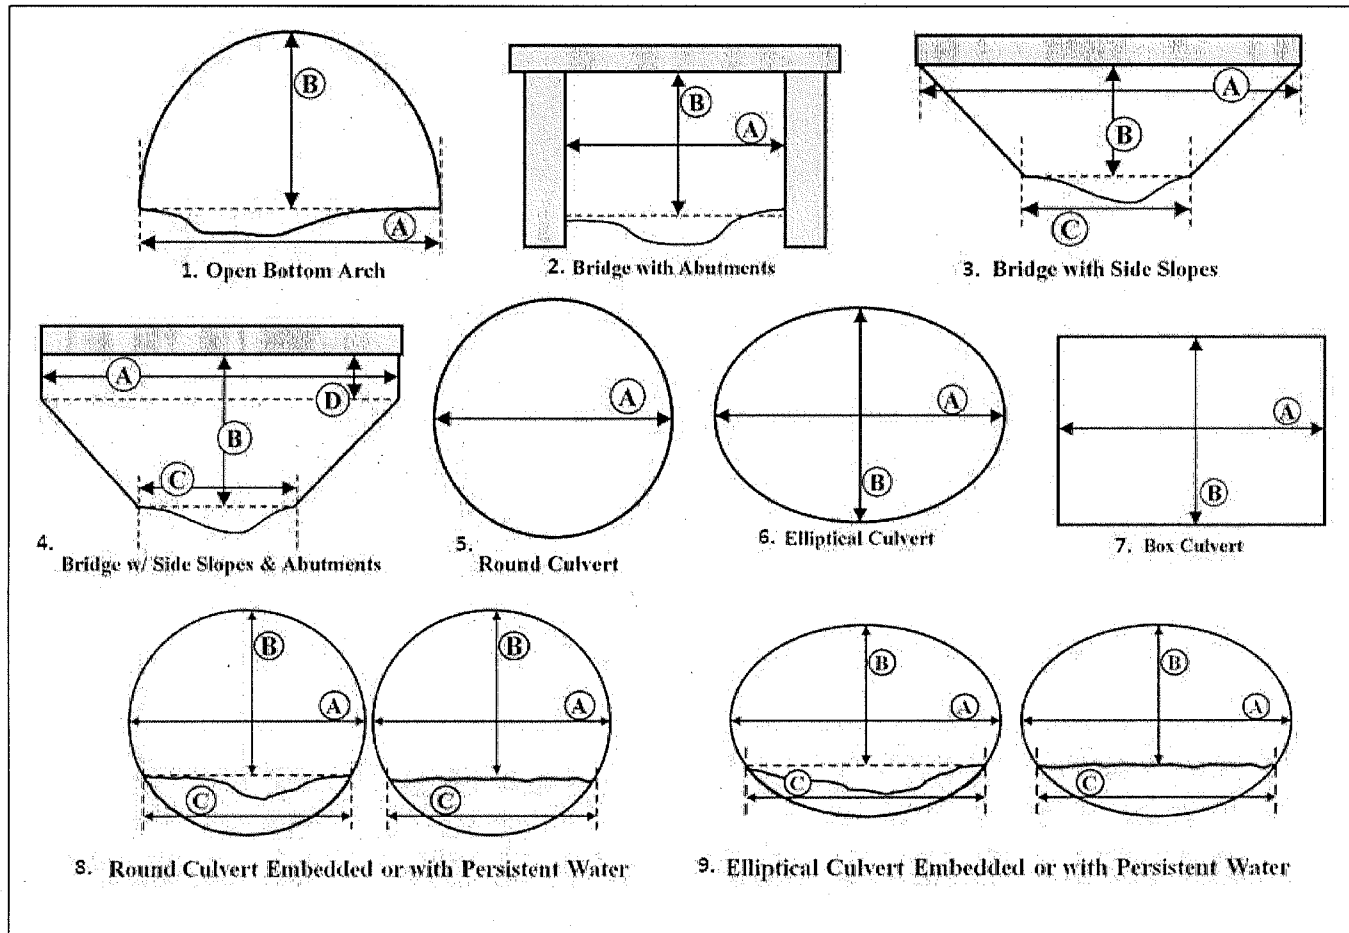
Condition of crossing: ☐ New ☒ Excellent ☒ Fair ☐ Poor

Water depth matches stream? ☐ Yes (comparable) ☒ No (deeper) ☐ No (shallower) ☐ Dry
 Water velocity matches stream? ☒ Yes (comparable) ☐ No (slower) ☐ No (faster) ☐ Dry
 Crossing Slope matches stream? ☒ Yes (comparable) ☐ No (flatter) ☐ No (steeper)

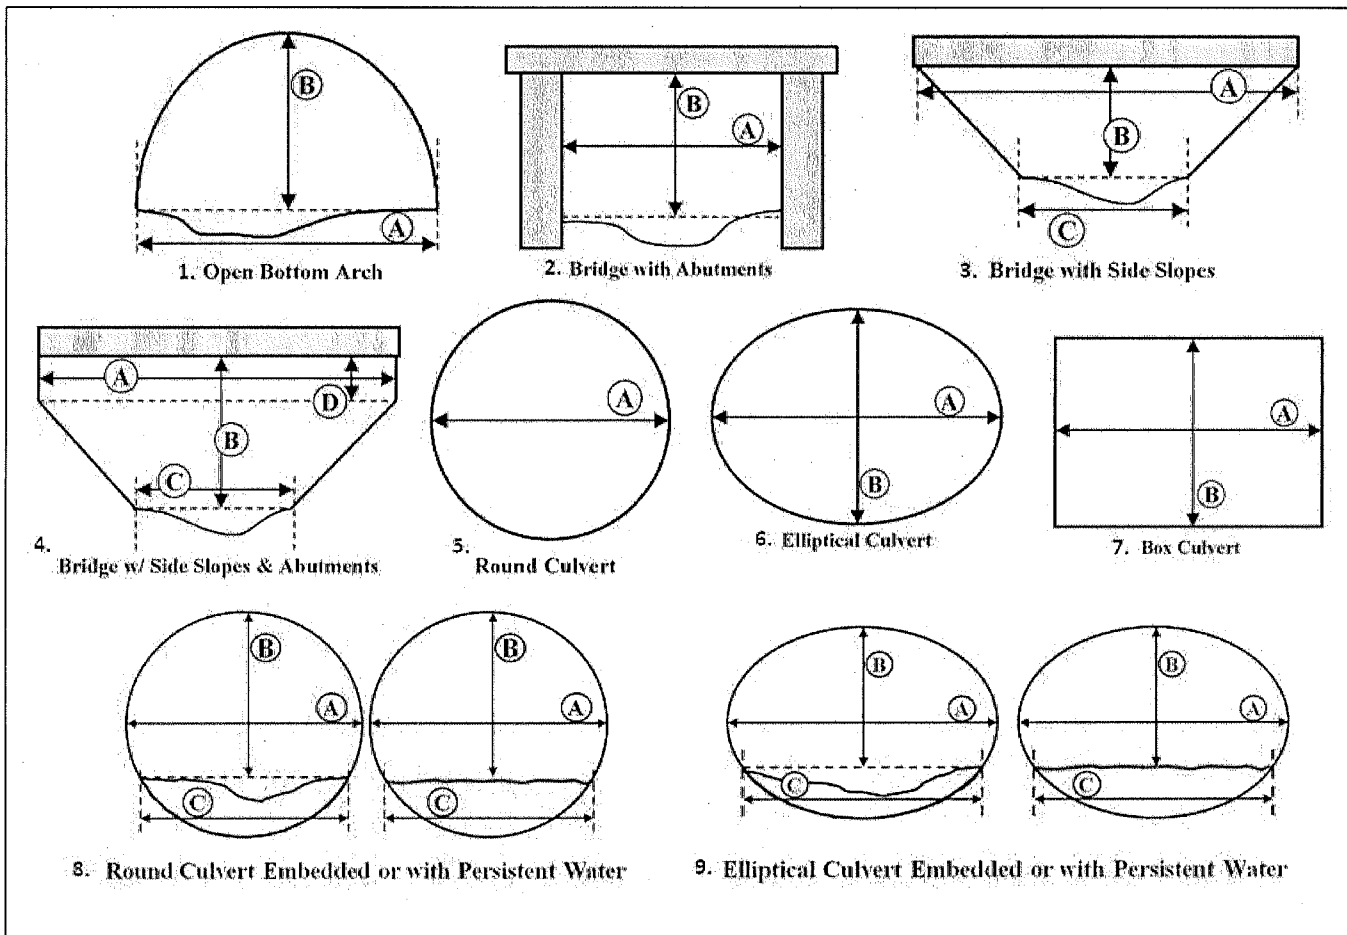
Condition of crossing: ☐ New ☒ Excellent ☐ Fair ☐ PoorDoes the stream at the crossing support fish? ☒ Yes ☐ Not likely ☐ Don't knowIs the stream flowing? ☒ Yes ☐ NoCrossing span: ☐ Severe constriction ☒ Mild constriction ☐ Spans bank to bank ☐ Spans channel & banksTailwater Scour pool: ☐ None ☒ Small (wider or deeper than stream) ☐ Large (width or depth 2X stream)Crossing alignment matches stream? ☒ Yes (flow aligned) ☐ No (skewed)**Culvert/Bridge Cell Characteristics (Culvert/cell #1; use page 3 for additional culverts or cells)**Structure embedded? ☒ Not embedded ☐ Partially embedded ☐ Fully embedded ☐ No BottomStructure substrate: ☐ None (smooth) ☒ None (rough/corrugated) ☐ Inappropriate ☐ Contrasting ☐ ComparableInternal features ☒ None ☐ Slip lined ☐ Baffles/Sills ☐ Weir(s) ☐ Support structuresPhysical Barriers to fish and wildlife passage: ☐ Severe ☒ Moderate ☐ Minor ☐ NoneDescribe any barriers: Like velocity barrier @ same place. no dry passageIs there a clear line of sight through the structure? ☒ Yes ☐ NoDoes the structure provide dry passage suitable for use by terrestrial wildlife? ☐ Yes ☒ NoIf yes, what is the maximum structure height in the portion that offers dry passage? NA Feet

Water depth matches stream? ☒ Yes (comparable) ☐ No (deeper) ☐ No (shallower) ☐ Dry
 Water velocity matches stream? ☒ Yes (comparable) ☐ No (slower) ☐ No (faster) ☐ Dry
 Crossing Slope matches stream? ☒ Yes (comparable) ☐ No (flatter) ☐ No (steeper)

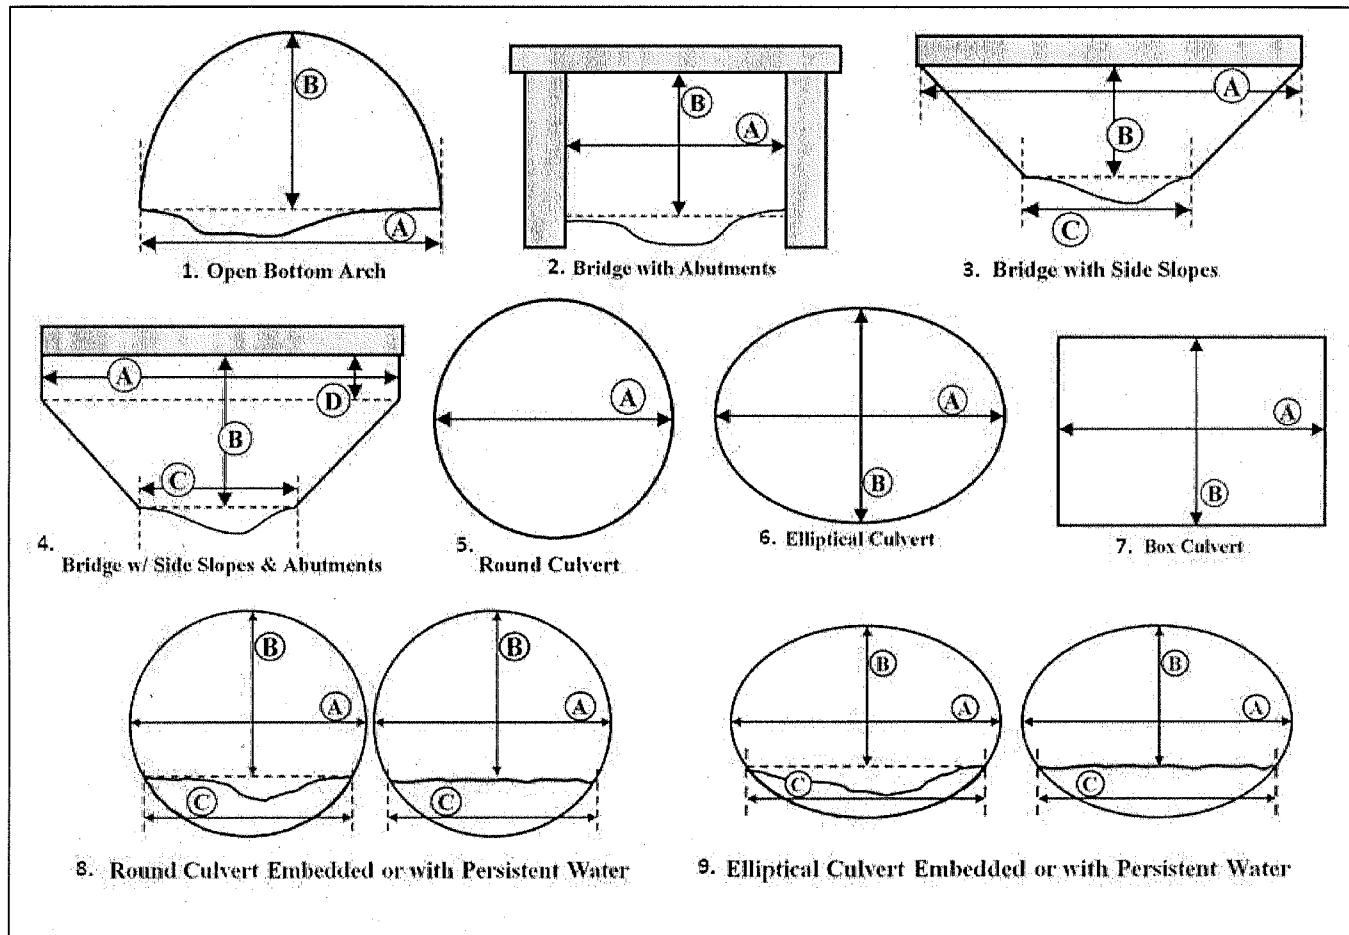
Condition of crossing: ☐ New ☒ Excellent ☐ Fair ☐ PoorDoes the stream at the crossing support fish? ☐ Yes ☐ Not likely ☐ Don't knowIs the stream flowing? ☒ Yes ☐ NoCrossing span: ☒ Severe constriction ☐ Mild constriction ☐ Spans bank to bank ☐ Spans channel & banksTailwater Scour pool: ☒ None ☐ Small (wider or deeper than stream) ☐ Large (width or depth 2X stream)Crossing alignment matches stream? ☒ Yes (flow aligned) ☐ No (skewed)

Water depth matches stream? ☐ Yes (comparable) ☐ No (deeper) ☒ No (shallower) ☐ Dry
 Water velocity matches stream? ☒ Yes (comparable) ☐ No (slower) ☐ No (faster) ☐ Dry
 Crossing Slope matches stream? ☐ Yes (comparable) ☒ No (flatter) ☐ No (steeper)

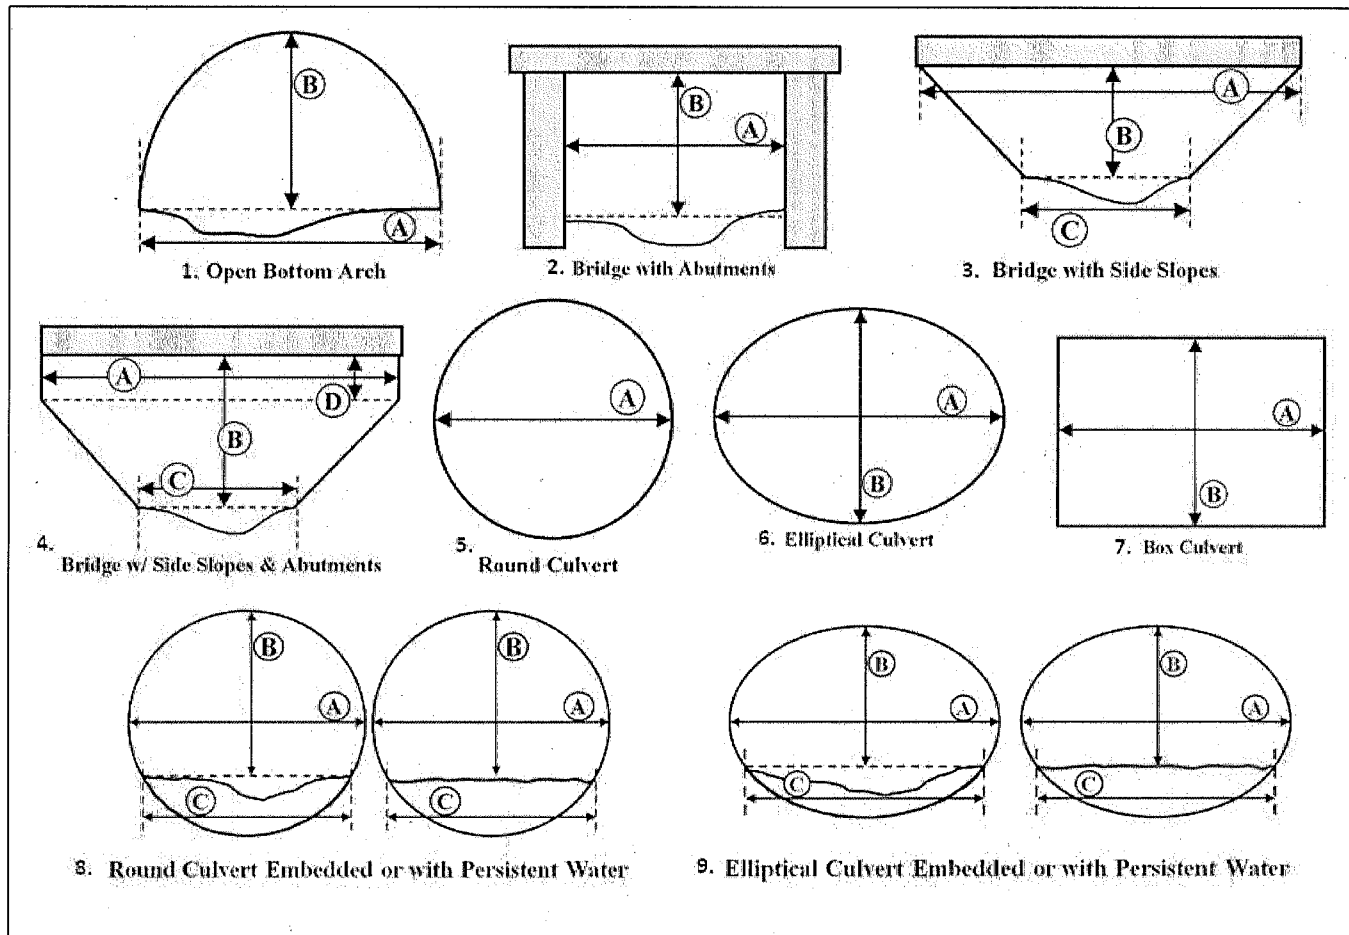
Condition of crossing: ☐ New ☐ Excellent ☒ Fair ☐ Poor

Water depth matches stream? ☒ Yes (comparable) ☐ No (deeper) ☐ No (shallower) ☐ Dry
Water velocity matches stream? ☒ Yes (comparable) ☐ No (slower) ☐ No (faster) ☐ Dry
Crossing Slope matches stream? ☒ Yes (comparable) ☐ No (flatter) ☐ No (steeper)
