# Site Reconnaissance, Preliminary Evaluation, and Opinion of Probable Cost for Dam Removal

## Old Mill Pond Dam West Tisbury, Massachusetts

June 2011

MILL POND DAM  
PHASE I  
INSPECTION / EVALUATION REPORT

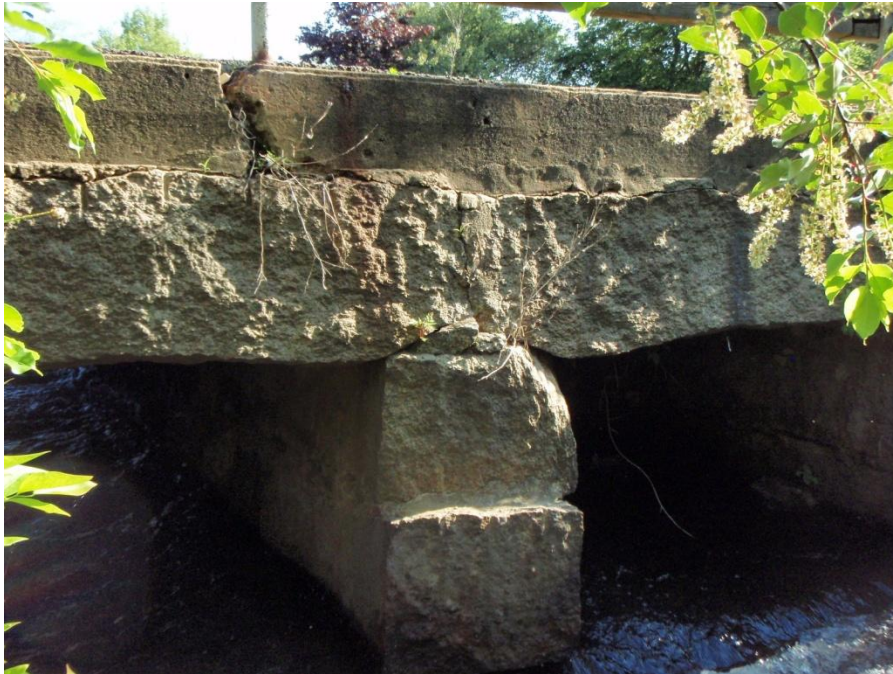
Despite the presence of a temporary upstream fishpass structure constructed of wood that was observed in the left masonry box culvert during the site visit, potential for upstream fish passage under the observed conditions was marginal due to shallow (depth of approximately 0.4 ft) and fast (speed of 5 to 6 feet per second) in the downstream portion of the culvert. It is therefore expected that upstream fish passage at this dam is limited to American eel (*Anguilla rostrata*) and perhaps river herring (*Alosa spp.*) under ideal flow conditions. Indigenous brook trout (*Salvelinus fontinalis*) occur in the headwater of Mill Brook and may similarly be able to pass upstream through the fishpass under ideal conditions. The Massachusetts Division of Fisheries and Wildlife stocks various trout species in the dam impoundment (Mill Pond).

**Photo 4: View Upstream through Left Spillway Culvert under West Tisbury-Edgartown Road**  
(note “fishpass” on left side of image)

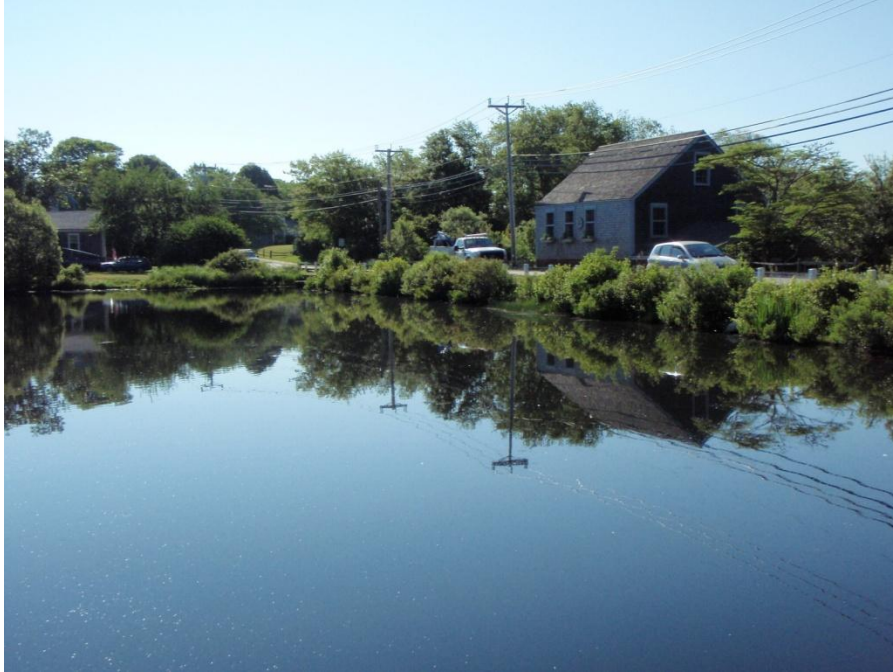
**Photo 6: Impoundment from Dam**

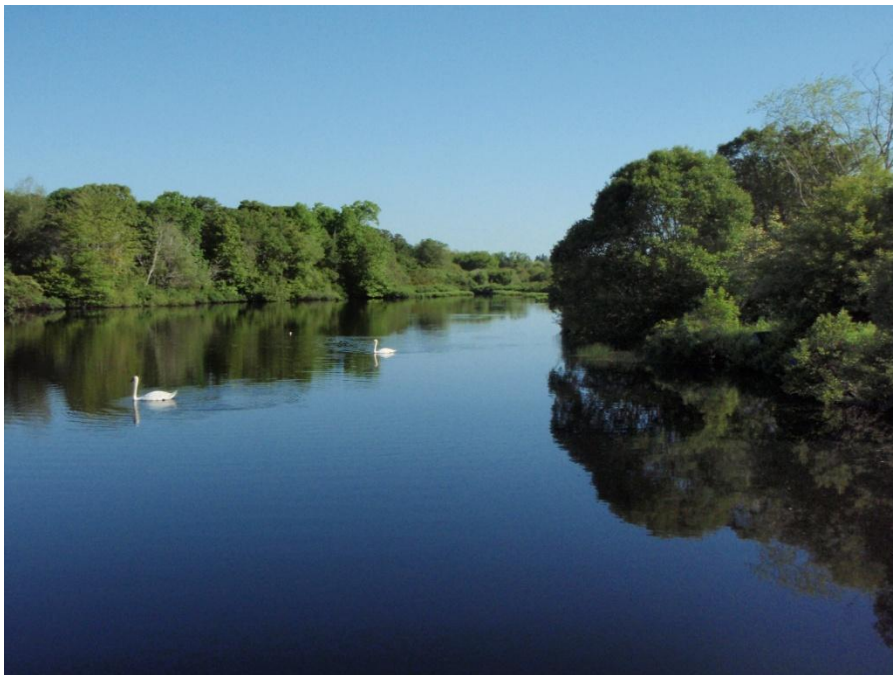
**Photo 7: Dam (background) from Upstream Limit of Impoundment**

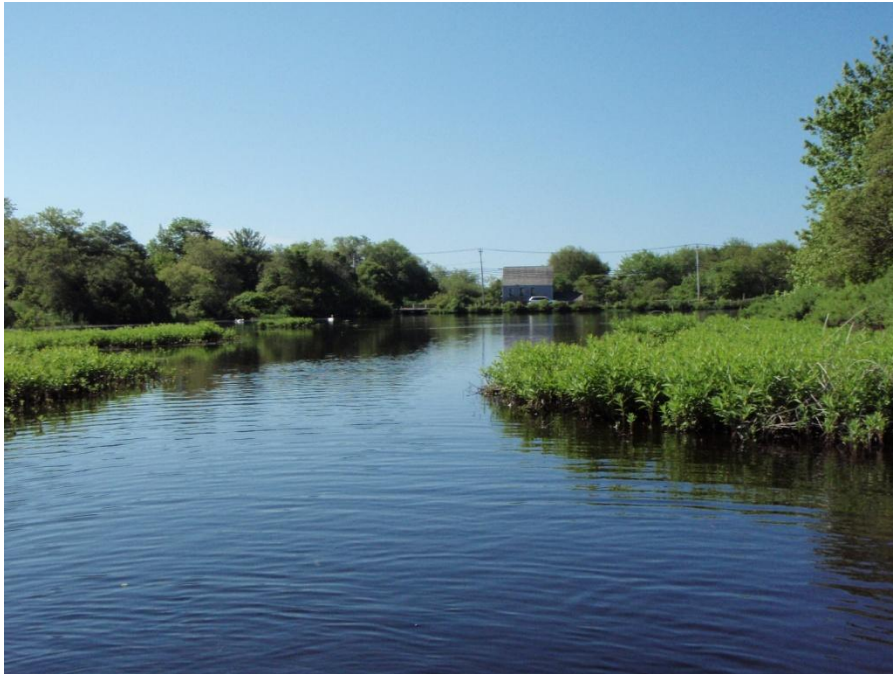
Given that much of the pond has depths of water at the normal pool elevation (e.g., top of stoplog boards) of less than 1 ft, removal of the stoplog boards, which were approximately 2 ft above the upstream invert of the spillway/masonry culvert apron during the June 7, 2011, site visit, would result in dewatering of portions of the impoundment. Observations of the impoundment from a canoe during the site visit and the bathymetric map included as Figure 4 in the ACT Report suggest that removal of the stoplogs would result initially in a stream channel along the right (west) side of most of the impoundment that would flow parallel to the dam and then into the spillway. Whether a channel would remain in this location would depend on subsequent fluvial processes.

**Photo 8: Vegetation in Impoundment (note relatively shallow water in foreground)**

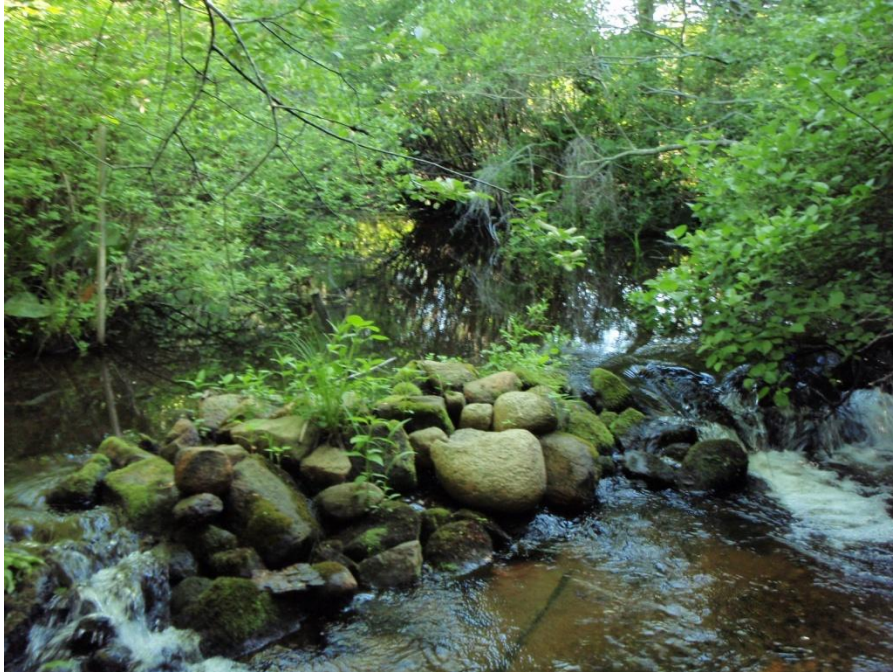
**Photo 10: Diversion Structure in Old Mill Pond Dam Impoundment to Maley's Pond**

Coordination with the local fire department is strongly recommended prior to implementation of any actions that would lower water levels in the dam impoundment or affect the supply of water to Maley's Pond.

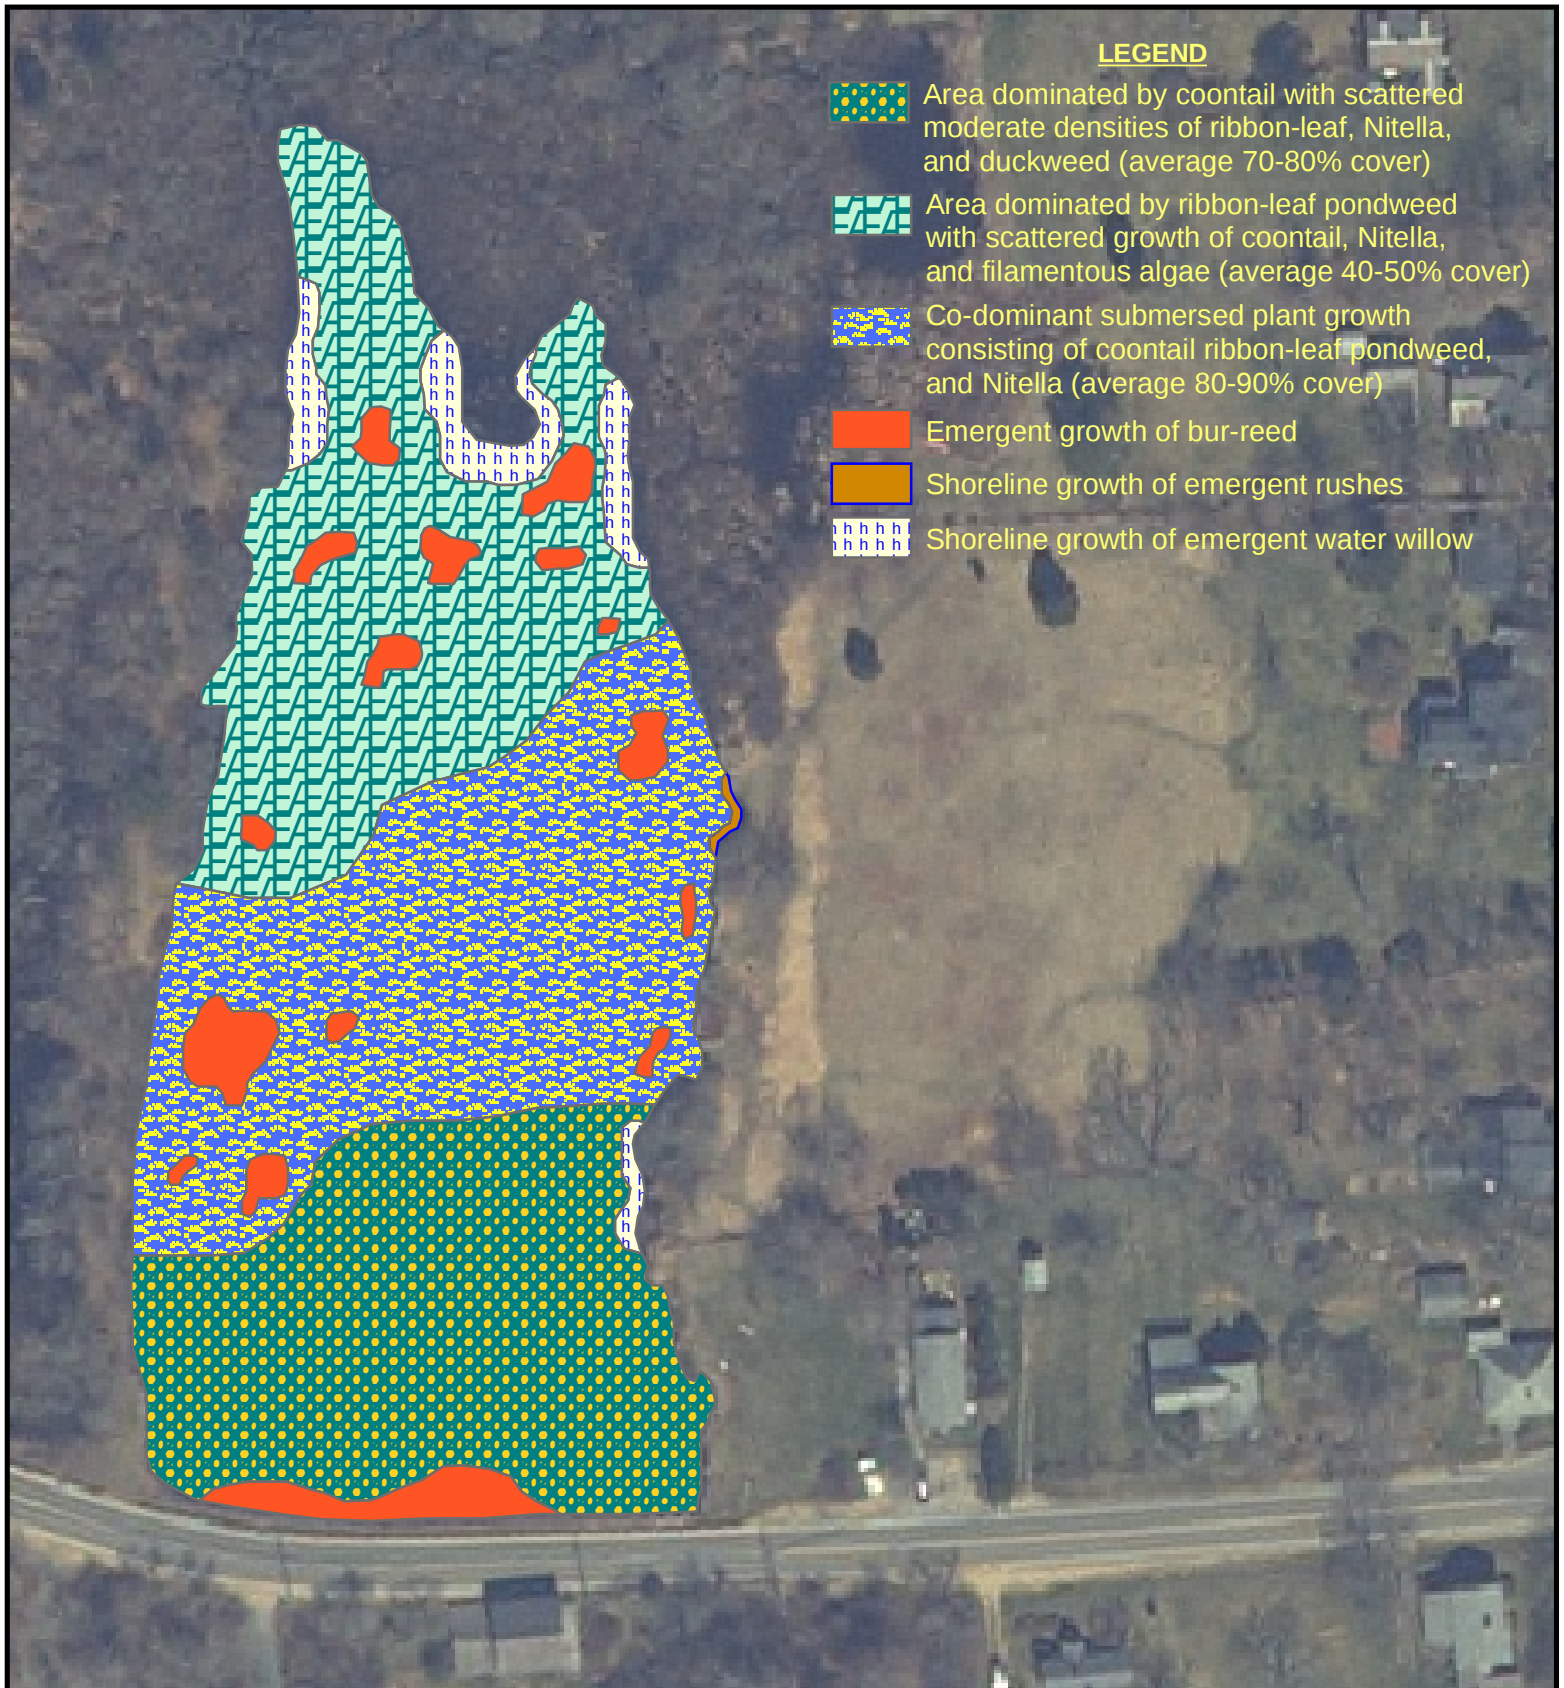
### Vegetation Distribution Map

The Pond has well-established populations of submersed and emergent vegetation. The vegetation growth throughout much of the pond averaged between 50%-90% bottom cover, with only small pockets of open water (see Figure 3 – Vegetation Distribution Map). The plant species found throughout the pond are listed in the following table:

As a result of the extremely shallow water depths (<0.5 ft.) in the northern portion of the pond the density of the submersed growth was lower in that region than elsewhere, with

an average areal coverage estimated in the range of 40%-50%. Although the shallow water depths in this region of the pond limited submersed plant densities, they facilitated widespread colonization by wetland/emergent growth, dominated by bur-reed and water willow.

The remaining two thirds of the pond harbored significantly greater densities of submersed vegetation, with scattered pockets of emergent bur-reed growth. Submersed vegetation densities in this area ranged between 70%-90% bottom cover. The dominant plant species were ribbon-leaf pondweed, coontail, and *Nitella*.

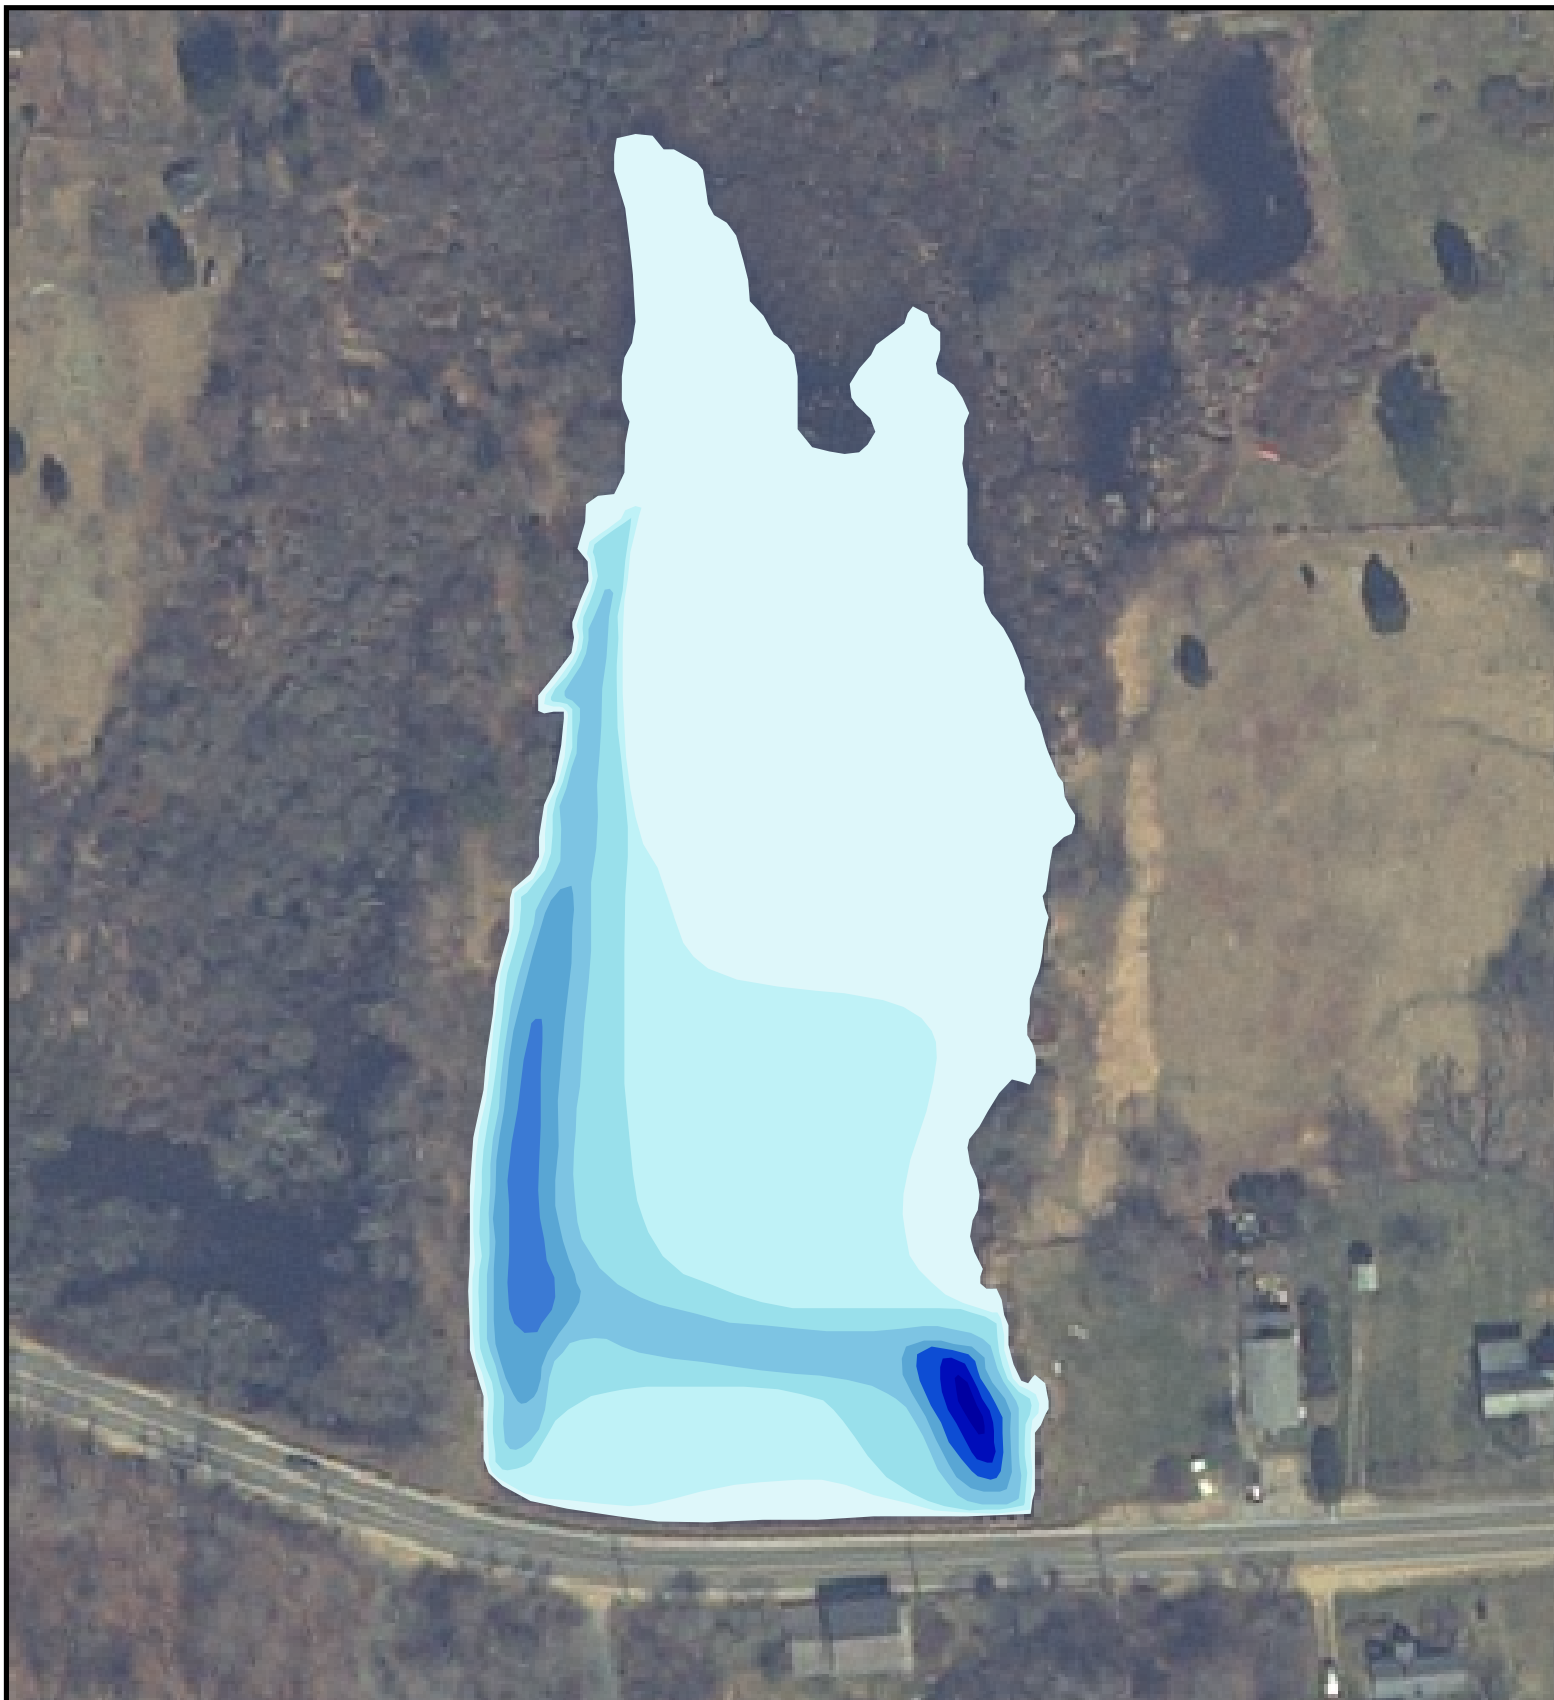
### Bathymetry Map

The Phase 1 Report lists the normal impoundment pool upstream from the dam as having a surface area of approximately 2.5 acres, a length of approximately 460 ft, an average width of approximately 250 ft, an average depth of 2 ft, and a storage volume of 5 acre-ft. The observed maximum depth was approximately 6 ft during the June 7, 2011, site visit. Emergent aquatic vegetation was observed in and along the margins of much of the impoundment, and particularly in the upstream end of the impoundment where observed depths were less than 1 ft.

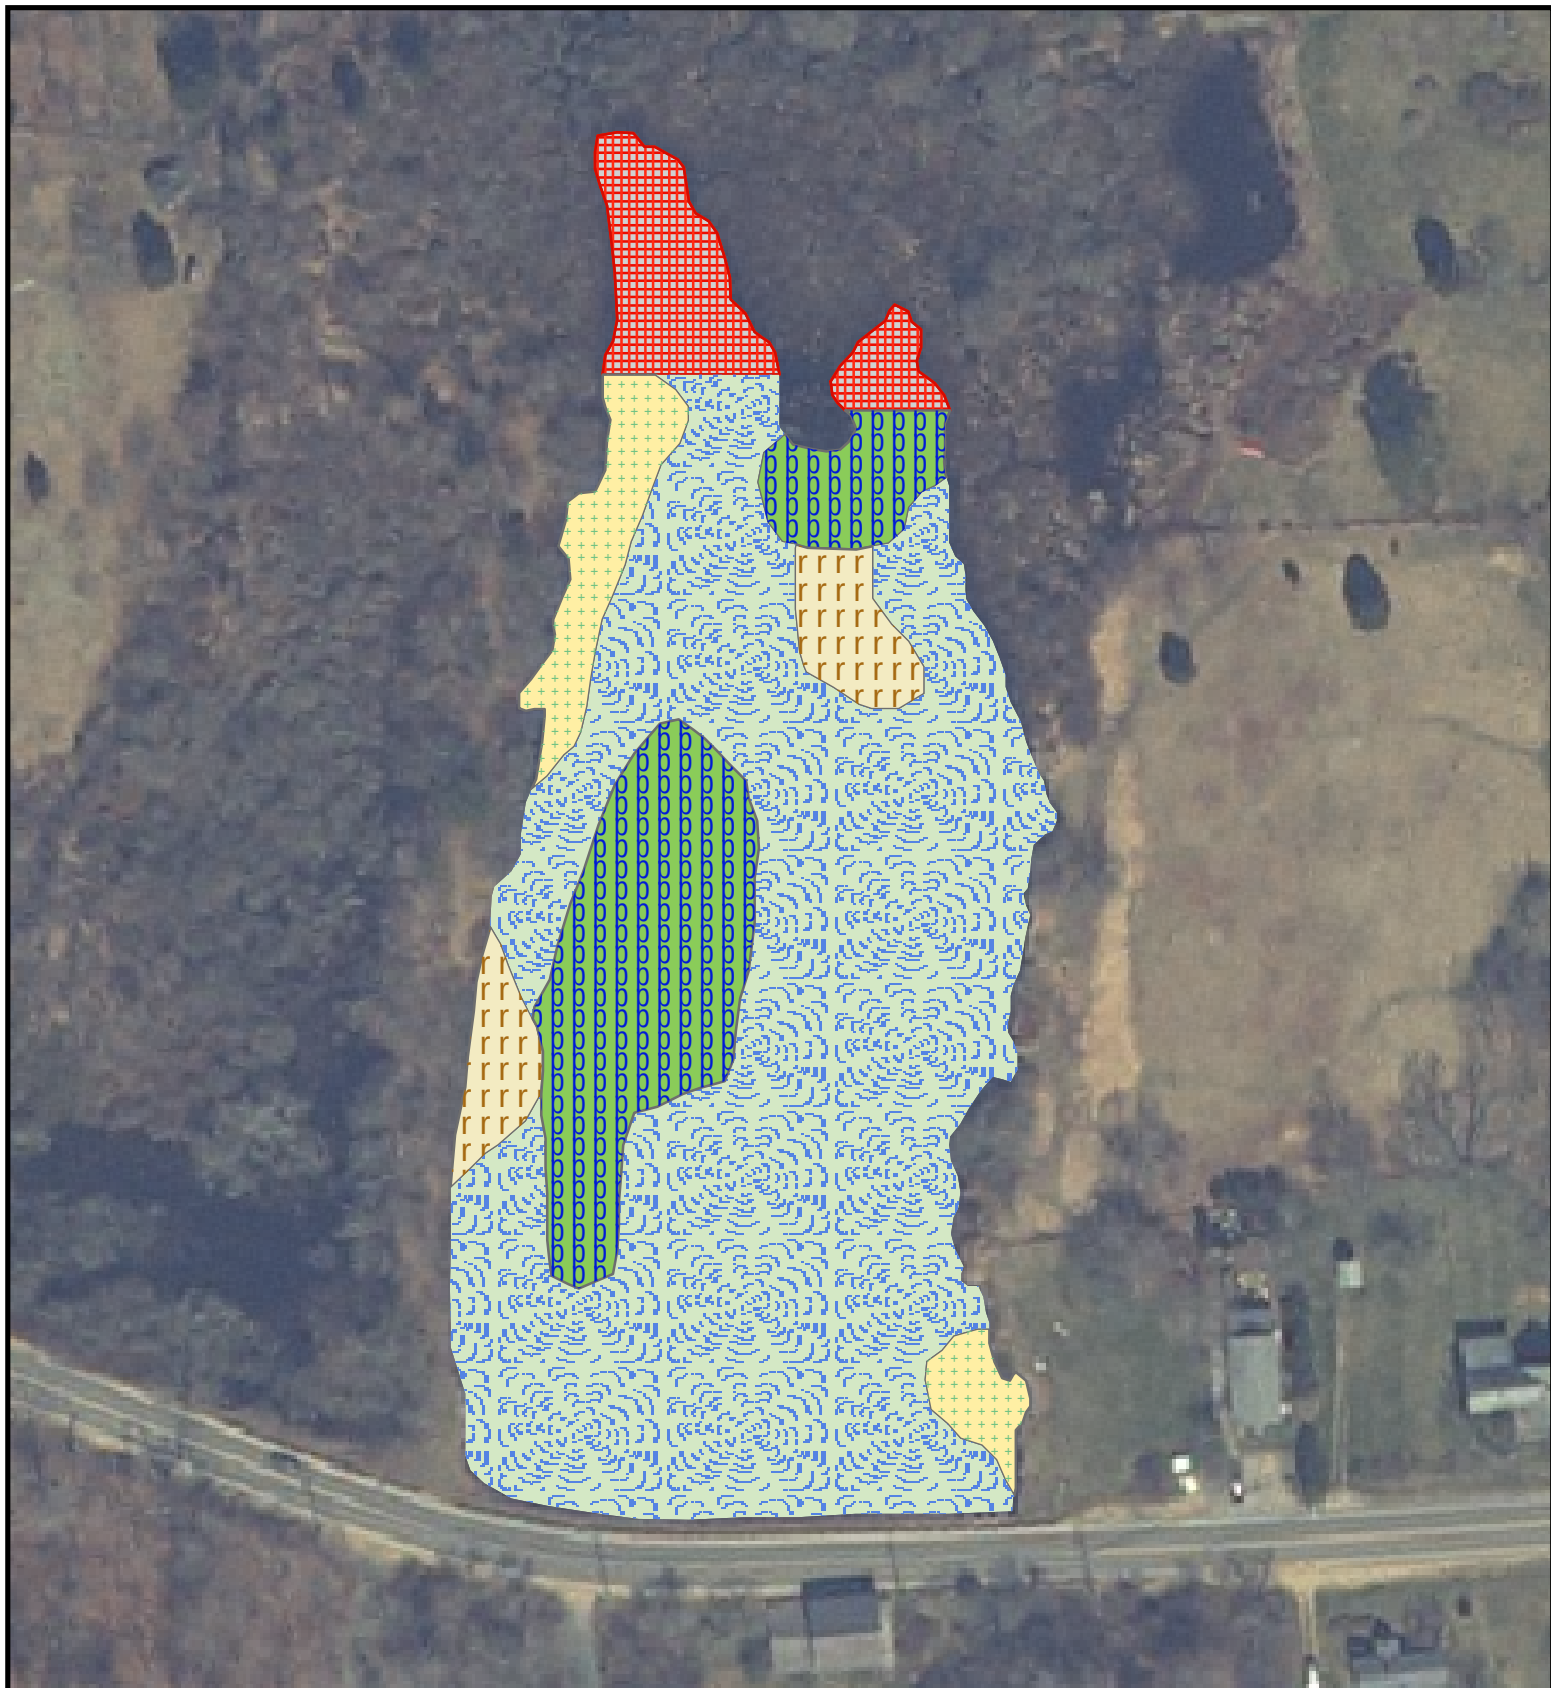
Unconsolidated Sediment  
Thickness Map

Accumulations of fine sediments were observed throughout the impoundment. The ACT Report describes this material as “organic muck” with depths of accumulation of up to 5 ft and an estimated volume of material of approximately 20,000 cubic yards (CY). While accumulated sediments are most apparent in the upper reach of the impoundment, where observed depths of water were less than 1 ft in many locations during the June 7, 2011, site visit, this material was observed in other locations at varying depths throughout the impoundment.

Based on qualitative observations of the sediments attached to the sediment probe during the field survey, the unconsolidated sediments were classified as a combination of organic rich muck and inorganic sand or silt. This sediment type is typically high in nutrients and capable of supporting aquatic plant growth. Nutrient rich sediments are constantly added to an aquatic system by the annual decay of aquatic vegetation, algae and leaf litter. The unconsolidated sediment layer in Mill Pond is typical of a eutrophic waterbody suffering from excessive plant growth. The thickness of this layer ranged from 0.5 ft. to >4.0 ft. with the greatest volume of sediment located in the southeastern and northwestern areas of the pond (see Figure 5 – Unconsolidated Sediment Thickness Map). The calculated average thickness of the unconsolidated sediment layer is 2.8 ft. A larger grain size or sand constituent was noted for the data points of transect A at the northern end of the pond. A higher degree of what was believed to be sand in the area of the inlets is probably the result of sediment deposition from the inlet waters. The heavier and larger sand grains settle out of suspension soon after entering the pond and the smaller and lighter silts and clay remain in suspension until flow velocities are further reduced upon entering the central and southern area of the pond; therefore, creating a distinct segregation of sediments based on grain size.
