July 27, 2023

TO: West Tisbury Conservation Commission
CC: George A. Sourati, P.E. (Sourati Engineering Group LLC)
FROM: Greg Berman, Coastal Processes Specialist (WHSG & CCCE)
RE: Site report for 271 John Cottle Road, West Tisbury, MA

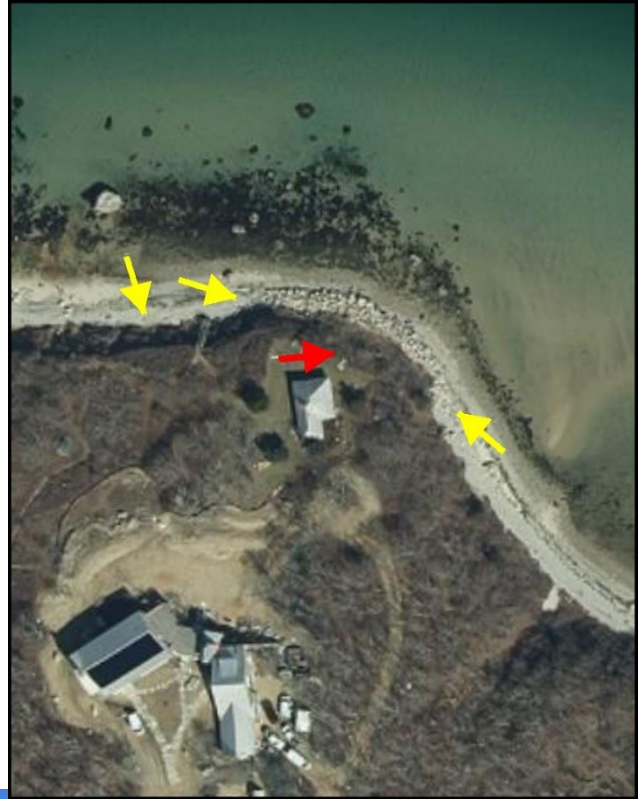
A series of photographs was taken during a site visit on 07/06/2023. Photograph 1 shows the edge of the cottage (built in the 1930s and so pre-dating the Wetlands Protection Act) is ~ 16' from the top of the bank. There has been some minor erosion recently at the top of the bank. There was no observed surface runoff issue at the site despite lawn extending to the top of the bank. A narrow (ex. 5-10') buffer zone of low native vegetation suitable for stabilization might reduce the erosion rate at the top of the bank. This would have little effect on the toe of the bank, which is only stabilized by the remains of a rock revetment. Photograph 2 shows the eastern end of the existing revetment, which extends further seaward than the adjacent shoreline. A cobble deposit extends 5-10' from the toe of the coastal bank. This cobble is more erosion resistant than sand and may be reducing the erosion rate at adjacent areas. The western end of the existing revetment (Photograph 3) also extends further seaward than the adjacent shoreline. There is a similar cobble deposit extending 5-10' from the toe of the coastal bank. The existing boulders from the revetment still provide some protection for the coastal bank, but will become less effective in the future. Areas to the west of the revetment (Photograph 4) have experienced erosion of the toe of the bank, which appears to have led to slumping of portions of the landform down the face of the bank. The cobble berm does not seem sufficient to prevent this erosion.

Photograph 1. The edge of the cottage is ~ 16' from the top of the bank. There was no observed surface runoff issue at the site despite lawn extending to the top of the bank.

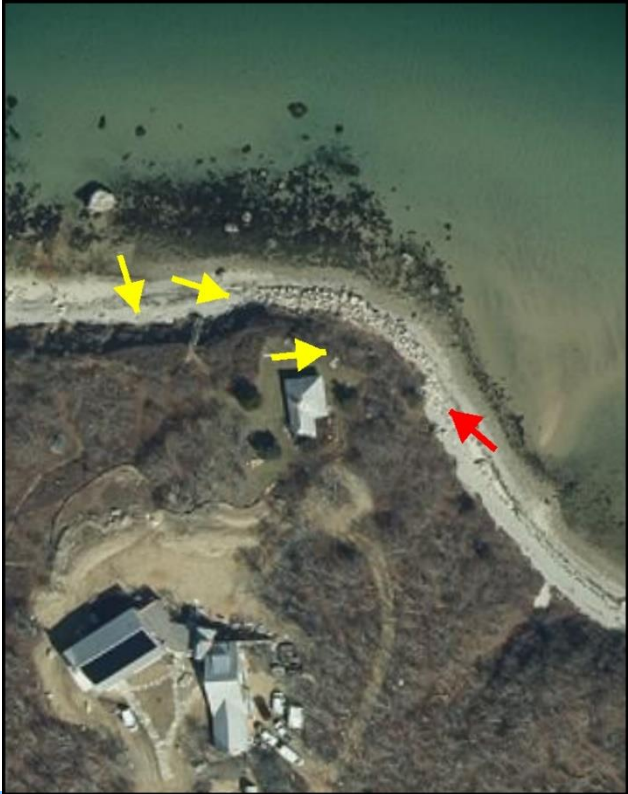
Erosion has been observed on both ends of the revetment, which has likely been accelerated by wave energy being refracted around the revetment and being focused on the shoreline, as well as the reduction in sediment supply from the upland protected by the existing revetment. The existing revetment has created a headland area (see images to the right) upon which wave energy is concentrated. The diagram shows how waves slow down in the shallow water in front of headlands, and move faster in the deeper water of bays. The bottom friction changes the wave direction (called wave refraction). As a result, the wave front parallels the coastline and wave energy is concentrated on the headlands. The coastline would have a very different configuration if this revetment had never been constructed. However, without this structure, the building it was originally designed to protect may have been damaged or lost.

Photograph 2. The eastern end of the existing revetment extends further seaward than the adjacent shoreline. A cobble deposit extends 5-10' from the toe of the coastal bank.

- It is likely that some expansion of the revetment (to the east and west) is warranted as wave energy will be focus at the terminal ends of the revetment. The proposal includes a transition (gabion/fiber roll), which is important for this site. The exact distance the revetment and transition should extend from the existing revetment could potentially be reduced, however there is no "standard equation" for this type of extension.

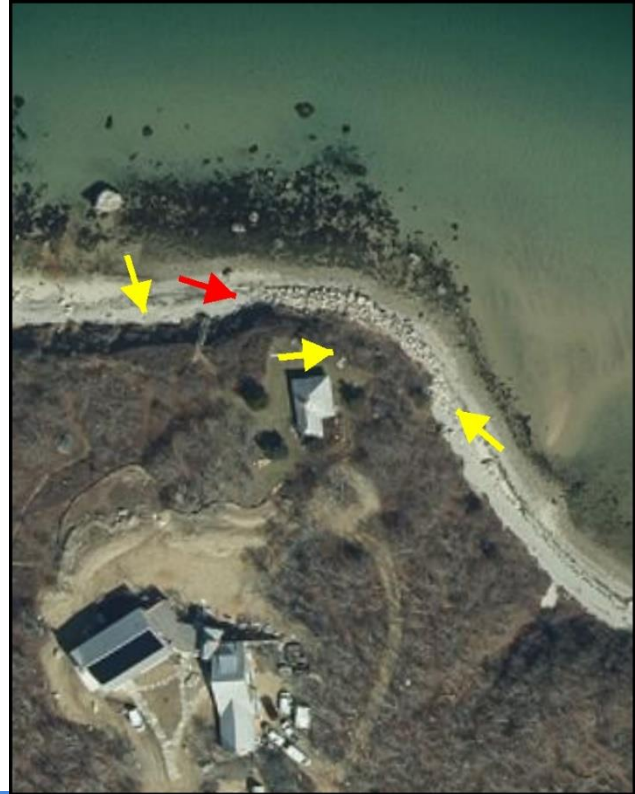
Photograph 3. The western end of the existing revetment also extends further seaward than the adjacent shoreline. A cobble deposit extends 5-10' from the toe of the coastal bank. The existing boulders from the revetment still provide some protection for the coastal bank, but will become less effective in the future.

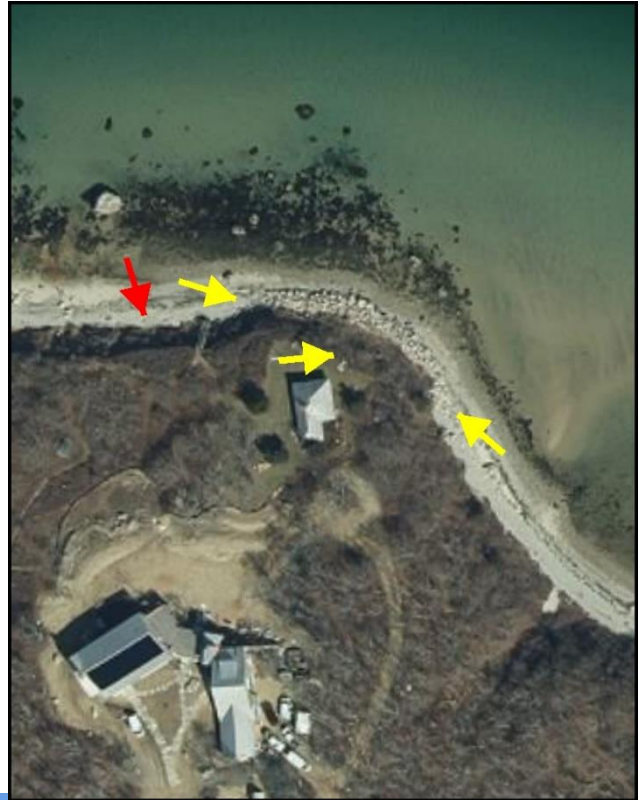
Photograph 4. Areas to the west of the revetment have experienced erosion of the toe of the bank, which appears to have led to slumping of portions of the bank down the face. The cobbles berm does not seem sufficient to prevent this erosion.
