COASTAL PROCESSES SPECIALIST
WOODS HOLE SEA GRANT | CAPE COD COOPERATIVE EXTENSION
gberman@whoi.edu | gberman@barnstablecounty.org
508-289-3046 | 193 Oyster Pond Road, MS #2, Woods Hole, MA 02543-1525

TO: West Tisbury Conservation Commission
CC: George Sourati (Sourati Engineering Group)
FROM: Greg Berman, Coastal Processes Specialist (WHSG & CCCE)
RE: Site visit to Makonikey, West Tisbury, MA – 03/04/2022

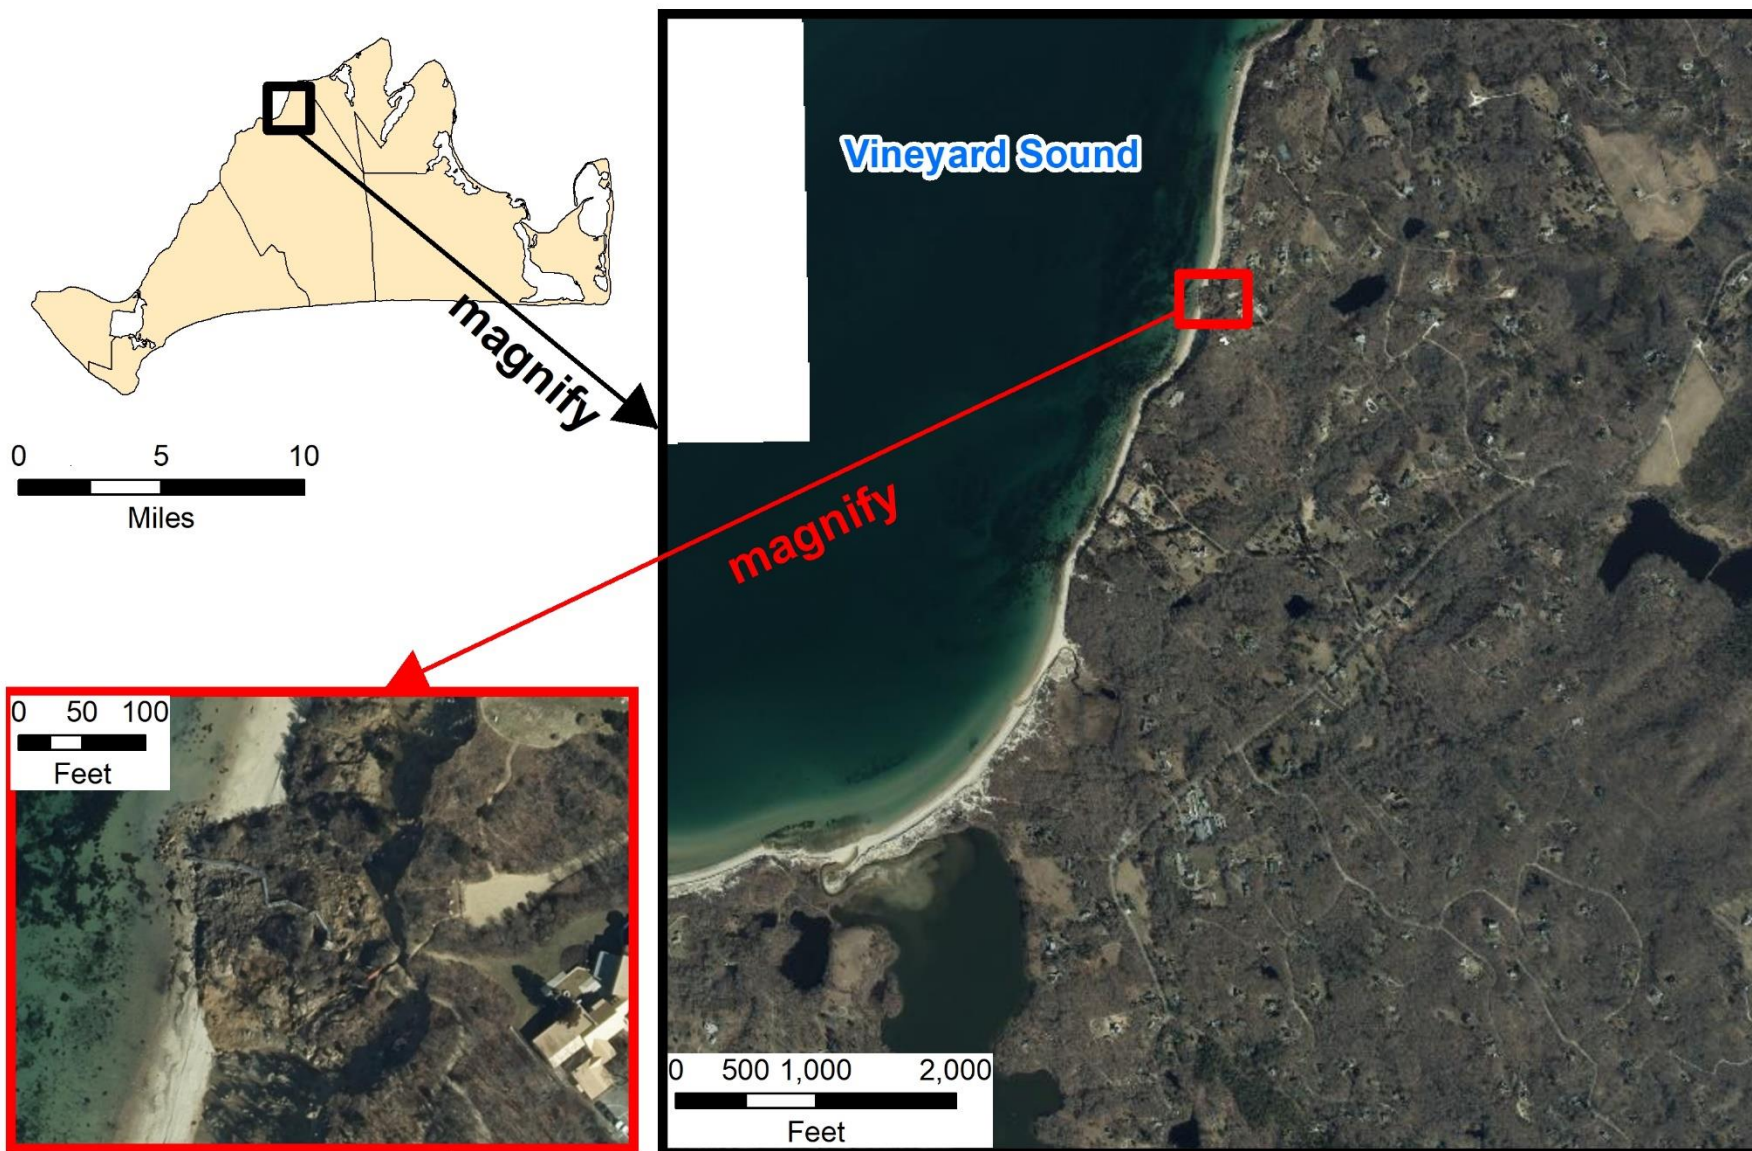
Figure 1. Location of site.

Site Details: This report focuses on the property of, and land immediately surrounding, the Makonikey Stairs in West Tisbury (Figure 1). The site is located on an eroding coastal bank on the Vineyard Sound shoreline of Marthas Vineyard. The upland area (including parking lot) slopes landward, away from the top of the bank. This indicates that surface runoff may not be a major contributor to the erosion. The existing wooden stairway to access the beach was destroyed by erosion and there is a current proposal (Sourati Engineering Group site plans dated 01/17/2022 and revised 02/16/2022) to install a new adjustable stair system. The Conservation Commission Board Administrator, for the town of West Tisbury requested a 3rd party review to examine the proposed stairs for potential impacts to the coastal bank and beach. It should be noted that this review is only for the potential impacts to the coastal resource areas. Longevity/durability of the stairs as well as any human safety impacts are not a part of this report.

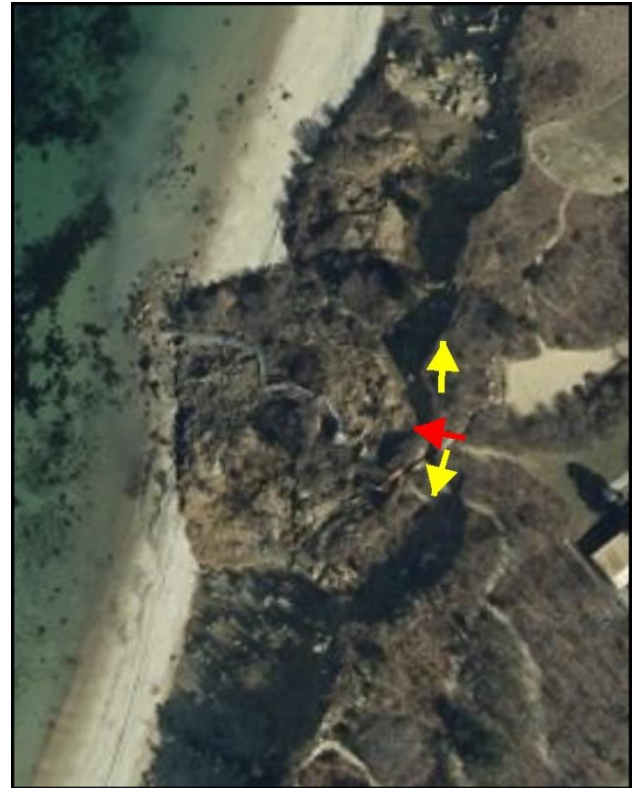
A series of photographs was taken during a site visit on 03/04/2022. Photograph 1 shows the coastal bank that is eroding and providing sediment to the beach at the site. The bank appears to have undergone recent collapse. A large portion of the vegetated bank, including some trees, has slumped down the face of the bank and deposited material on the beach. The slumping of the coastal bank at the site has compromised the wooden stairway system to access the beach. While it was not observed during the site visit, it was shared during the site visit that groundwater seeps out of the coastal bank near the elevation of the beach. It was speculated that this seep may have created instability in the bank and lead to the collapse. Photograph 2 shows the coastal bank, to the south of the destroyed stairs, has eroded and much of the bank is unvegetated save for the sections of bank that have slid down relatively intact. The proposed location (Photograph 3) for the new stairs is also in an area that has experienced erosion, but not quite as severe as the rest of the bank.

Photograph 1. Slumping of the coastal bank at the site has compromised the wooden stairway system to access the beach.

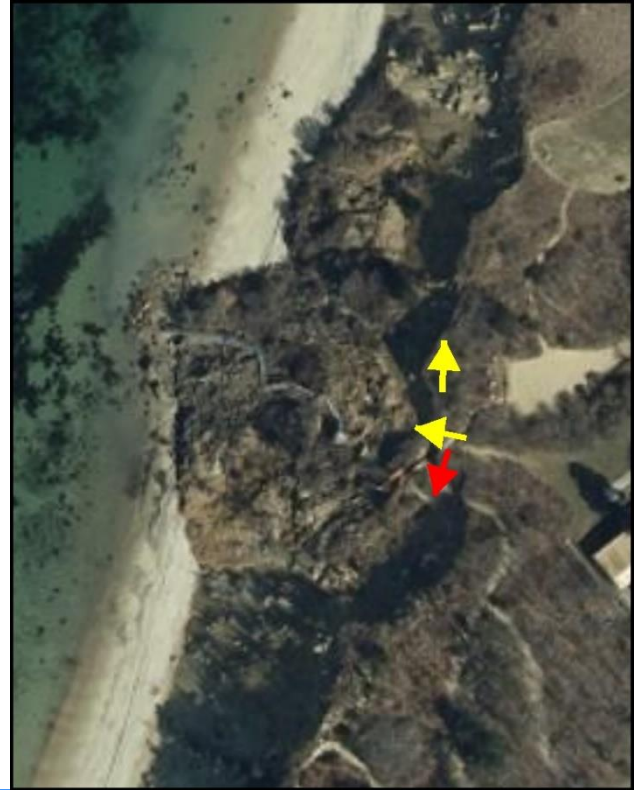
Photograph 2. The coastal bank, to the south of the destroyed stairs, has eroded and much of the bank is unvegetated, save for the sections of bank that have slide down relatively intact.

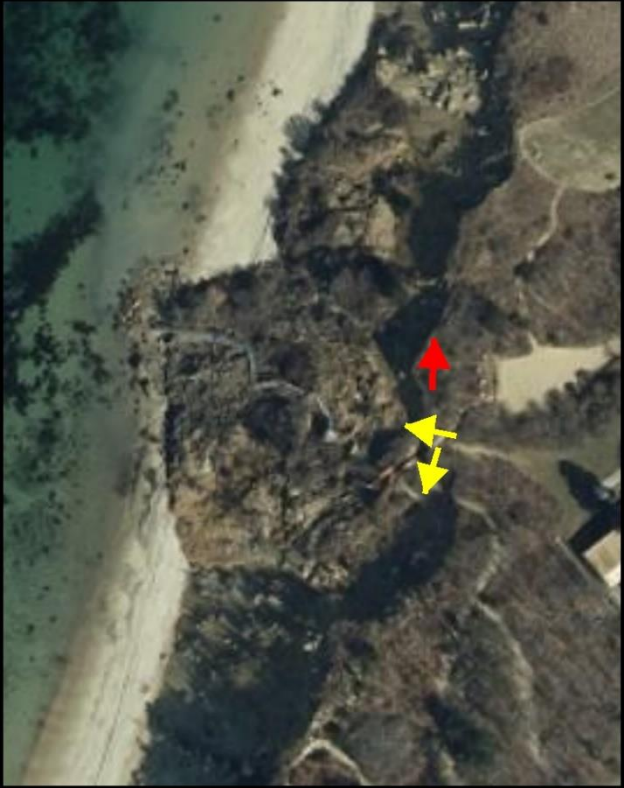
Photograph 3. The proposed location for the new stairs is also in an area that has experienced erosion, but not quite as severe as the rest of the bank.
