FACILITY CONDITION ASSESSMENT

HOWES HOUSE 1042 State Road

West Tisbury, Massachusetts 02568

EMG

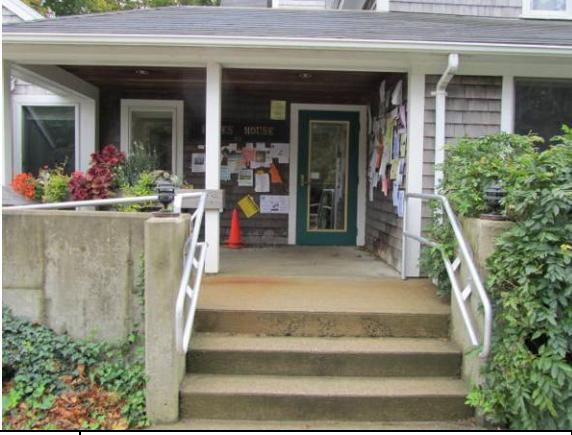
Photo Main entrance #1:

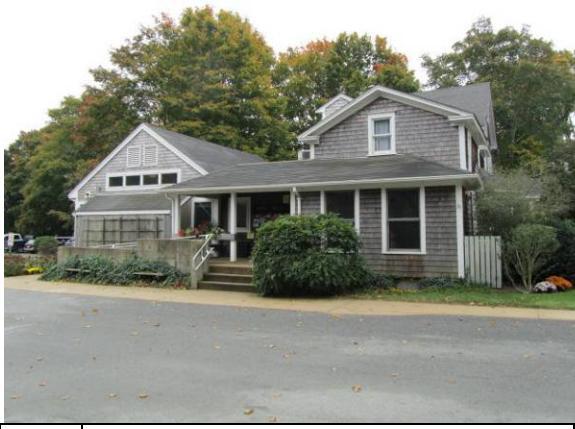
Photo Left side elevation #3:

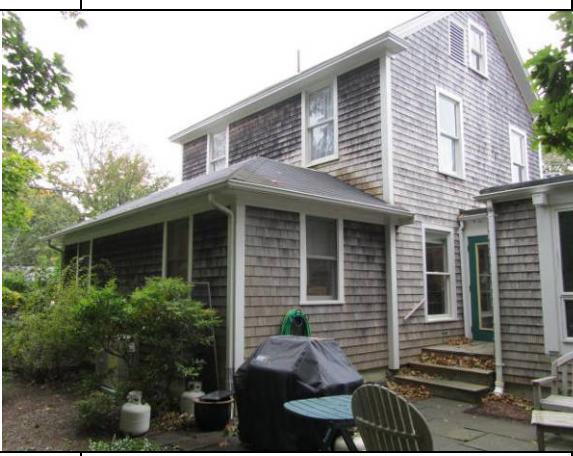
Photo Right side elevation #4:

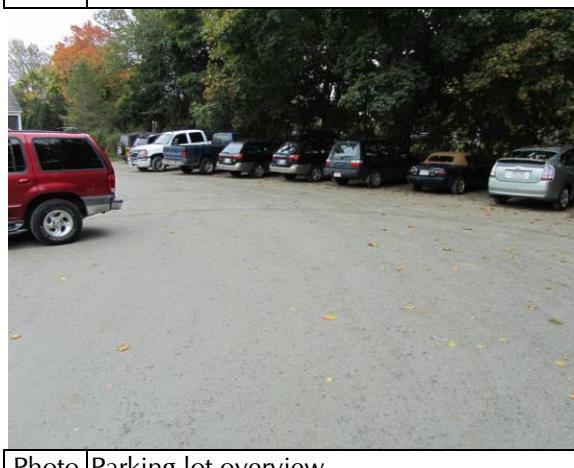
Photo Parking lot overview #6:

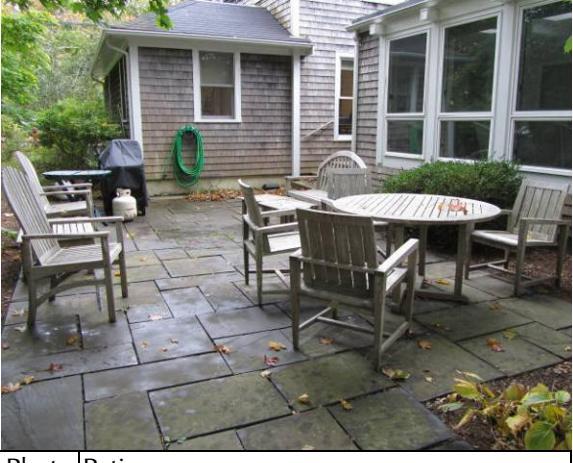
Photo Patio #7:

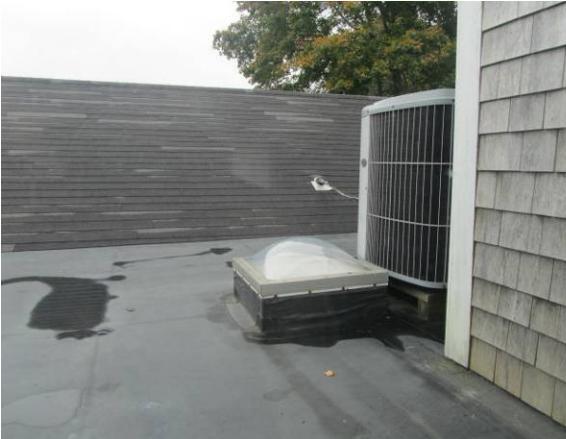
Photo Flat roof area with condensing unit and #9: skylight

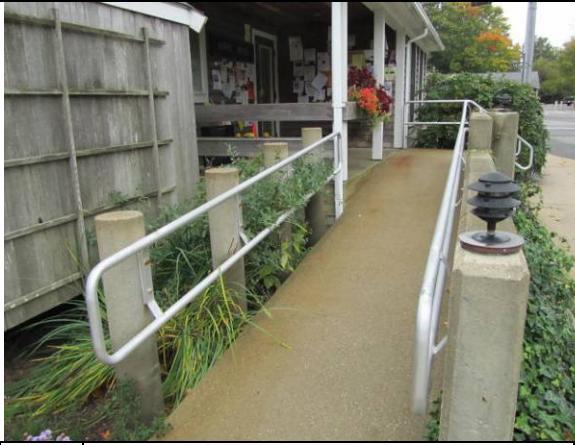
Photo Ramp railing (note: left rail stops before #10: top of ramp)

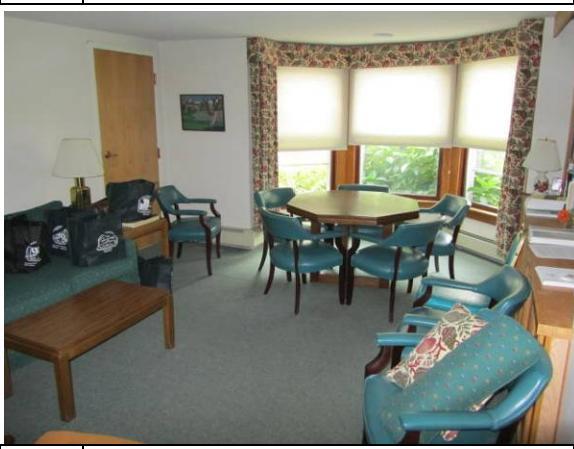
Photo Interior of Parlor #12:

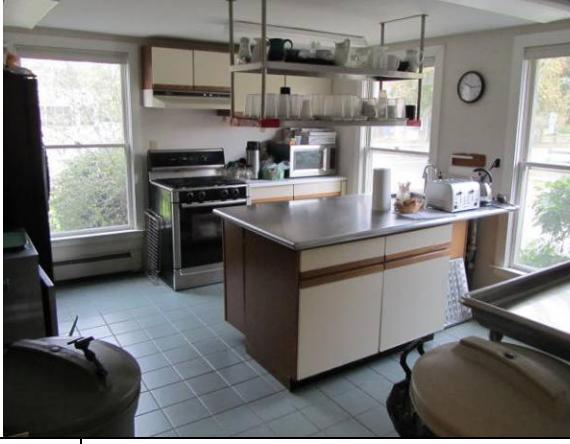
Photo Kitchen #13:

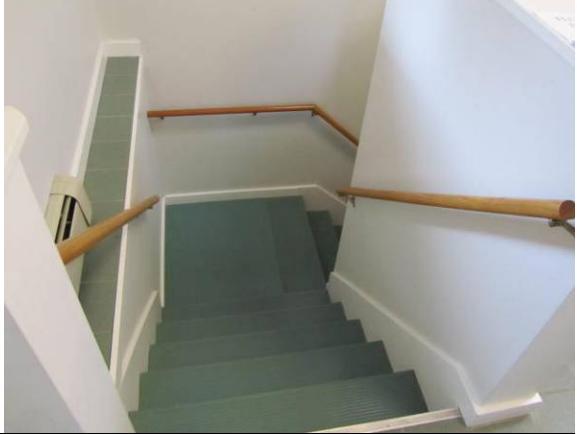
Photo Stairwell #15:

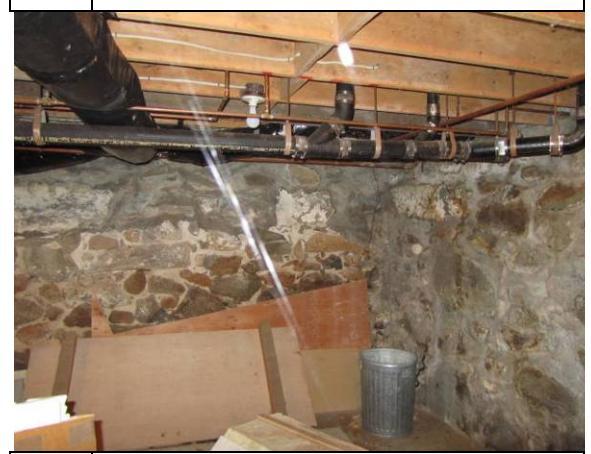
Photo Unfinished basement with piping #17:

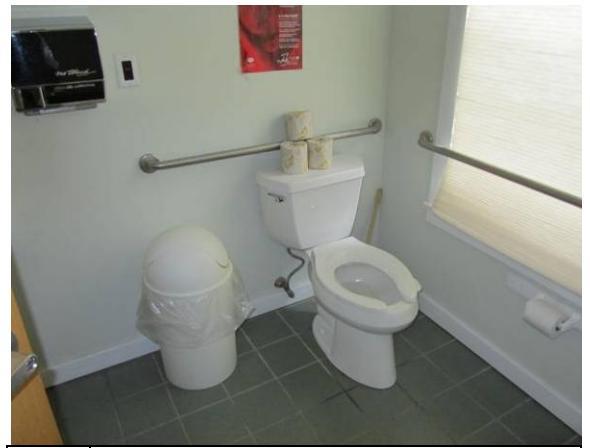
Photo Accessible restroom #14:

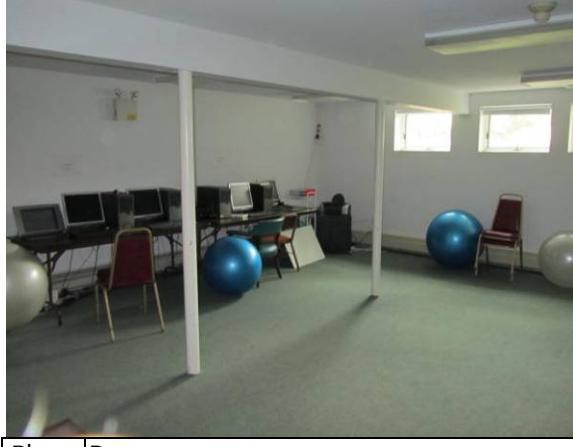
Photo Basement #16:

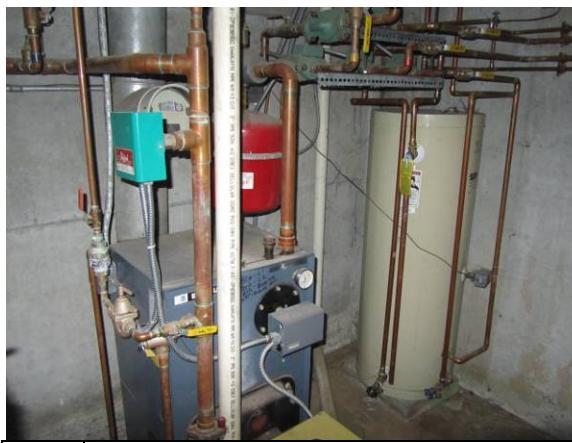
Photo HVAC boiler and water heater #19:

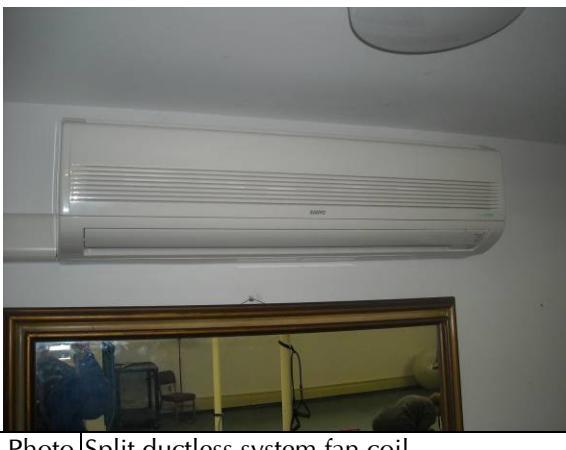
Photo Split ductless system fan coil #21:

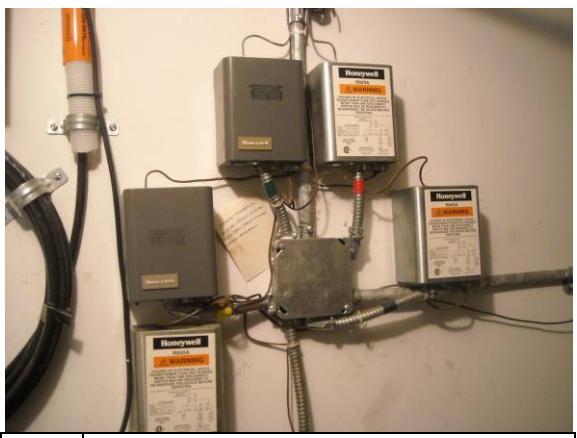
Photo Heating zone controls #23:

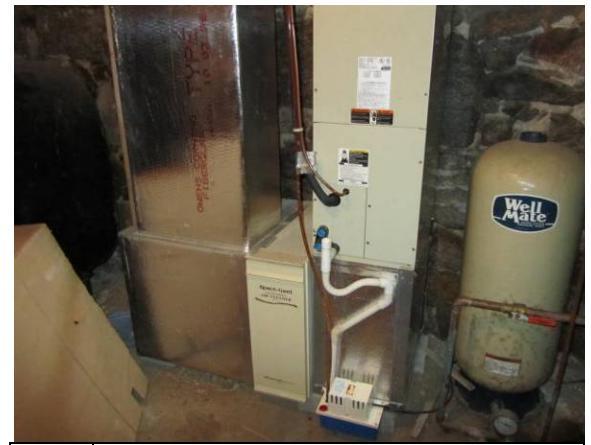
Photo Basement fan coil unit #20:

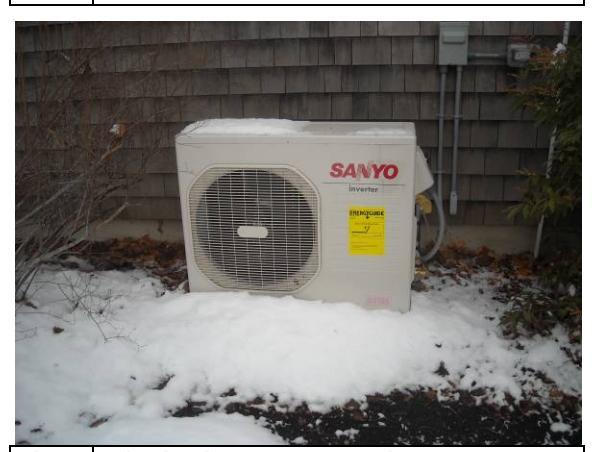
Photo Split ductless system condensing unit #24:

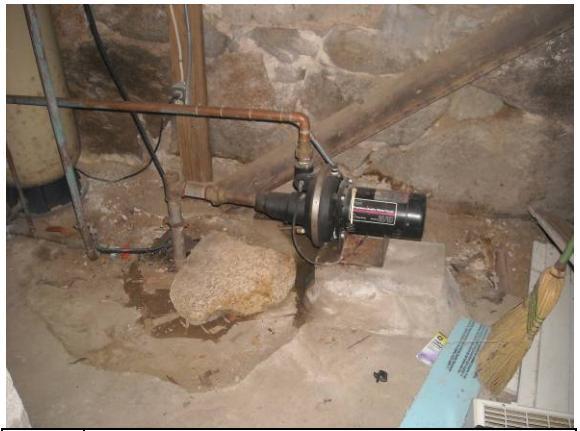
Photo Well and pump #25:

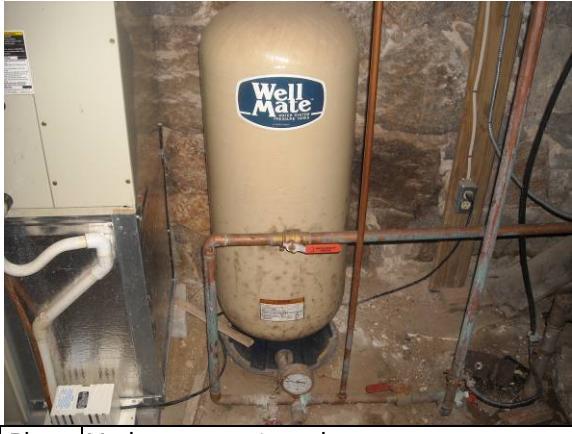
Photo Hydropneumatic tank #27:

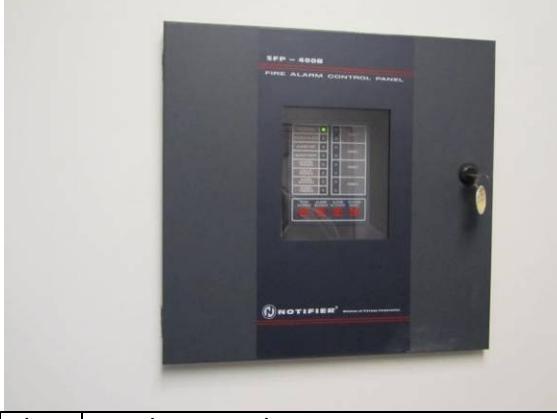
Photo Fire alarm panel #29:

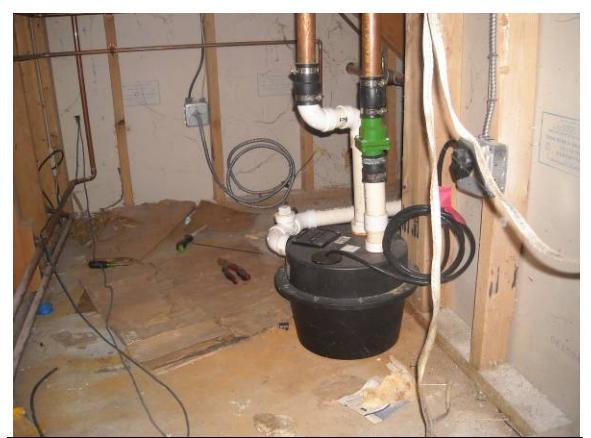
Photo Package lift station under stairs #26:

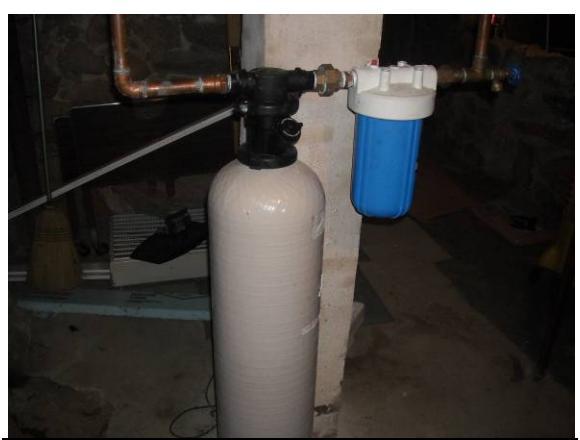
Photo Water treatment tank and filter #28:

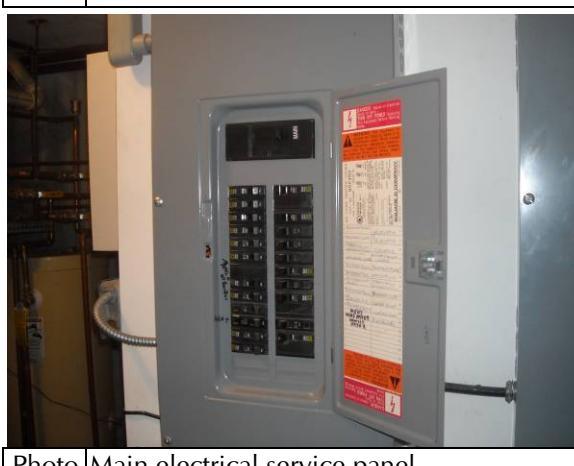
Photo Main electrical service panel #30:

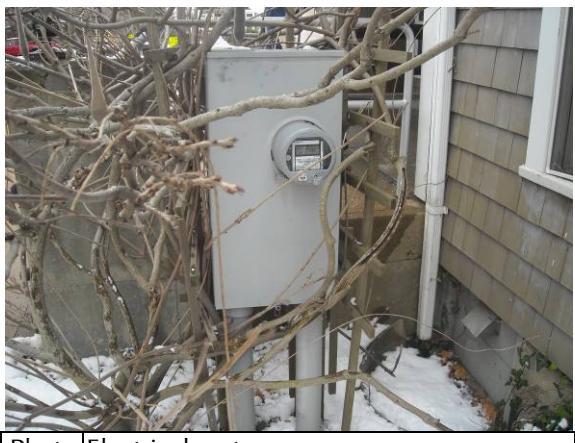
Photo Electrical meter #33:

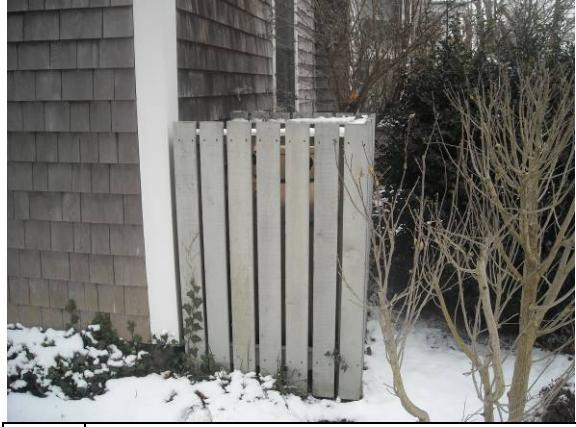
Photo LP gas tank by kitchen #35:

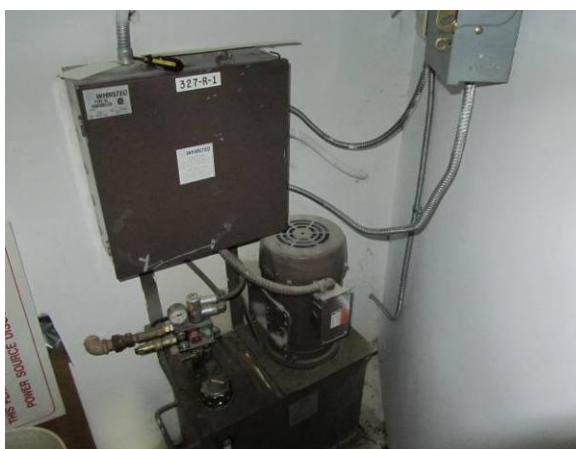
Photo Elevator machine room #32:

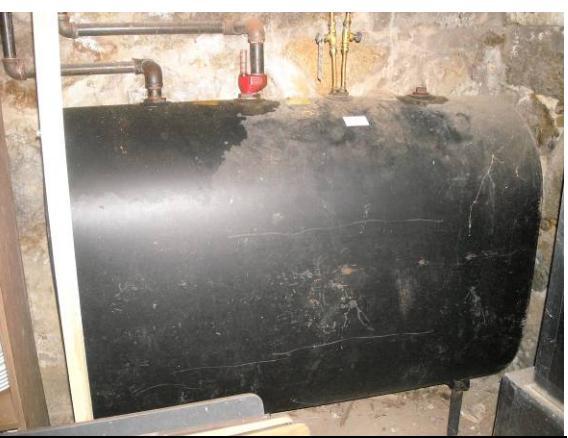
Photo Fuel oil tank in basement crawlspace #34:

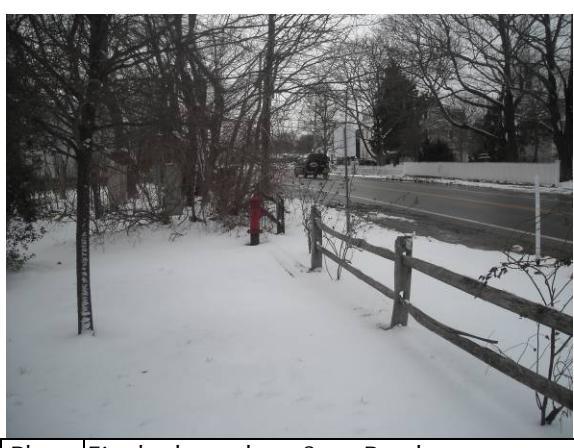
Photo Fire hydrant along State Road #36:

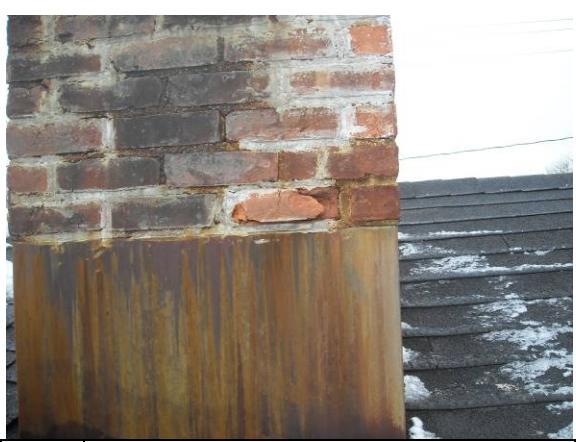
Photo Brick, pointing, and flashing at chimney #42:
